Fatigue Behaviour Under Service and Ground Test Conditions (A Comparison Based on the Dakota Wing)

By
W.J. Winkworth

November, 1961

Several Dakota wings have been tested in fatigue under various conditions. The objective was to obtain an assessment of full scale testing procedures.

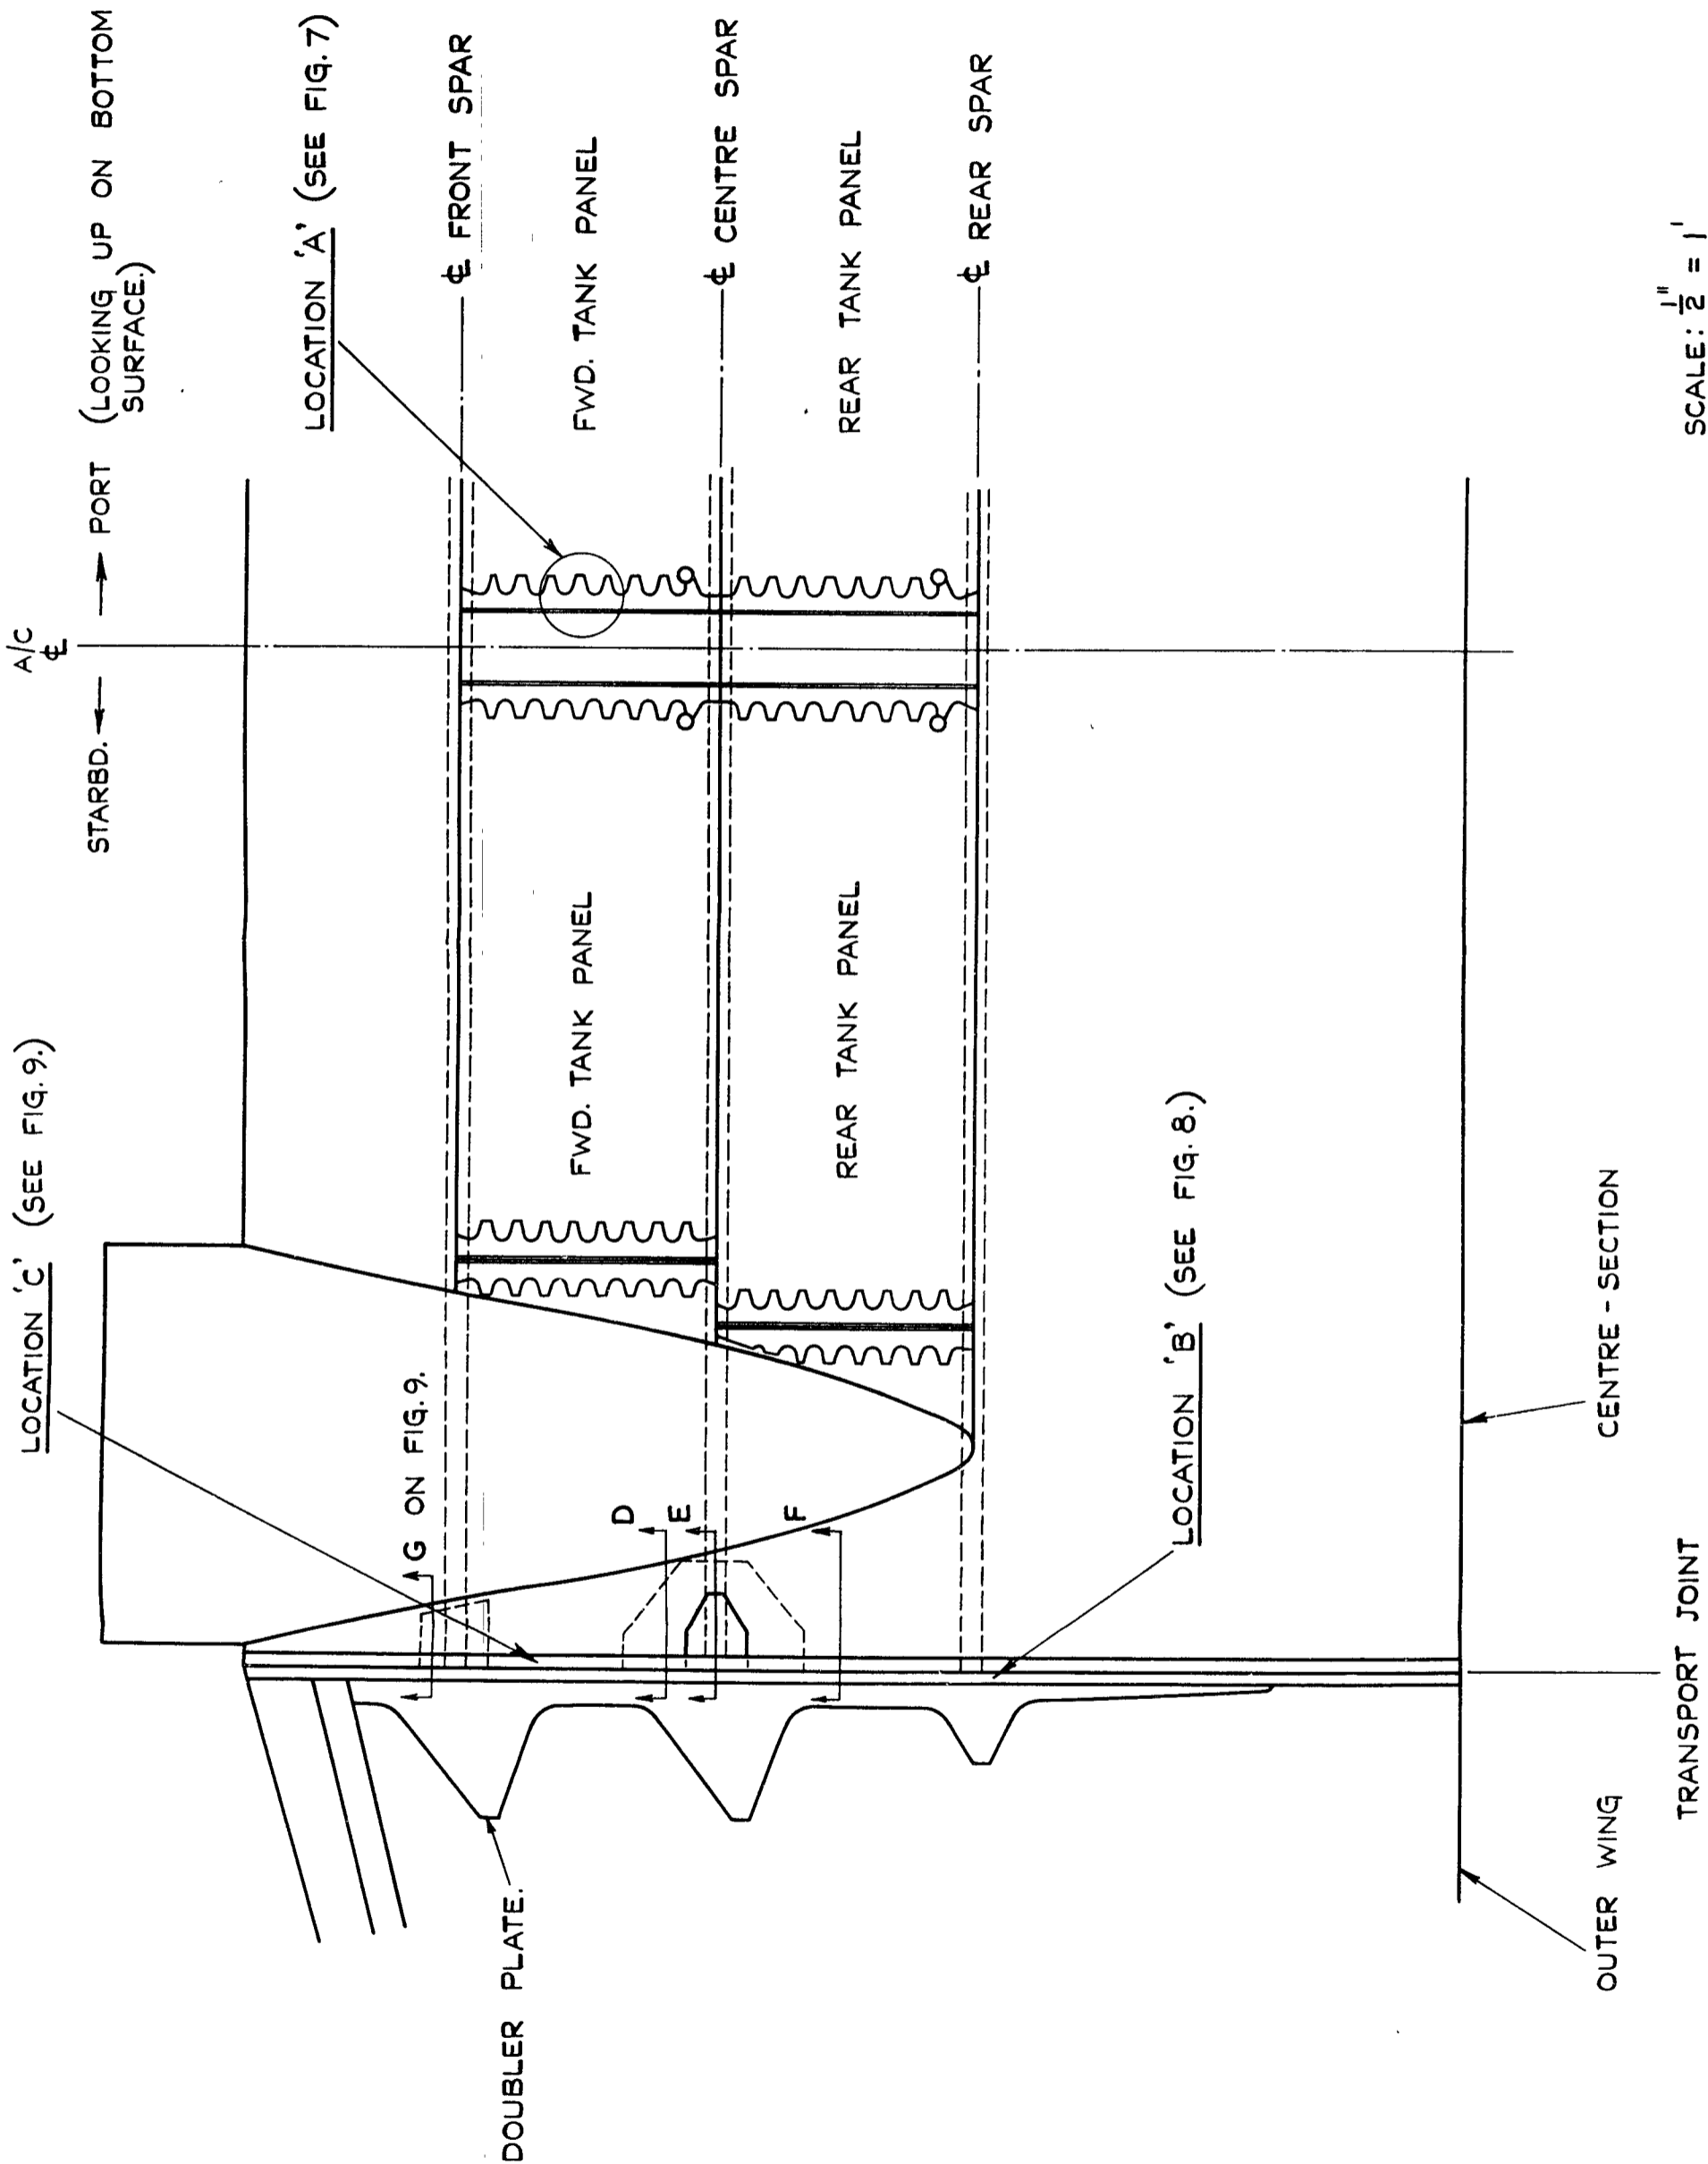
FIG. 6. THE LOCATIONS OF FATIGUE DAMAGE ON THE BOTTOM SURFACE OF THE WING.

The position of the failures at the inboard ends of the fuel tank access panels and on both sides of the transport joint are shown on Fig.6 and described below:-

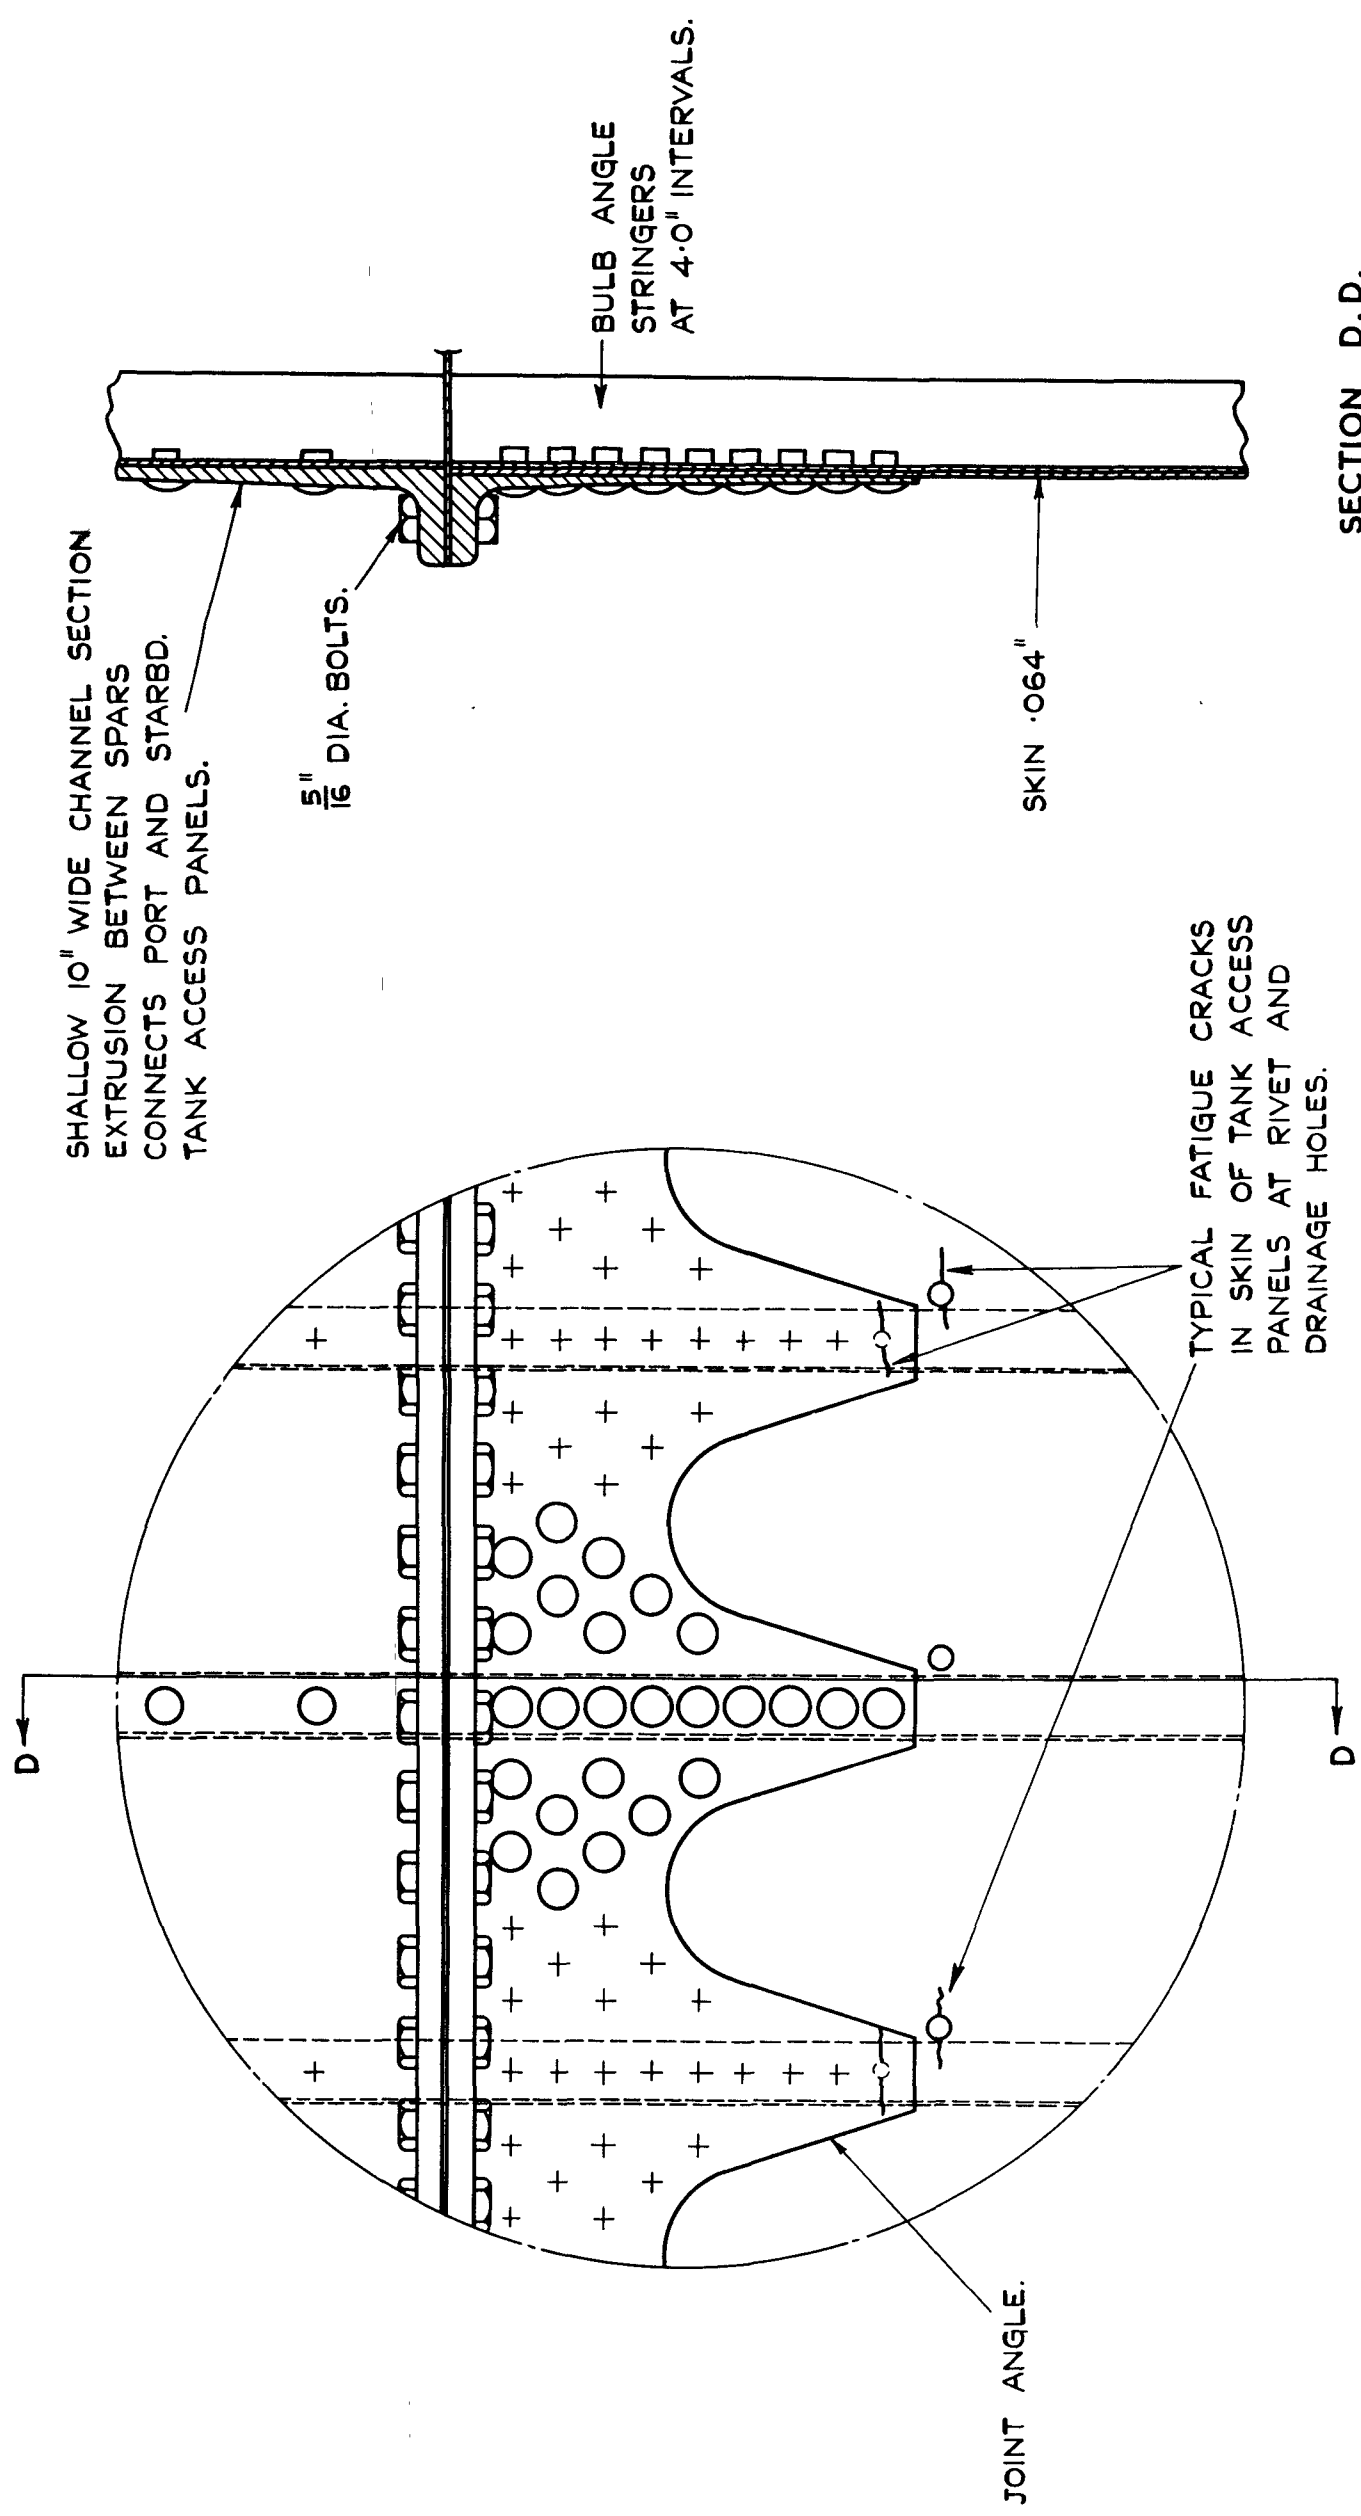
FIG. 7. TYPICAL FATIGUE DAMAGE AT THE INBOARD ENDS OF THE REMOVABLE FUEL TANK ACCESS PANELS IN THE CENTRE SECTION - LOCATION A.

Fatigue cracks formed in the skin at the end rivets attaching the chordwise joint angle and, at a later stage when these had become extensive, further cracks occurred in the bulb angle stringers, Fig.7. A few cracks also formed at the $\frac{1}{4}$ in. diameter drain holes near these end rivets and at the large holes which accommodate fuel drain cocks.

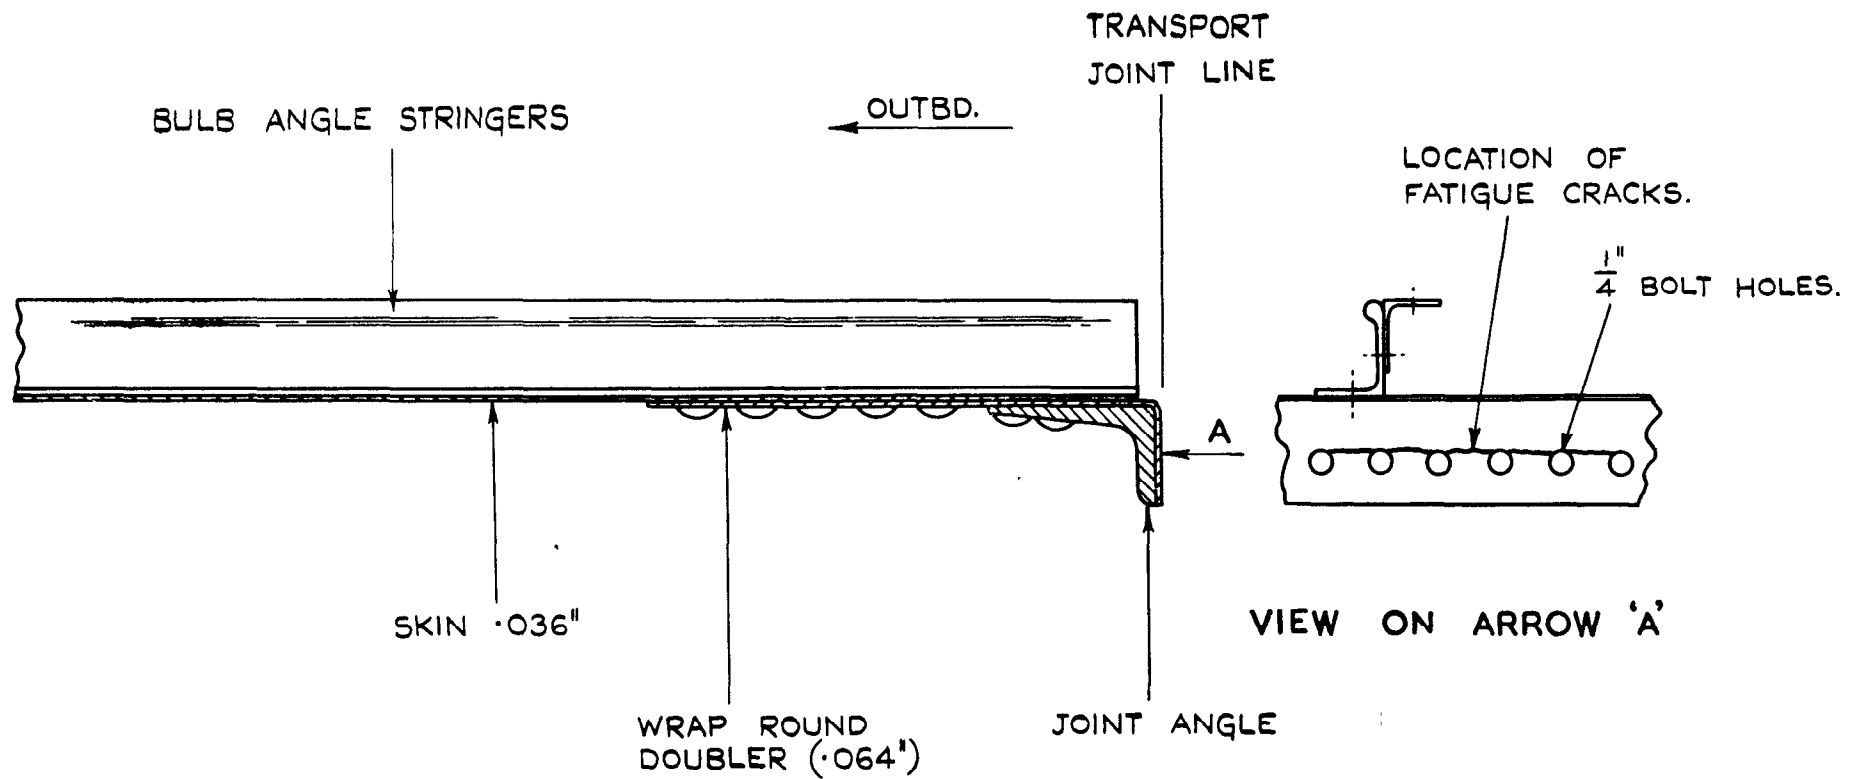
FIG.8. TYPICAL FATIGUE DAMAGE AT THE OUTER WING SIDE OF THE TRANSPORT JOINT - LOCATION B.

Fatigue cracks formed in the vertical flange of the wrap-round doubler; in all cases these were at the spar positions and either tangential to the joint bolt holes, Fig.8, or clear of the bolt holes, Fig.22.

There have been many instances of cracks at B (i.e. in the vertical flange of the outer wing lower skin wrap-round doubler) in the region of the front and centre spars. A statistical survey of these failures which are summarised in Appendix 3 indicates endurances ranging between 2,500 and 24,000 hours, the frequency distribution showing two peaks, the smaller at about 12,000 hours and the larger at about 20,000 hours. Crack lengths were from $\frac{1}{4}$ in. to $6\frac{3}{4}$ in.

A further indication of the fatigue life of these skin doublers is provided by the service inspection and maintenance procedures. Inspections are required at 8,000 hours and then at intervals not exceeding 4,000 hours. The doublers are replaced at 16,000 hours³.

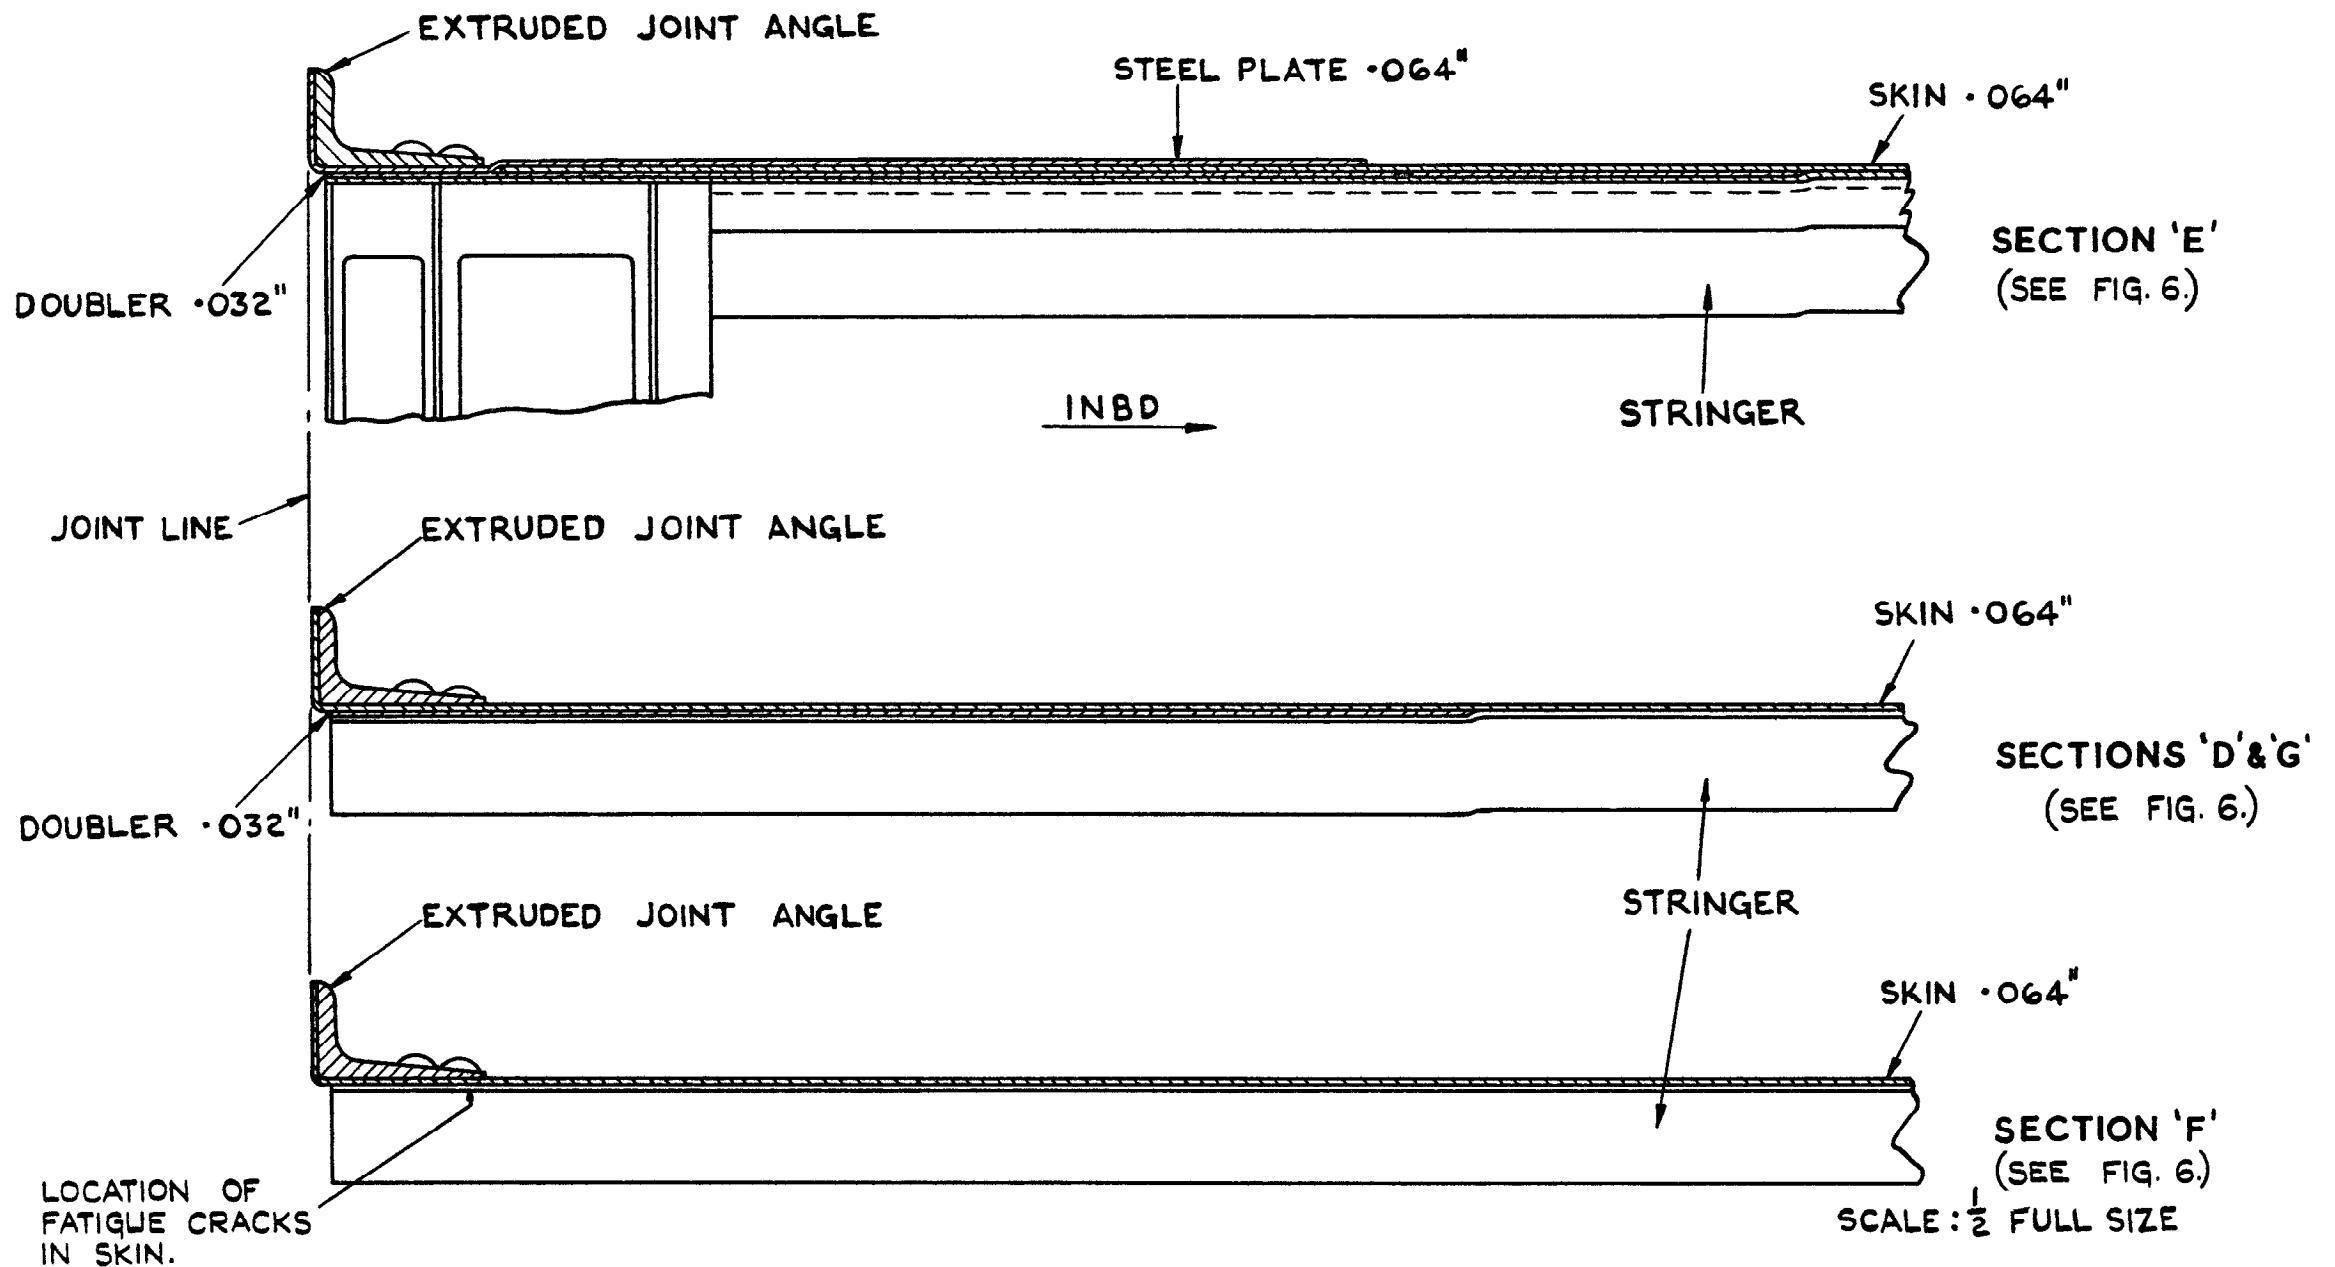
**FIG. 9. DETAILS OF WING STRUCTURE AT THE CENTRE - SECTION
 SIDE OF THE TRANSPORT JOINT - LOCATION C.**

Fatigue cracks formed in the skin at the end rivets attaching the extruded joint angle, Fig.9. As the skin was sandwiched between the joint angle and the internal doubler plate, these cracks could not be seen.

Details are given of four instances of fatigue failure in the vertical flange of the bottom skin in the centre-section at the wing transport joint. The lives of the aircraft were between 20,374 and 26,773 hours and the fatigue cracks were in the region of the centre spar. This failure is similar to the outer wing lower doubler failures, i.e. Location B in the wing tests. The method of repair is not detailed, (it might possibly be the steel plate insertion shown in Fig.9 which was incorporated on all the test wings).

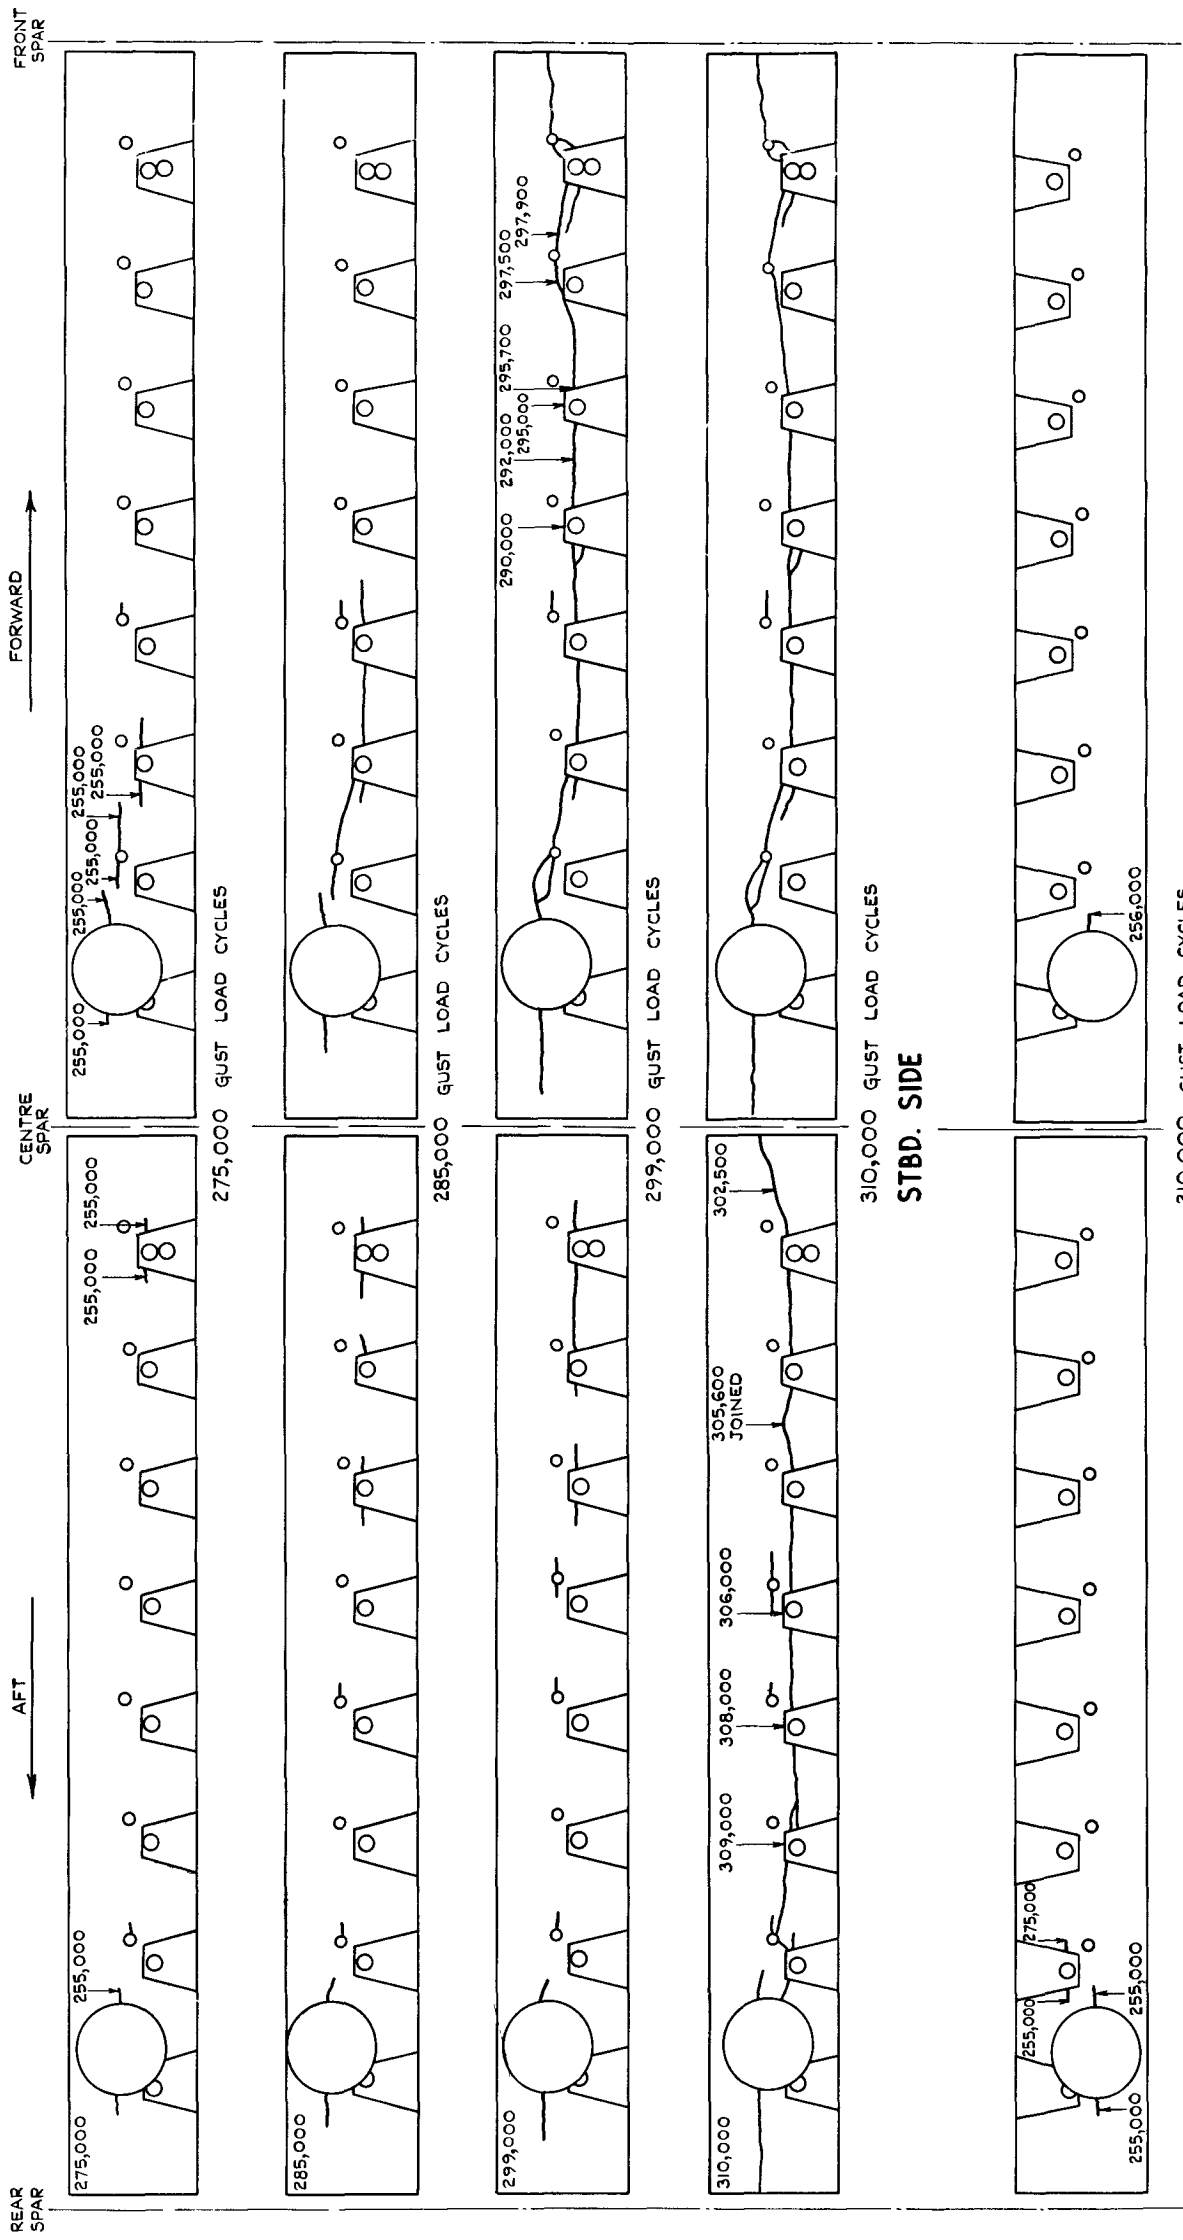
FIG. 10. DETAILS OF SKIN CRACKS AT LOCATION 'A'.

255,000	Fatigue cracks were found at Location A; these cracks grew and others originated as the test proceeded, Fig.10.
300,600	The forward removable tank access panel on the starboard side had fractured at Location A, Fig.11.
313,000	The rear access panel had also fractured, Fig.12. The test was stopped to replace the centre-section as complete failure was imminent at Location A on the starboard side. There were only one or two small cracks on the port side. Fatigue cracks at A first appeared at 209,000 gust load cycles in the replacement centre-section. It sustained 346,000 gust load cycles and, in general, its performance was similar to the original one.

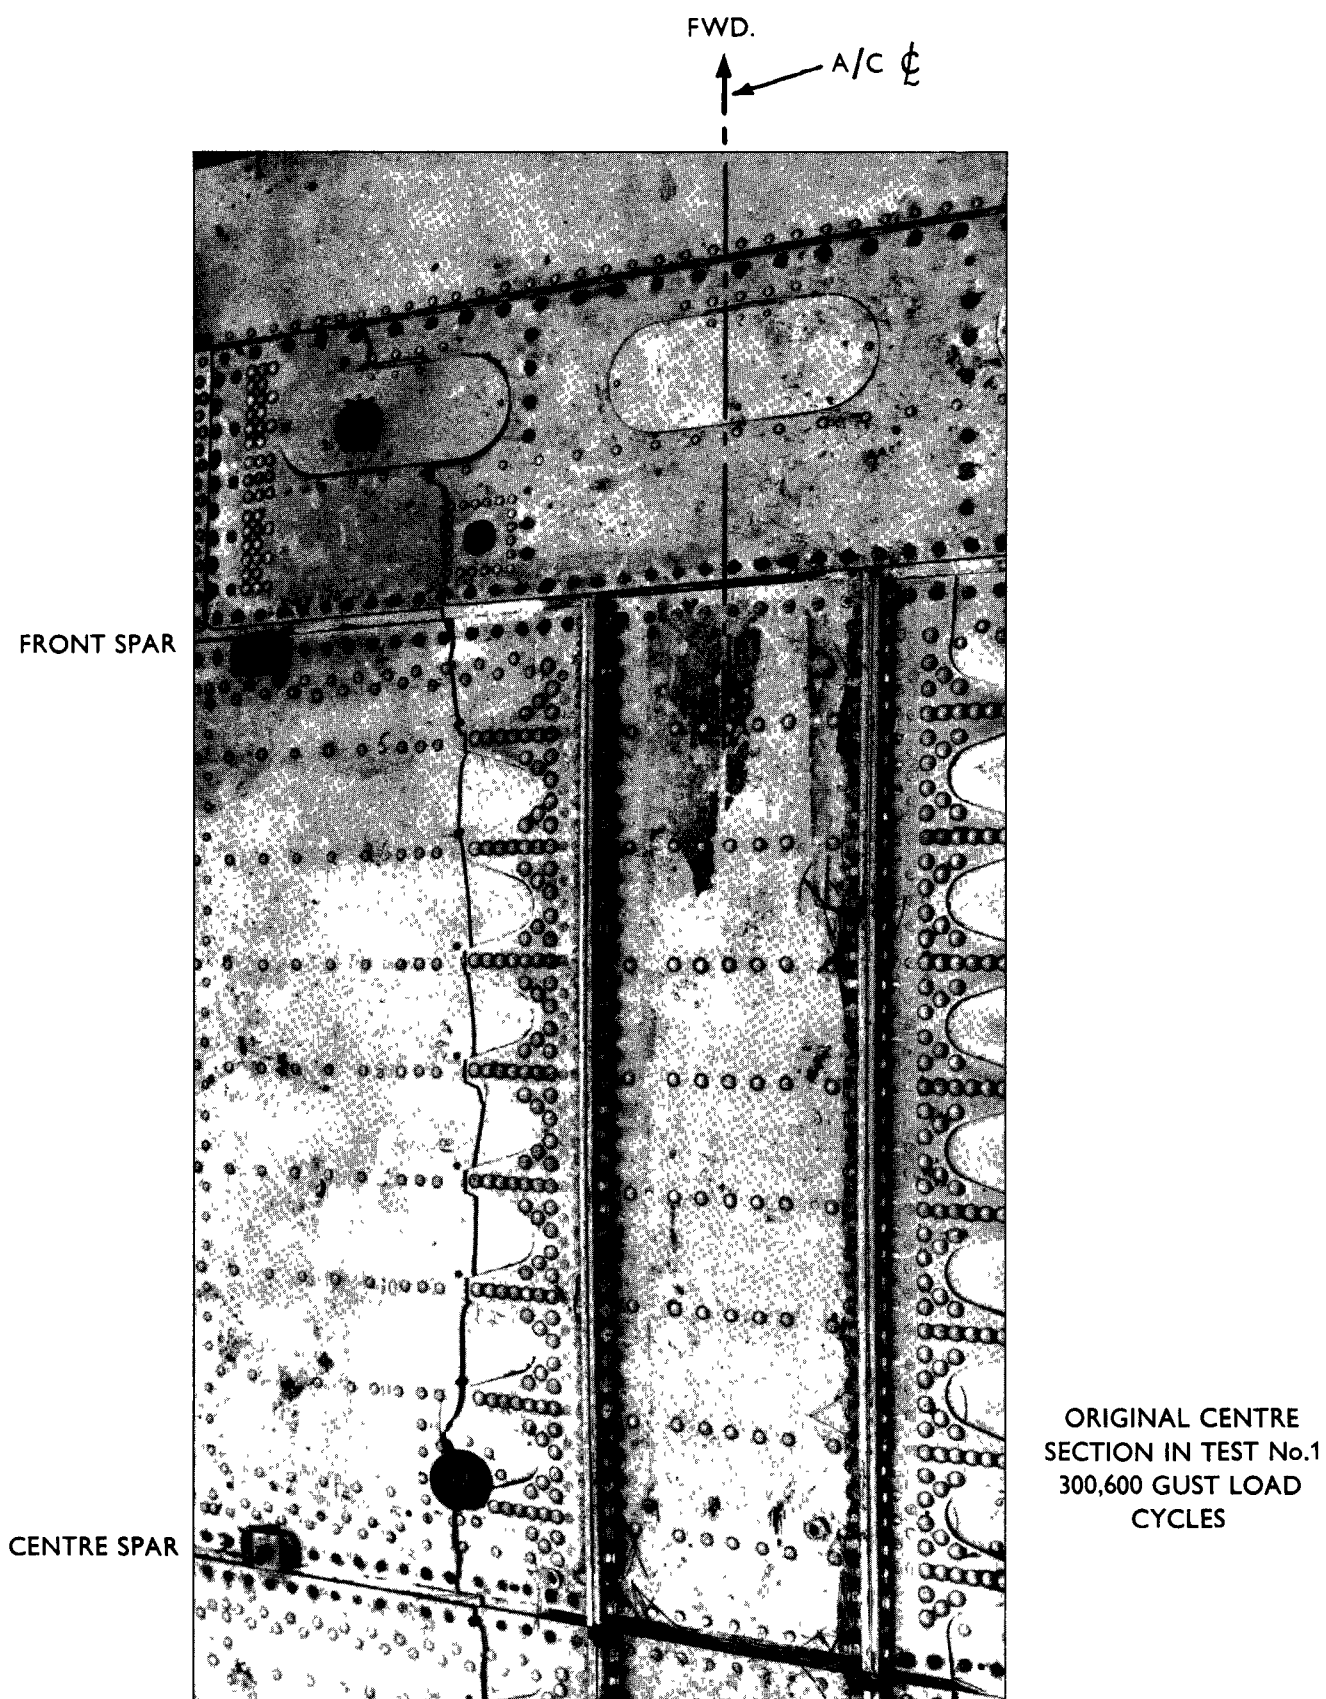
PHOTO AT END OF TEST WHEN THE INDIVIDUAL CRACKS WHICH HAD ORIGINATED AT RIVET AND DRAIN HOLES HAD FINALLY JOINED TO PRODUCE FRACTURE OF THE ACCESS PANEL

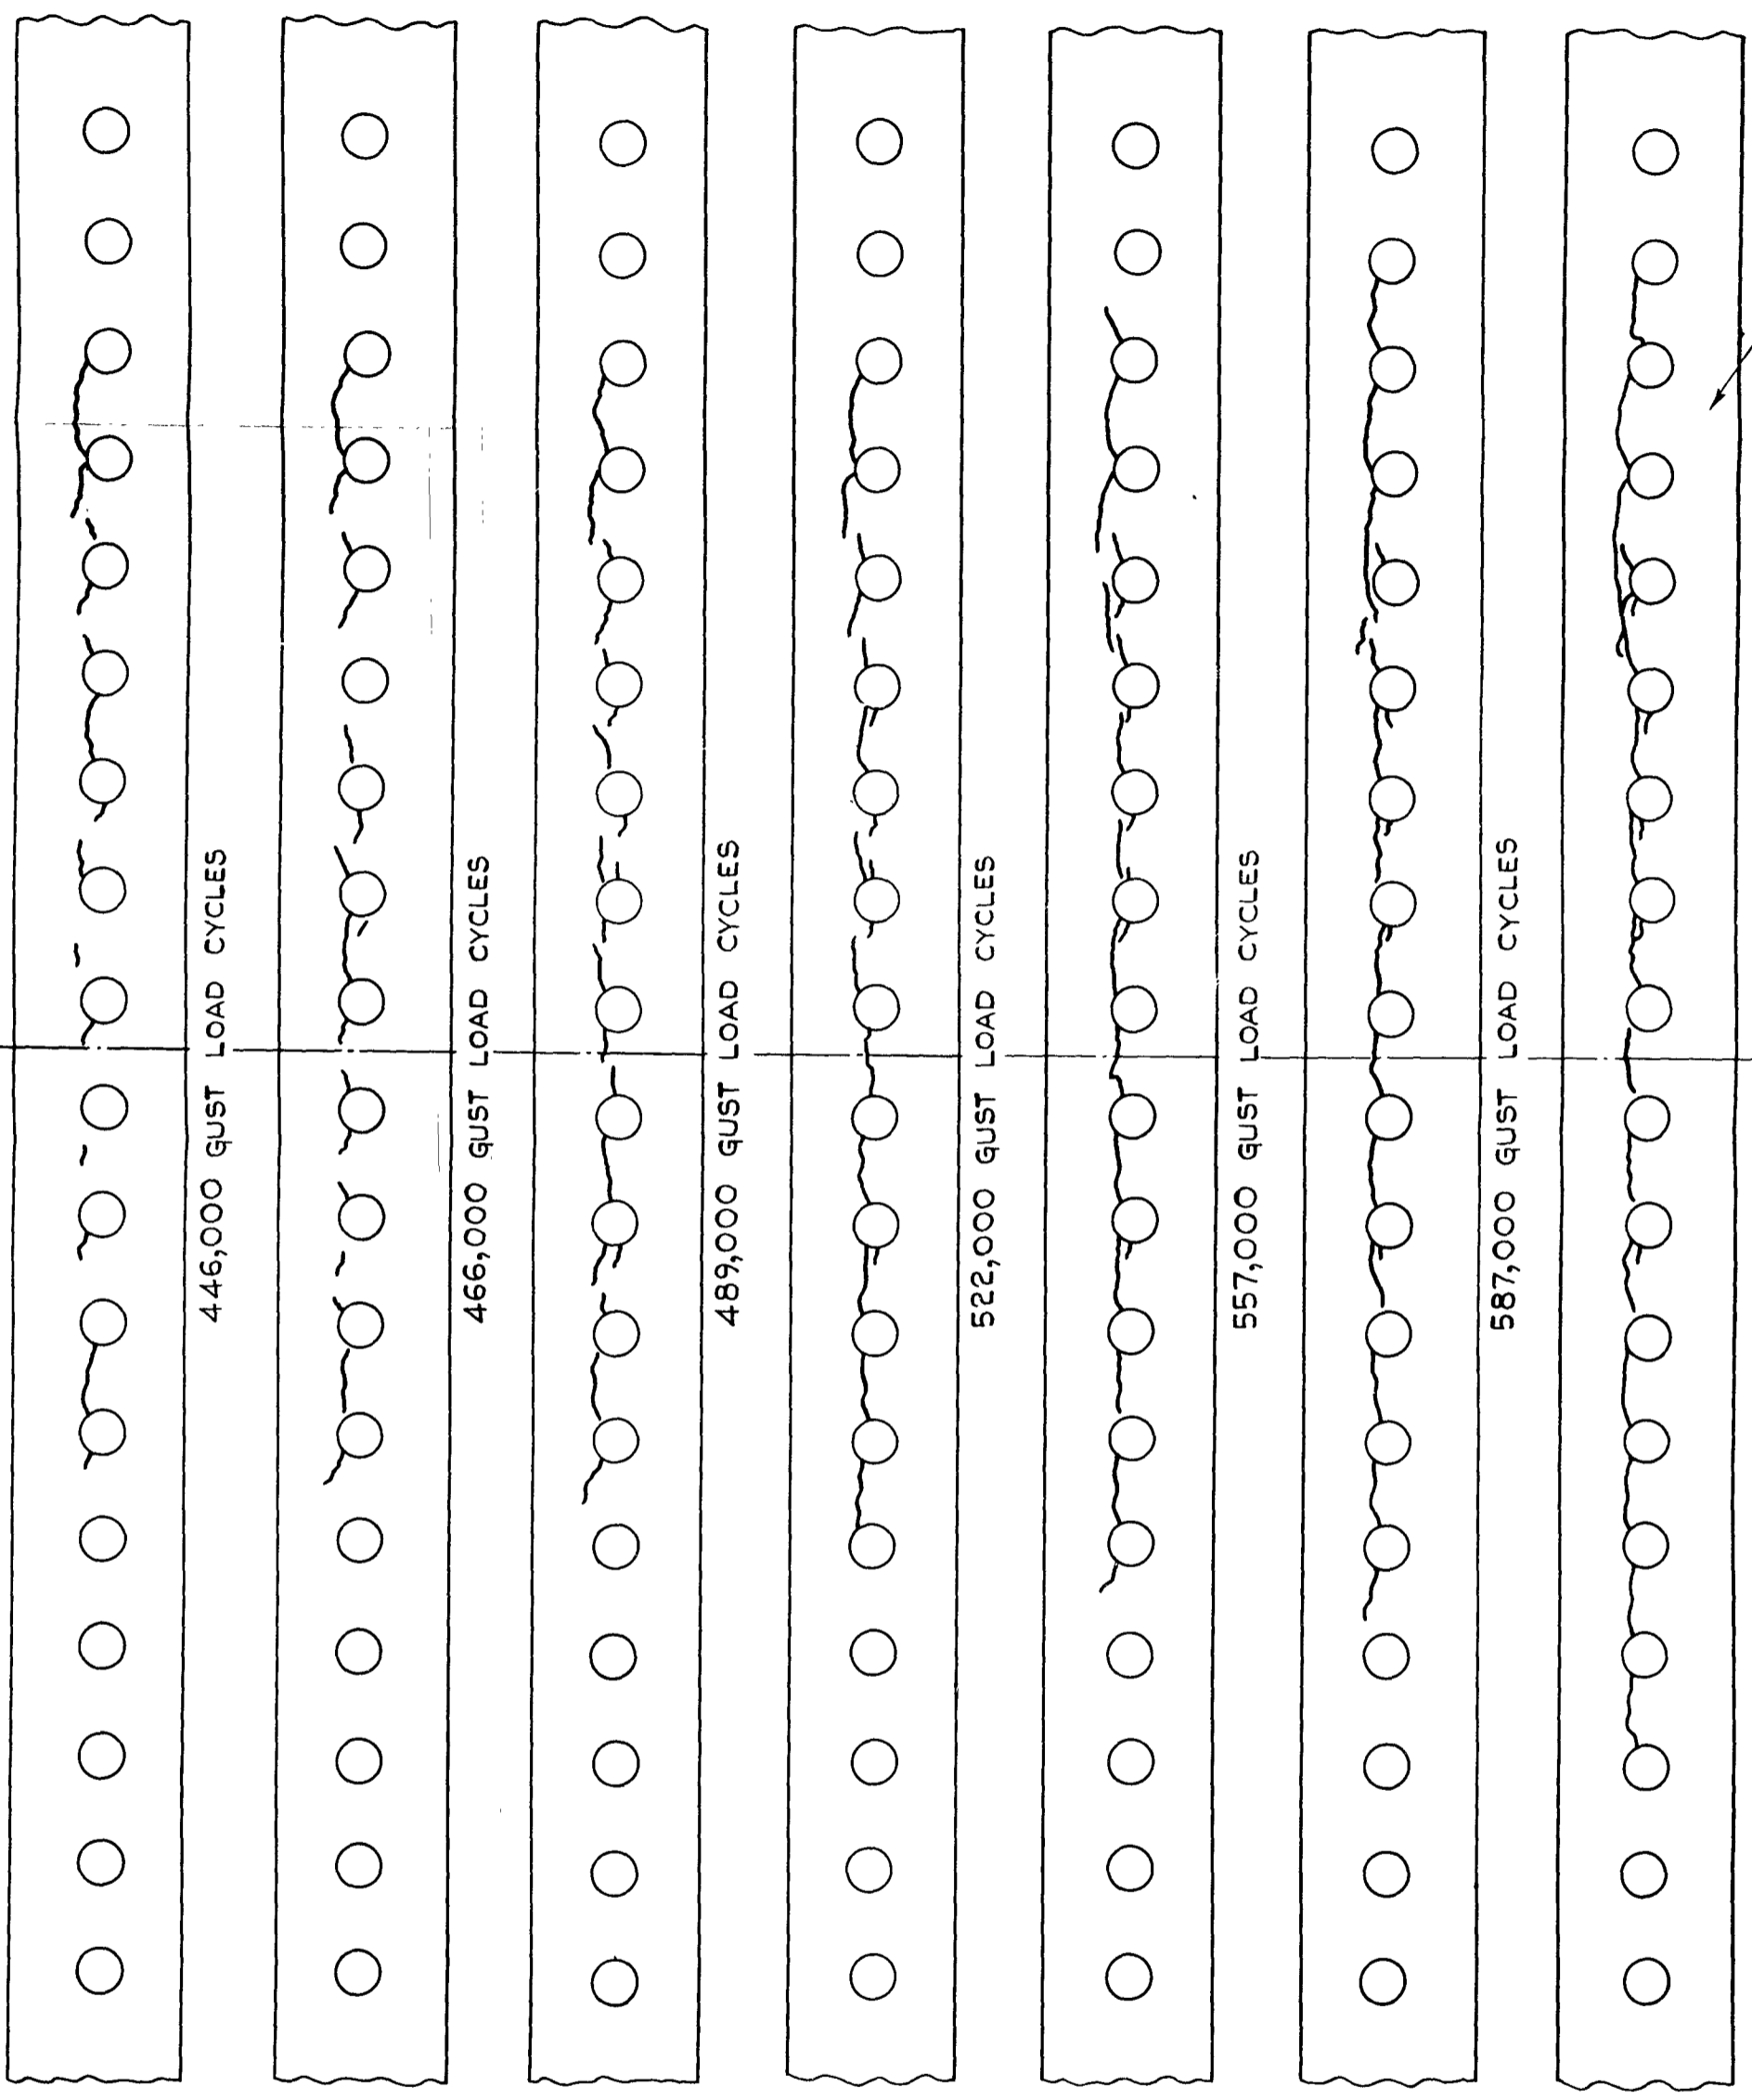
**FIG. 13. GROWTH OF FATIGUE CRACKS AT LOCATION 'B',
STARBOARD OUTER WING IN TEST No. 1.**

<u>Gust load cycles</u>	
313,000	No damage was visible at Location B when the transport joint was disconnected for centre-section replacement.
446,000	Cracks which possibly began to form at about 400,000 cycles were found at B at the centre spar position on the starboard wing only; these grew fairly slowly, Figs.13 and 14.
623,000	The vertical flange of the joint angle at B had also cracked at the centre spar position on the starboard wing, Fig.15.
659,000	The test was stopped as failure was imminent at Location A on the replacement centre-section.

The crack in the joint angle at B was 5 ins. long and a similar crack 1.5 ins. long was visible at the rear spar position, also on the starboard wing. There was no visible damage at B on the port wing.

VIEW ON TRANSPORT JOINT FACE
i.e. ON THE VERTICAL FLANGE OF
THE WRAP-ROUND DOUBLER.

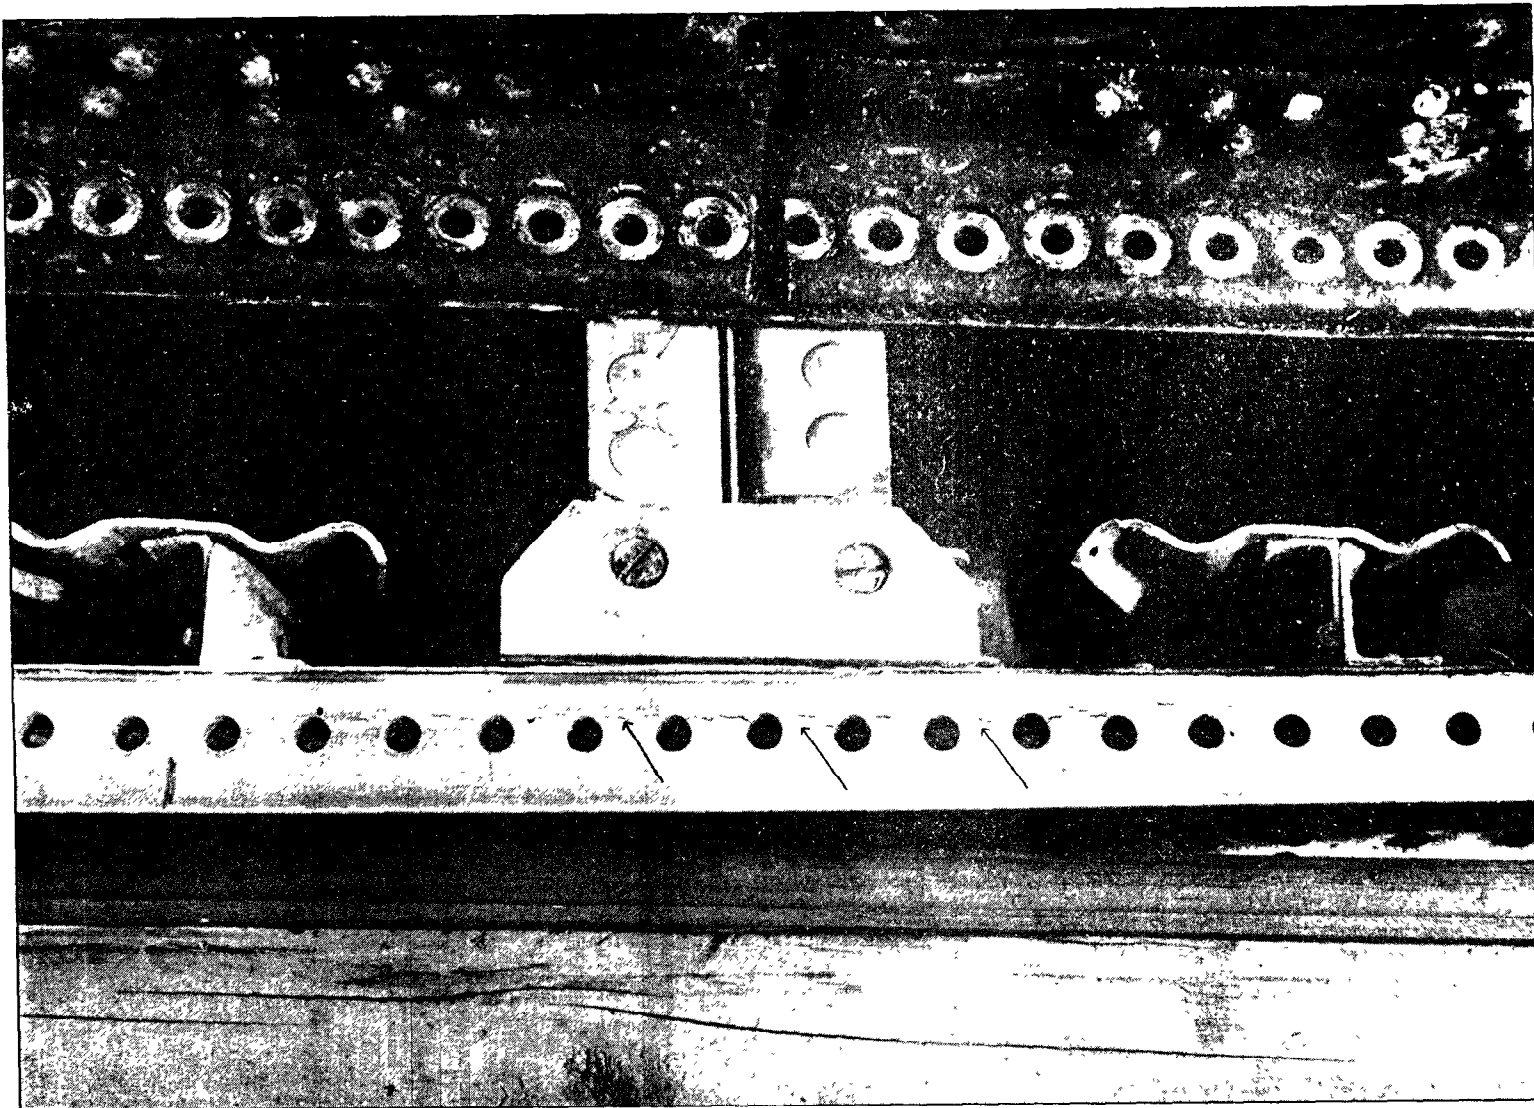
FIG.14. FATIGUE DAMAGE IN THE 16 S.W.G. WRAP-ROUND
DOUBLER AT THE TRANSPORT JOINT (OUTER WING SIDE)
(LOCATION 'B' ON FIGS.6 and 8)

STARBOARD OUTER WING
IN TEST No.1
CENTRE SPAR POSITION
PHOTO TAKEN AT 587,000
GUST LOAD CYCLES
