Fatigue Behaviour Under Service and Ground Test Conditions (A Comparison Based on the Dakota Wing)

By
W.J. Winkworth

November, 1961

Several Dakota wings have been tested in fatigue under various conditions. The objective was to obtain an assessment of full scale testing procedures.

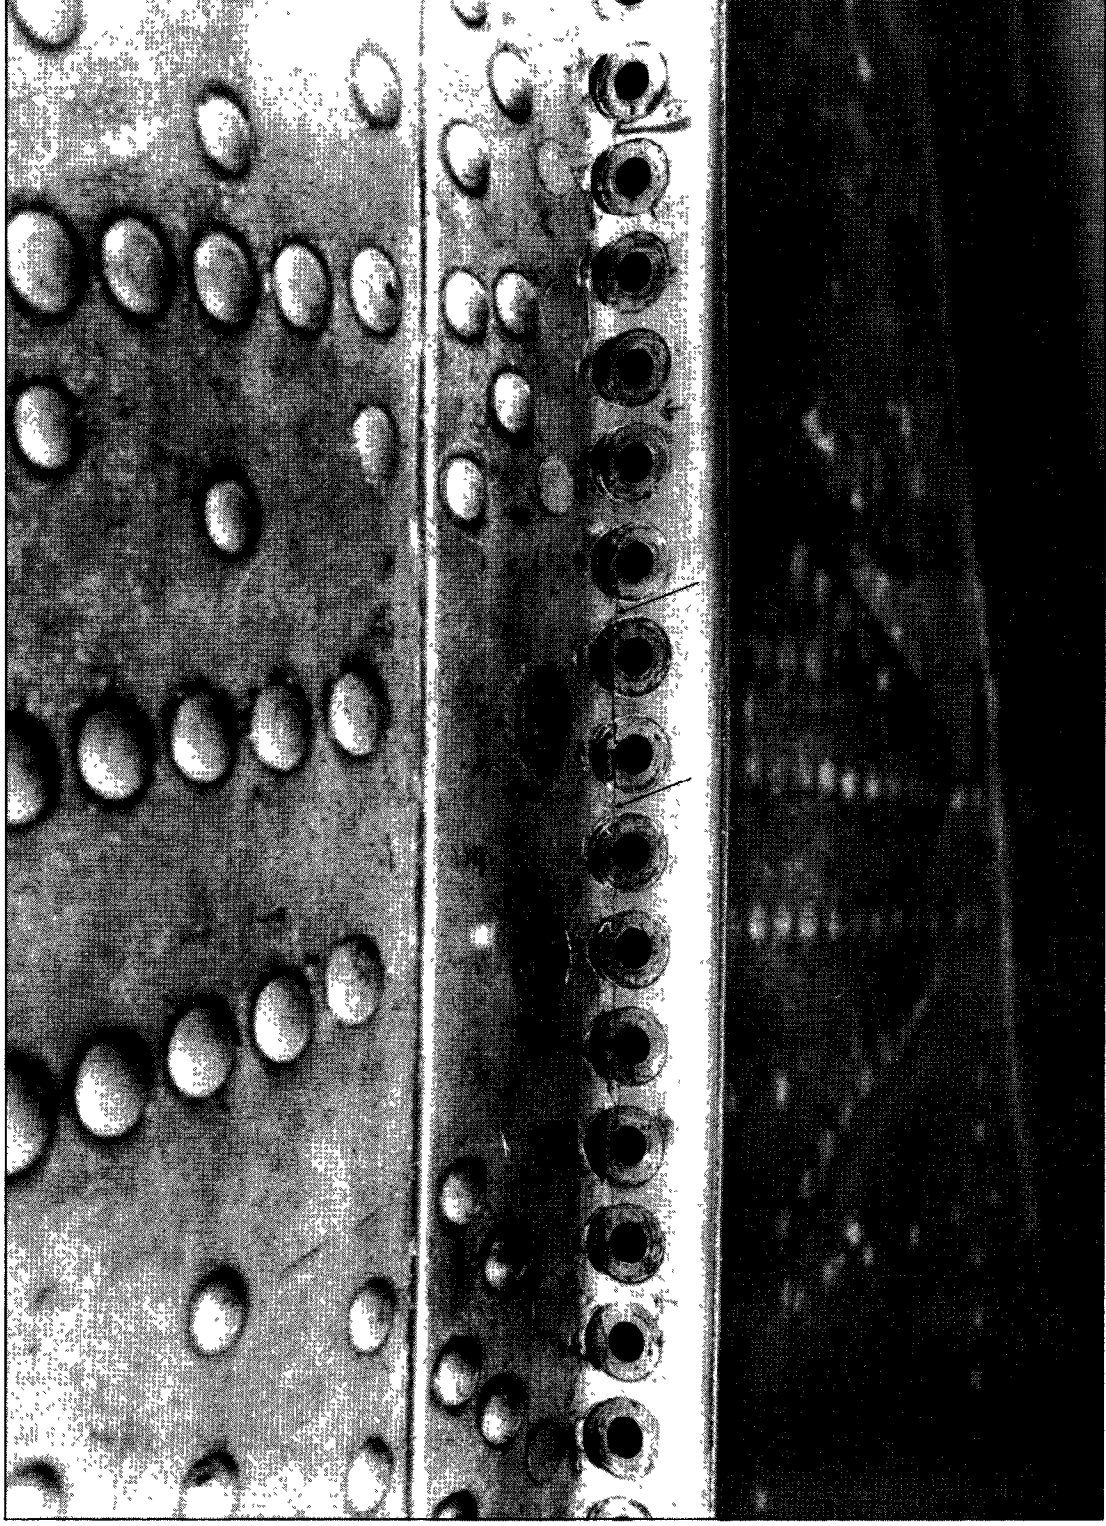
FIG.15. FATIGUE CRACK IN THE VERTICAL FLANGE OF THE EXTRUDED
JOINT ANGLE AT THE TRANSPORT JOINT (OUTER WING SIDE)
(LOCATION 'B' ON FIG.6)

STARBOARD OUTER WING
IN TEST No.1
659,000 GUST LOAD CYCLES
AT CENTRE SPAR POSITION

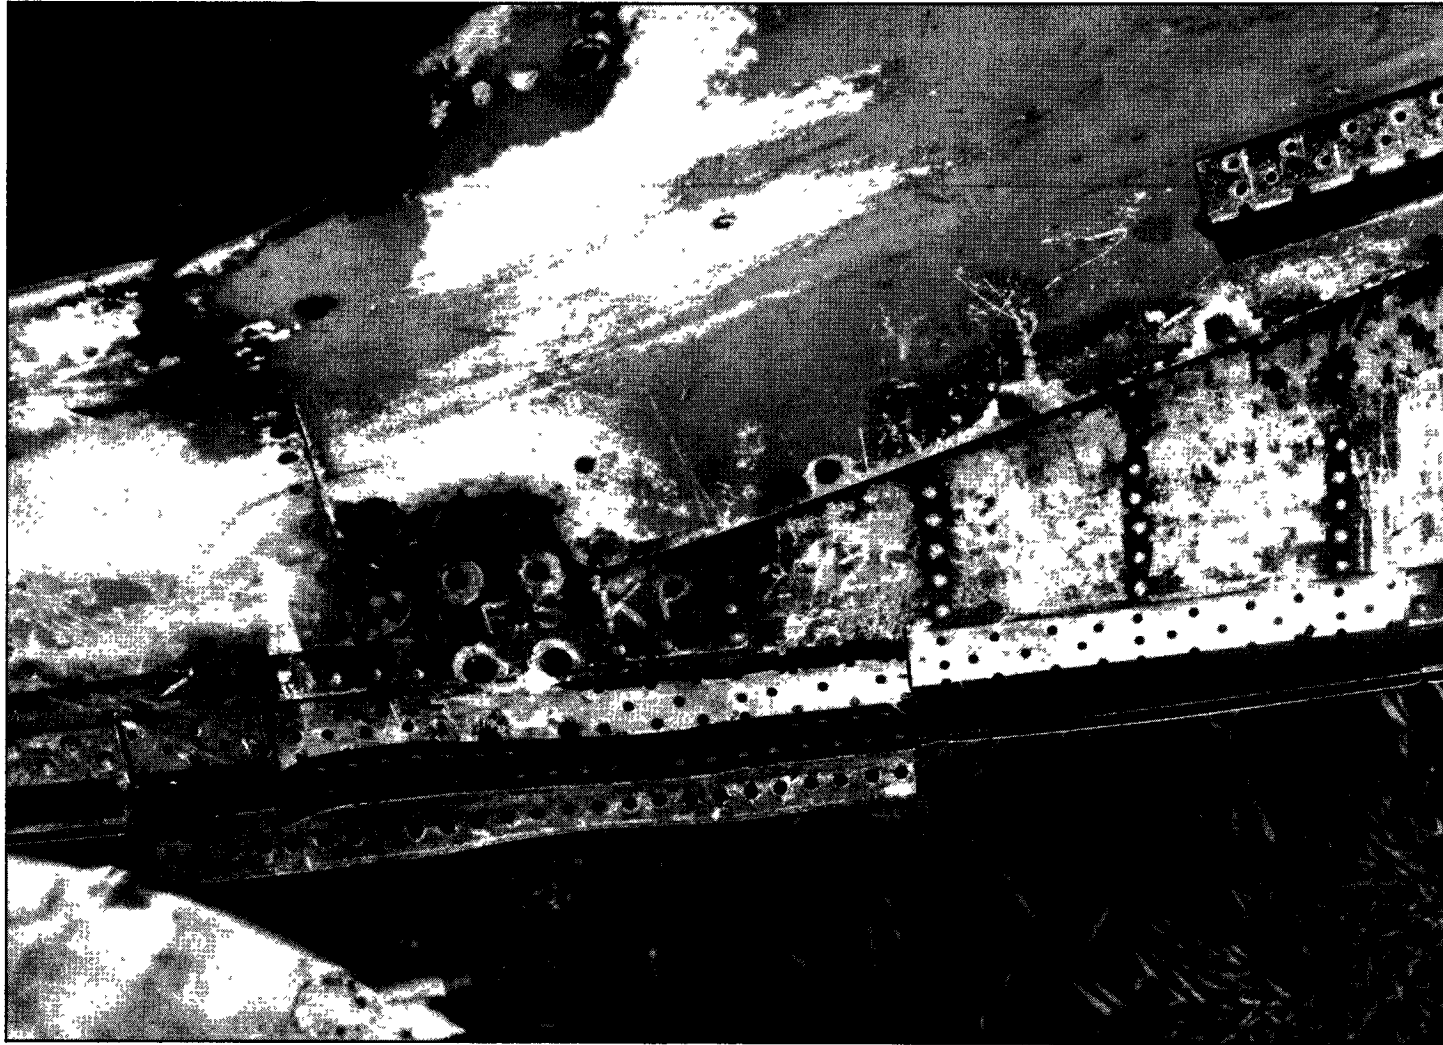
FIG.16. FATIGUE DAMAGE IN THE CENTRE SECTION AT THE
TRANSPORT JOINT

Location C type damage was unsuspected until failure occurred at this point in the third test. By this time the original centre-section had been disposed of and it was therefore not possible to establish whether or not damage had taken place. On removing the joint angle on the replacement centre-section, extensive skin cracks were revealed on the starboard side, Fig.16. No cracks were visible at Location C on the port wing.

REPLACEMENT CENTRE SECTION
IN THE FIRST TEST.
346,000 GUST LOAD CYCLES
SKIN CRACKS UNDER THE TRANSPORT
JOINT ANGLE IN THE REGION OF
THE FRONT SPAR

*EXTRUDED JOINT ANGLE REMOVED TO SHOW FATIGUE CRACK IN SKIN
(LOCATION "C" ON FIG.6)*

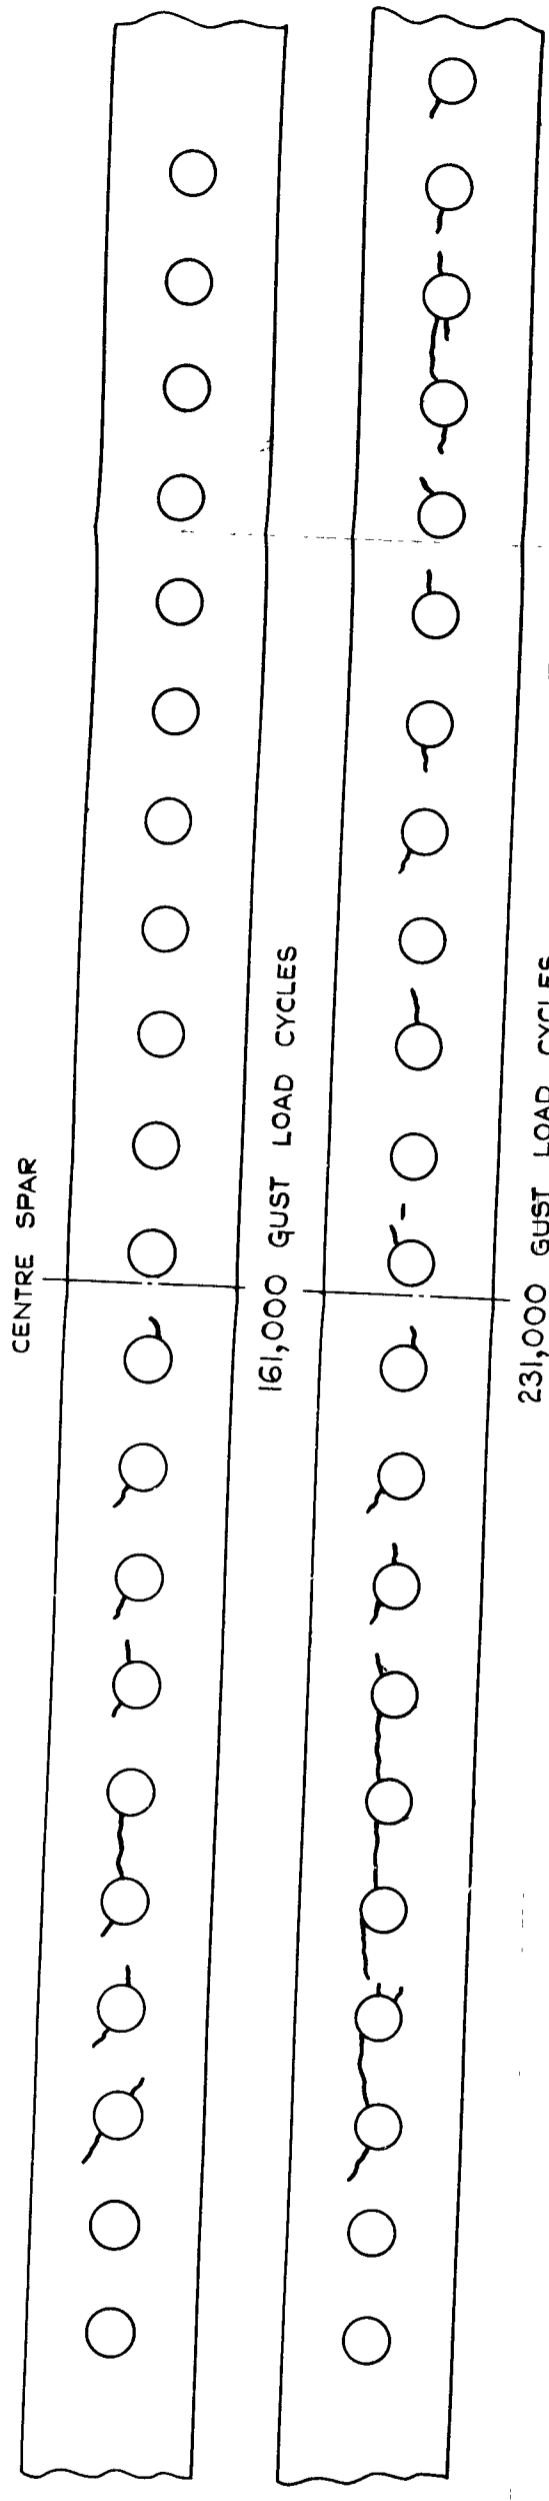
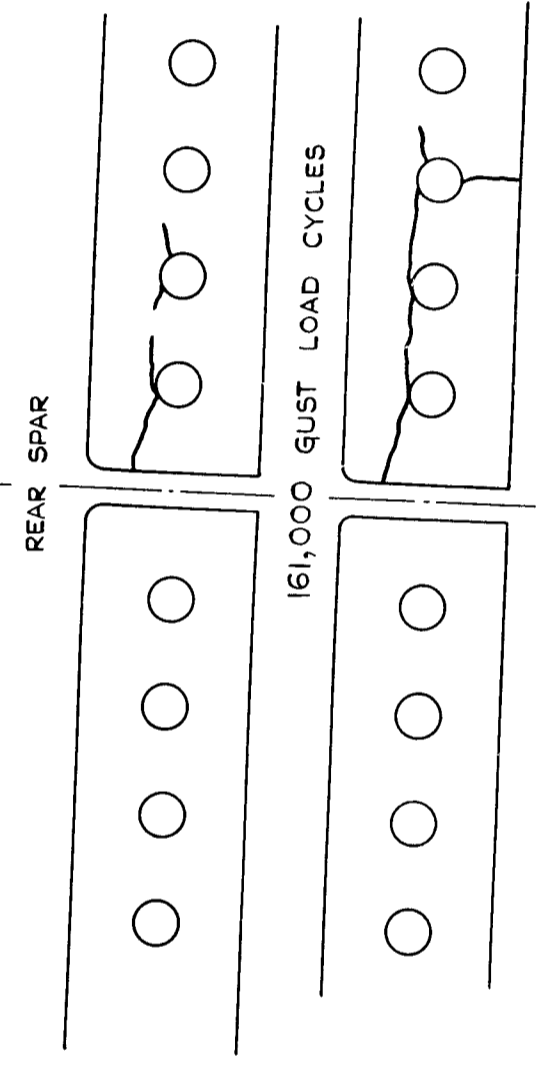
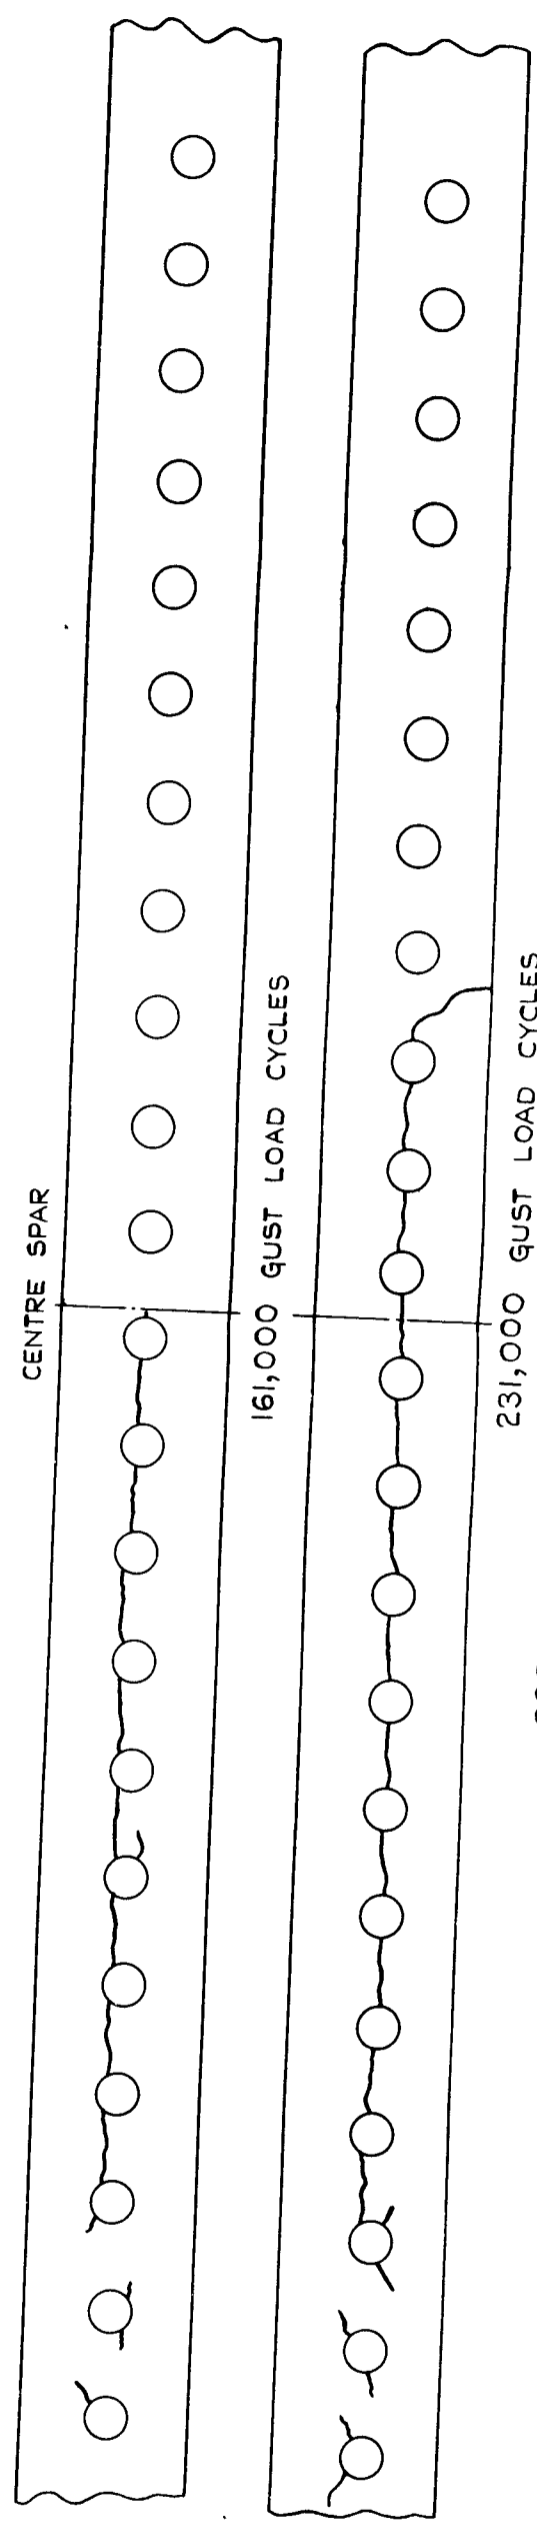
FIG. 17. GROWTH OF FATIGUE CRACKS AT LOCATION 'B' IN TEST No. 2.

At B there were cracks at the centre-spar positions on both sides, and also at the rear spar position on the port side. The joint angle at this latter position was cracked in its vertical flange over four bolt pitches (about 2 inches). These cracks possibly began to form at about 100,000 gust load cycles.

The extent of cracking at Location B is shown on Fig.17.

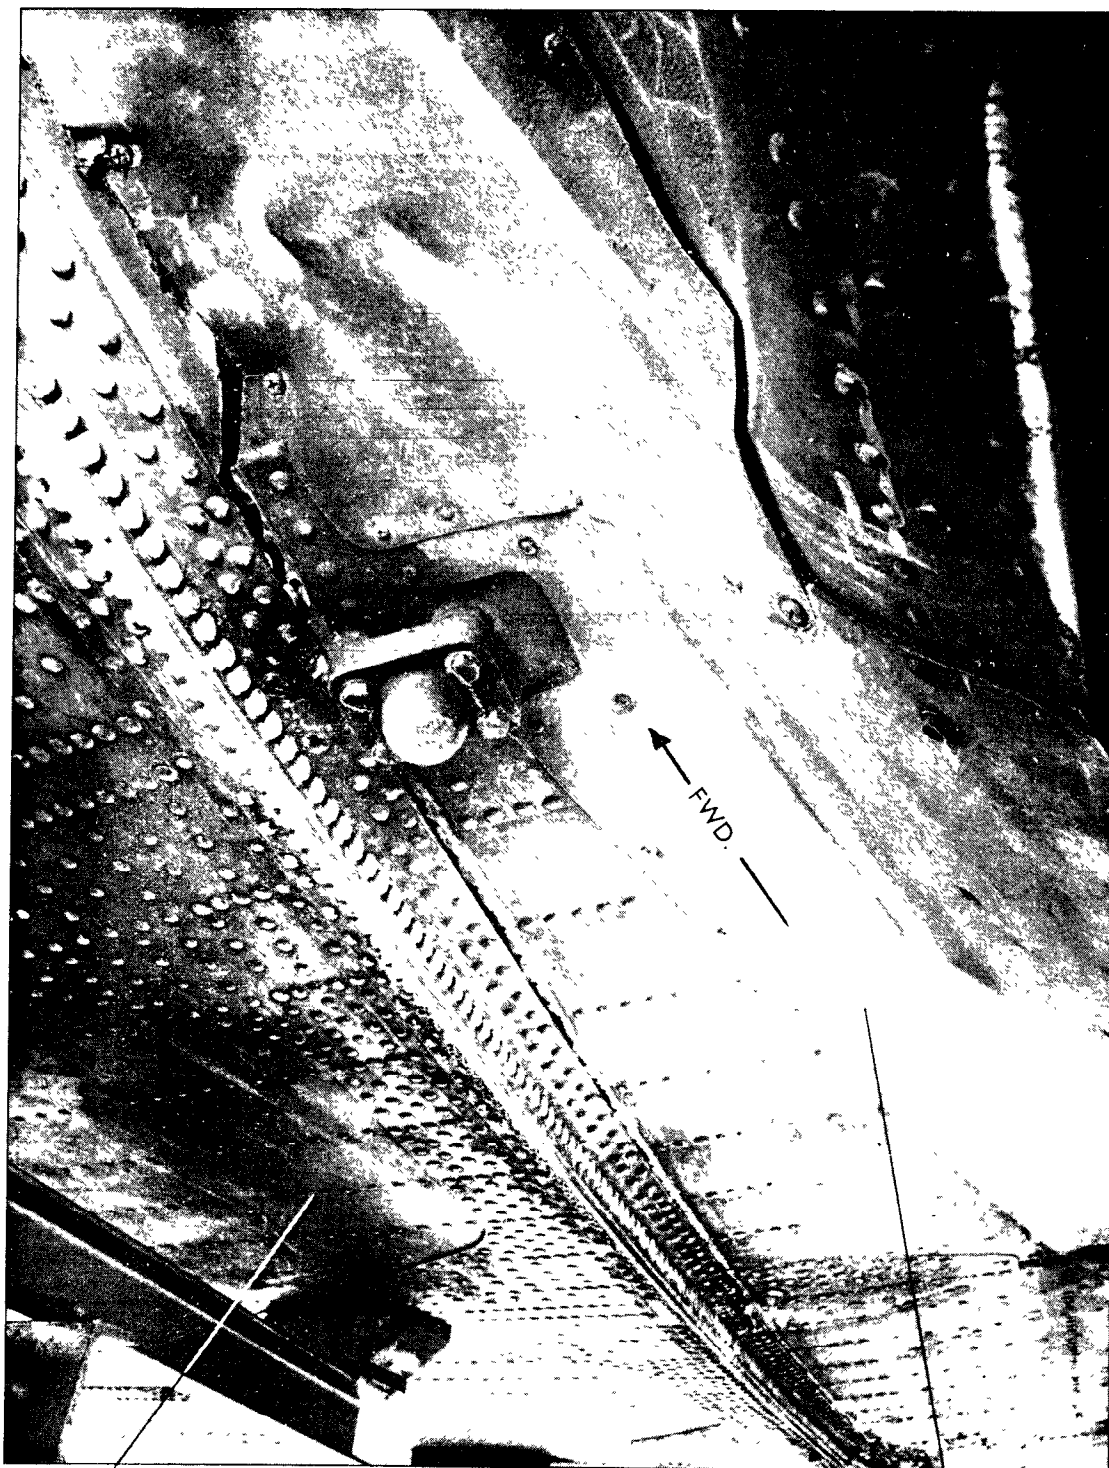
FIG.18. FAILURE IN BOTTOM SKIN OF CENTRE-SECTION
AT THE TRANSPORT JOINT

A complete failure occurred at Location C on the starboard wing, Figs.18, 19 and 20. The fracture was in the wing skin and the developing fatigue cracks had not been found during inspections, because they were between the external joint angle and the internal skin doubler and therefore not visible.

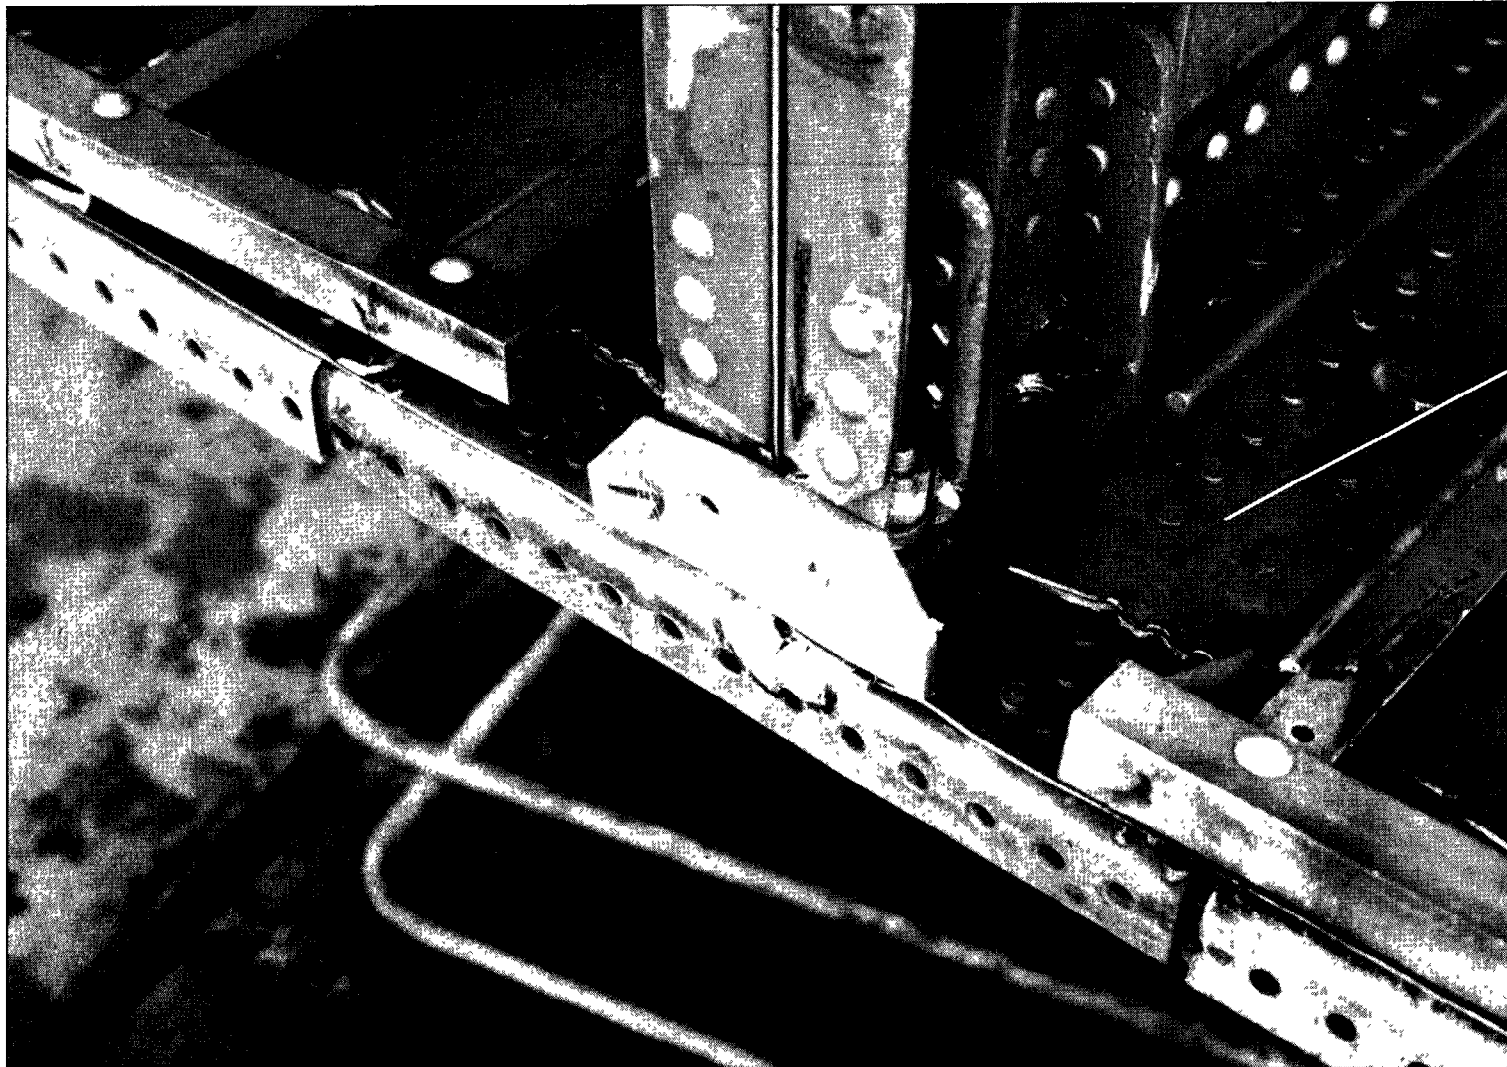
FIG.20. FAILURE OF BOTTOM SKIN OF CENTRE-SECTION
AT THE TRANSPORT JOINT
(LOCATION 'C' - TEST No.3)

NOTE:-
THE FATIGUE CRACKS WHICH
CAUSED THE FAILURE ORIGINATED
IN THE SKIN BETWEEN THE
INTERNAL SKIN DOUBLER AND
THE MAIN JOINT ANGLE, AND WERE
NOT, THEREFORE, VISIBLE DURING
THE TEST

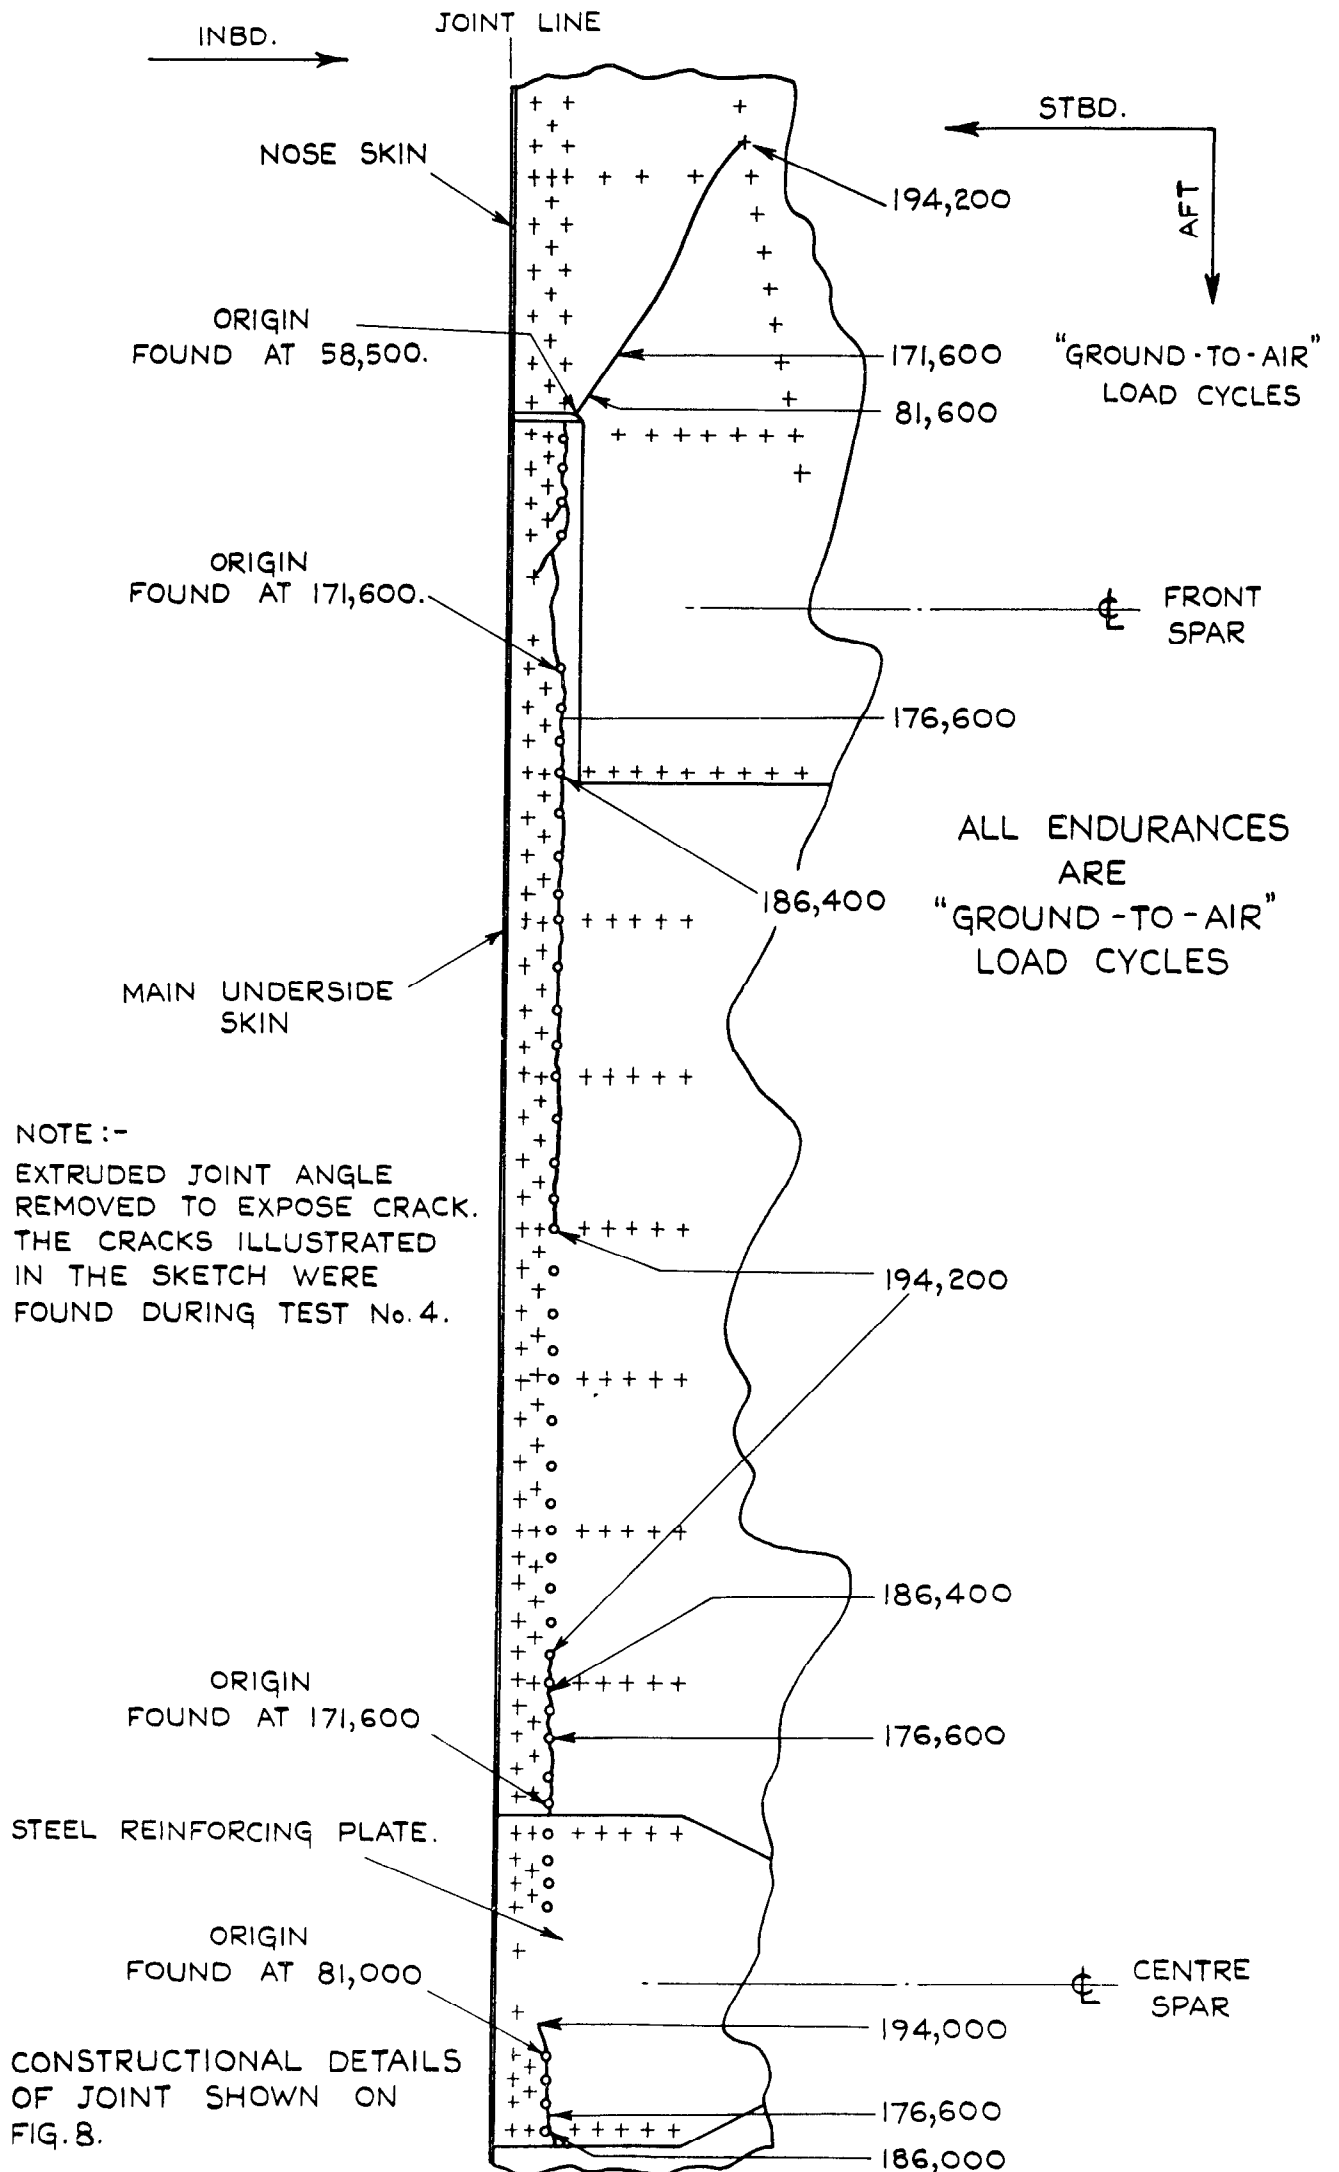
58,500	A fatigue crack in the skin at Location C starboard side was found by X-ray technique. The position of the crack and its subsequent growth is shown on Fig.21.
107,000	No damage was visible at Location B
116,000	A $2\frac{1}{4}$ inch crack was observed near Location B in the horizontal flange of the transport joint angle at the starboard centre spar position; its subsequent growth was very slow ($3\frac{1}{4}$ inch long at the end of the test).
139,000	Fatigue cracks were found at Location B at the starboard front and rear spar position, Fig.22.
