Civil Aircraft Airworthiness
Data Recording Programme
Special Events Relating to
Airspeed Control and Handling
(January 1968 to February 1969)

CAADRP Special Events Working Party

CIVIL AIRCRAFT AIRWORTHINESS DATA RECORDING PROGRAMME

SPECIAL EVENTS RELATING TO AIRSPEED CONTROL
AND HANDLING (January 1968 to February 1969)

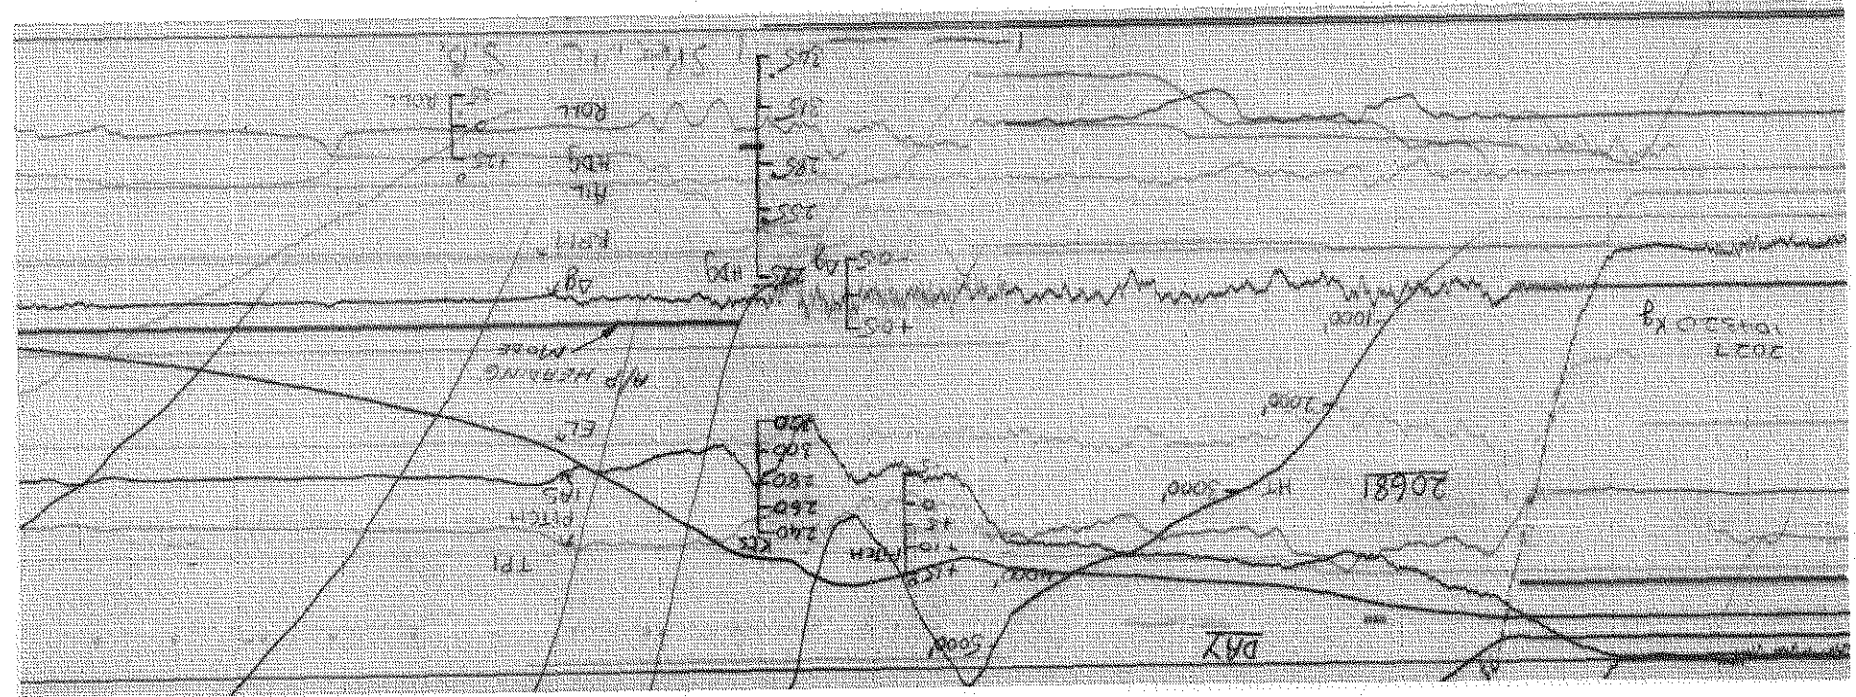
Fig. 2. Event in flight 20681

(iii) The height control events in Figs.2, 3 and 7 were caused by failing to anticipate local height keeping requirements in good time and two of the events involved manoeuvre loads of a magnitude which only occur roughly once in 3000 hours.

The aircraft climbed out from Montreal to 5500 ft and then descended in light to moderate turbulence with reduced power to 3200 ft before continuing the climb. Power and pitch changes at the resumption of the climb caused the airspeed to oscillate for one cycle between 280 kt and 320 kt before the autopilot was engaged. (See Fig.2.)

The meteorological conditions for the area were a moderate to strong north westerly airflow (290°/20-30 kt) which was very unstable up to 6000 ft with a stable isothermal layer between 6000 ft and 10000 ft. This was producing 3/8 cumulus with bases at 4000 ft but occasionally 3000 ft with snow showers. Moderate to severe turbulence was forecast.

The standard instrument departure from Montreal clears to 3500 ft. It appears that this level was flown through and returned to. Turbulence may have contributed to the untidy re-entry into the climb.

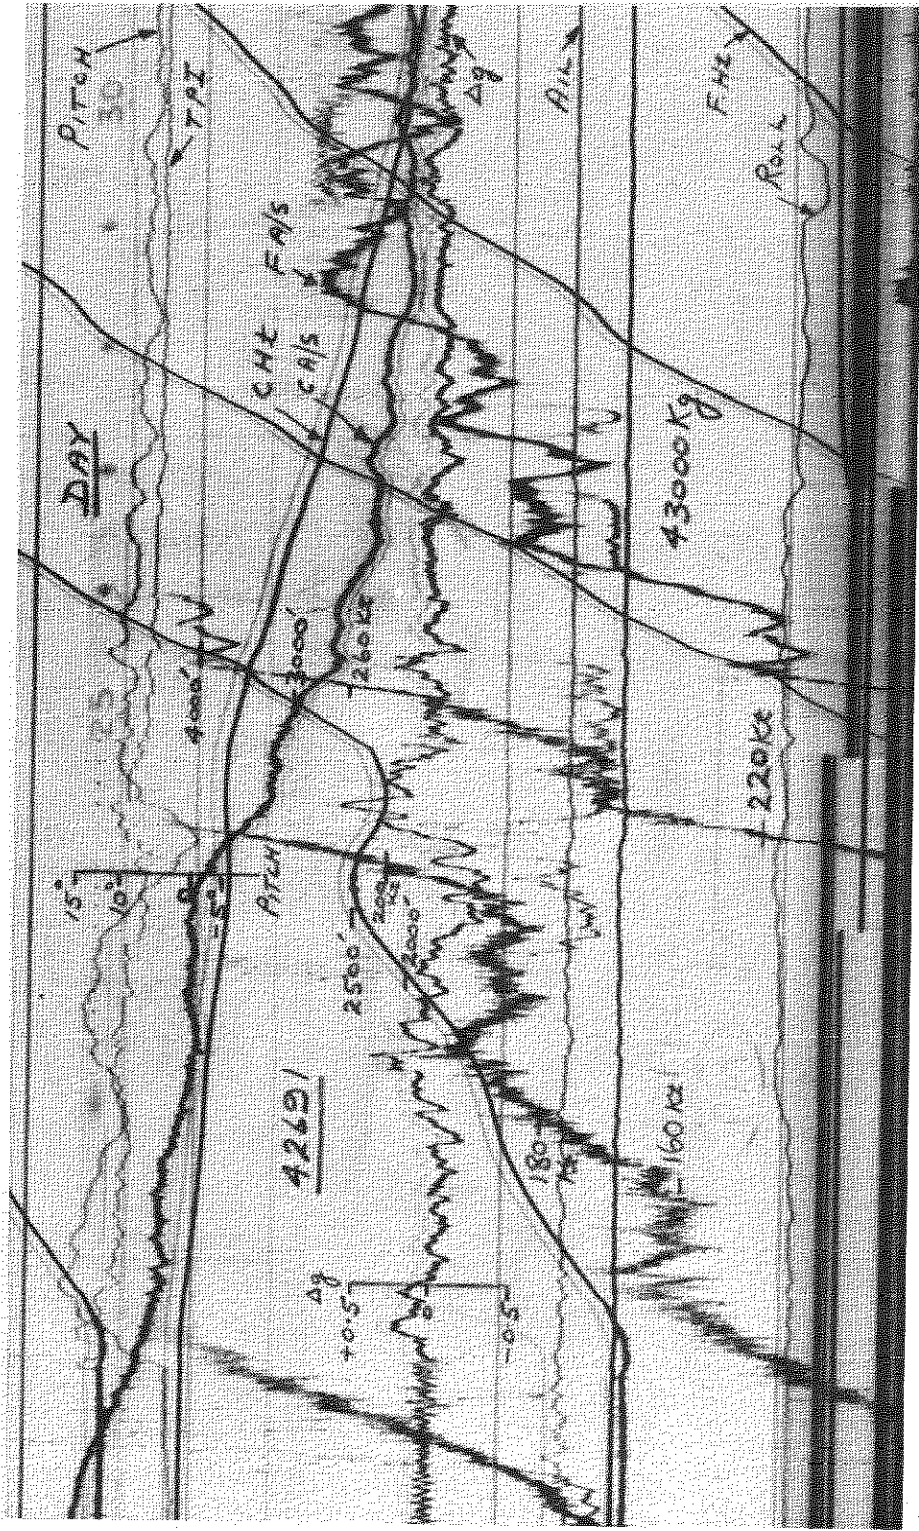
Fig.3. Event in flight 42691

The climb out from Birmingham was interrupted at 2500 ft when the aircraft descended 200 ft. The climb was re-established by means of a +0.6g increment manoeuvre. (See Fig.3.)

The initial clearance out of Birmingham is usually to 2500 ft.

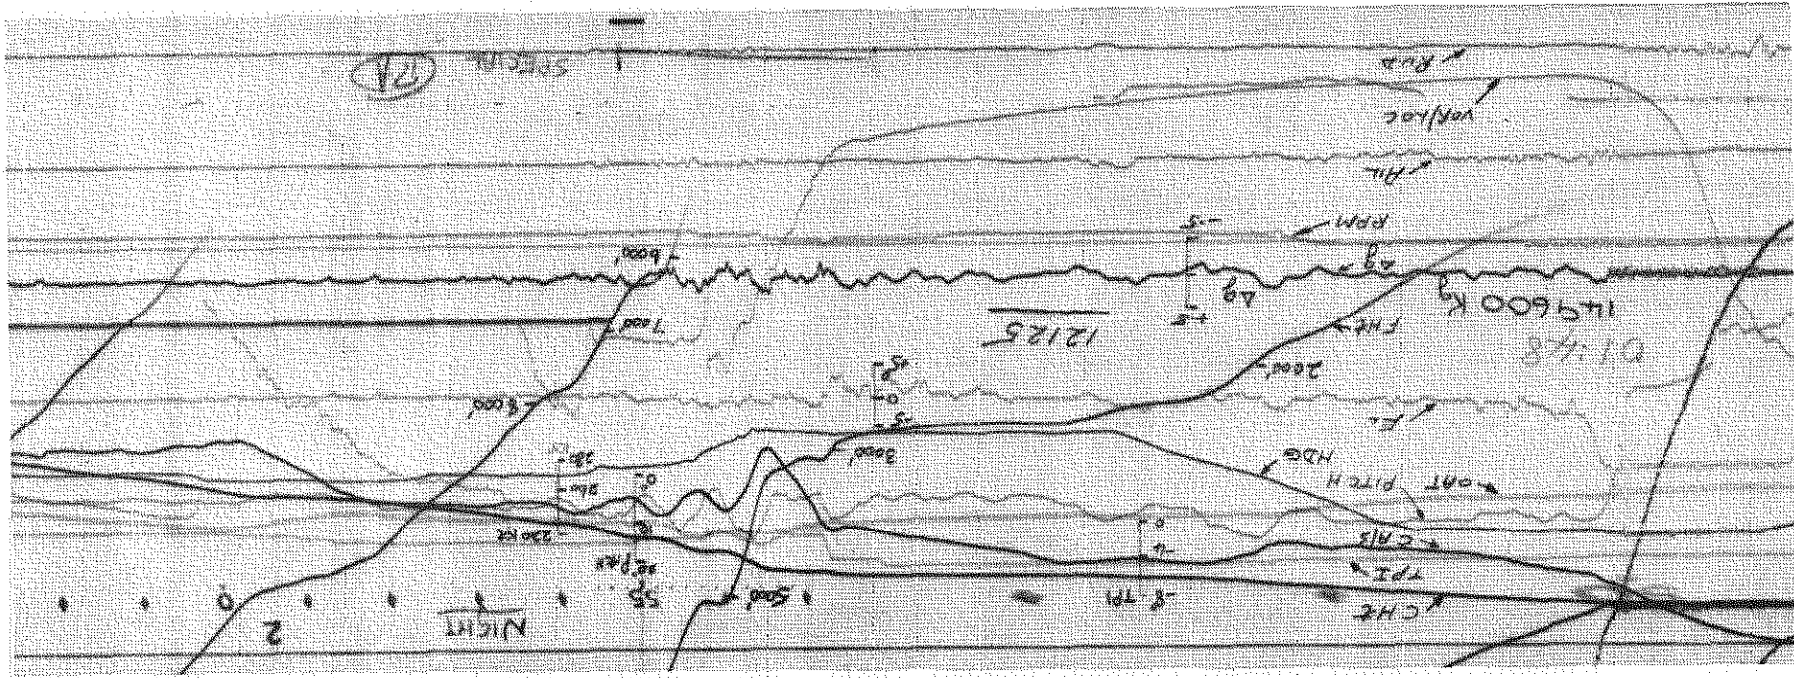
Fig. 5. Event in flight 12125

(i) The pitch oscillations in Figs.4, 5, 6, 8 and 16 were all initiated by an input such as flap raising or an overshoot, and the new pitch attitude was not accurately maintained. The pitch oscillation in Fig.15 is unusual and may have been caused by a faulty autothrottle.

The flaps were raised during the climb at 3000 ft and the airspeed was allowed to build. This was checked by a pitch up manoeuvre which developed into a 50 second period oscillation in pitch, airspeed and rate of climb. (See Fig.5.)

The oscillation started when the flaps were raised and stopped when No. 1 autopilot was engaged.

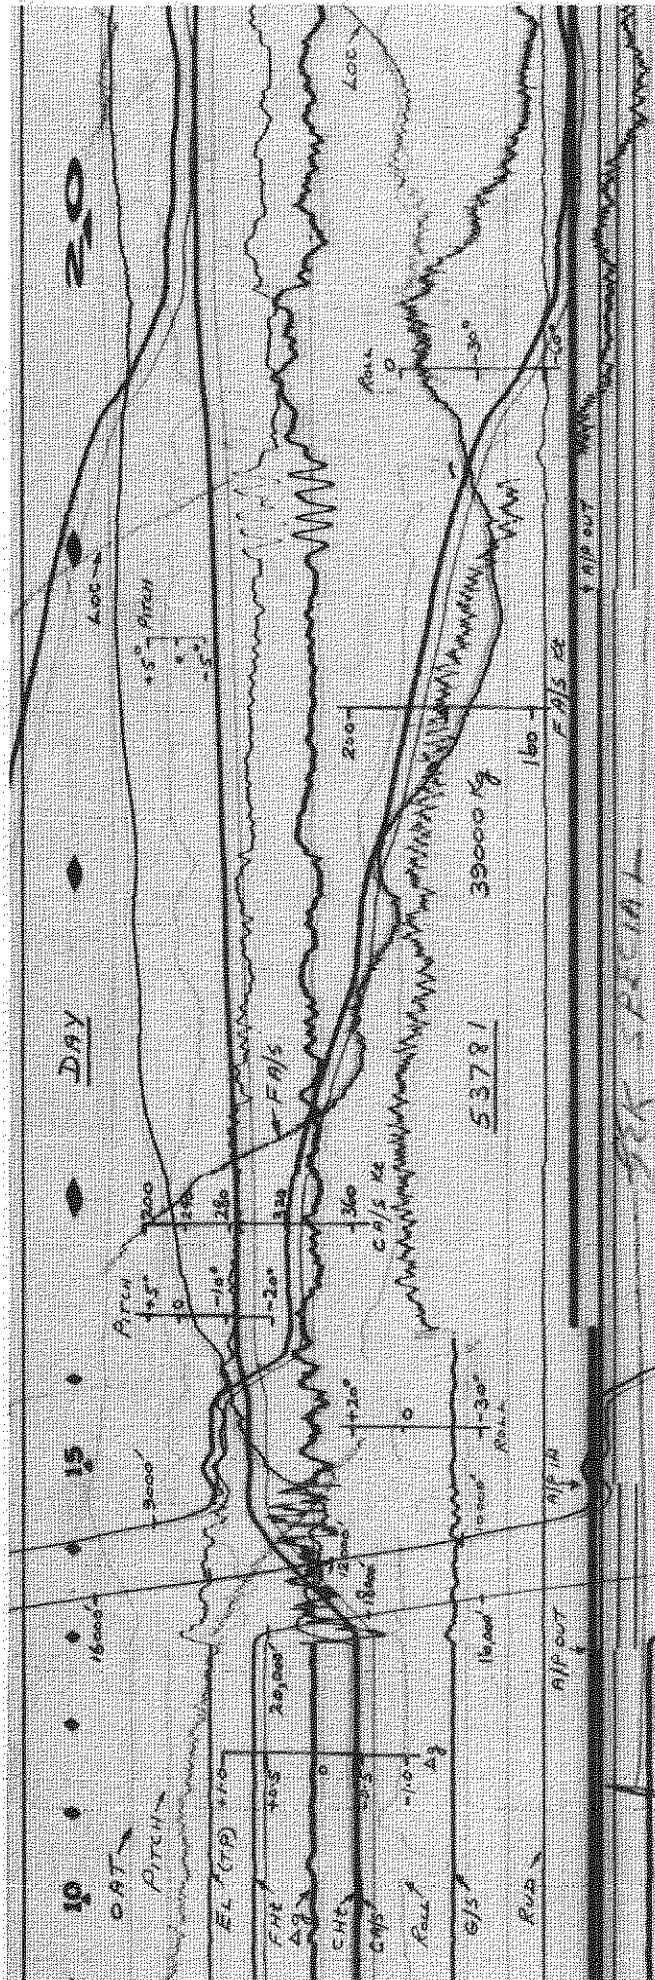
Fig. 9. Event in flight 53781

(ii) The high rates of descent in Figs.10, 11 and 12 were generated after the aircraft were found to be too high on the approach. Although the rates were much higher than recommended and continued to below 500 ft, the recoveries were straightforward and well controlled. The high rate of descent in Fig.9 is emergency descent rate, but as no emergency was reported, the event is largely unexplained.

The descent from 20000 ft was initiated, after the autopilot had been disconnected, by a $-0.7g$ increment manoeuvre and 8900 ft/min rate of descent was maintained down to 9000 ft whereupon the autopilot was re-engaged. Four minutes later the autopilot was disconnected again and an oscillation in pitch at 3 seconds per cycle developed for four cycles. The aircraft then entered a turn where the maximum angle of bank was 50° . (See Fig.9.)

No information is available for this event, but as there is no entry in the aircraft log it was apparently not an emergency descent. The large bank angle was applied when the localiser signal went through zero.

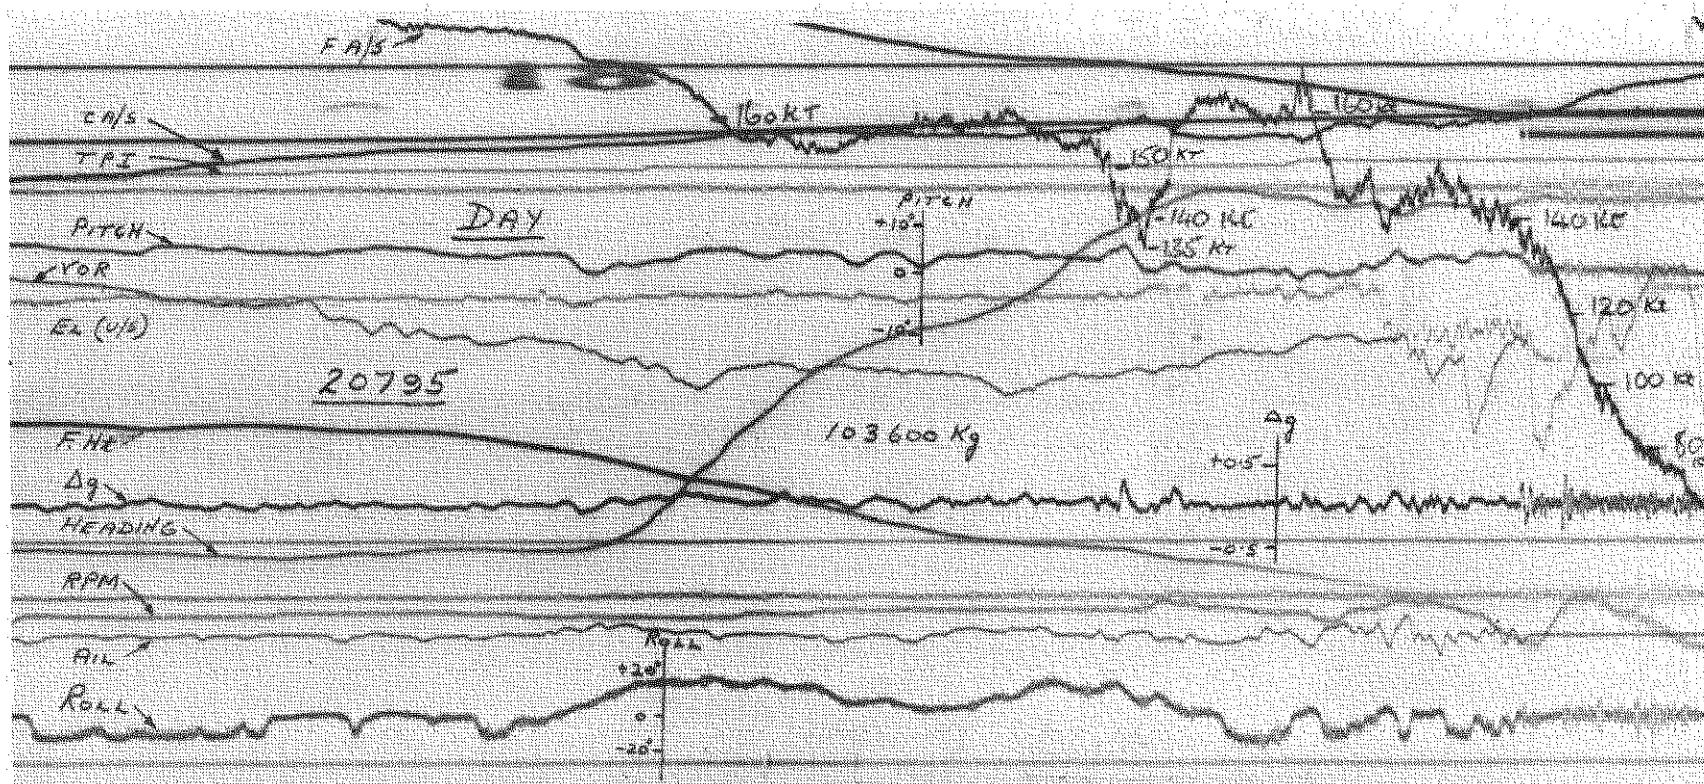
Fig.13. Event in flight 20795

(iv) The low airspeed in Fig.13 was probably initiated by wind shear and the one in Fig.14 occurred during localiser/glide slope capture.

During the approach there were large variations in indicated airspeed. (See Fig.13.)

The Captain was monitoring a relatively inexperienced second pilot. However there is an almost instantaneous 10 kt increase in airspeed after the lowest value, which suggests that wind shear may have contributed significantly to the speed variations.

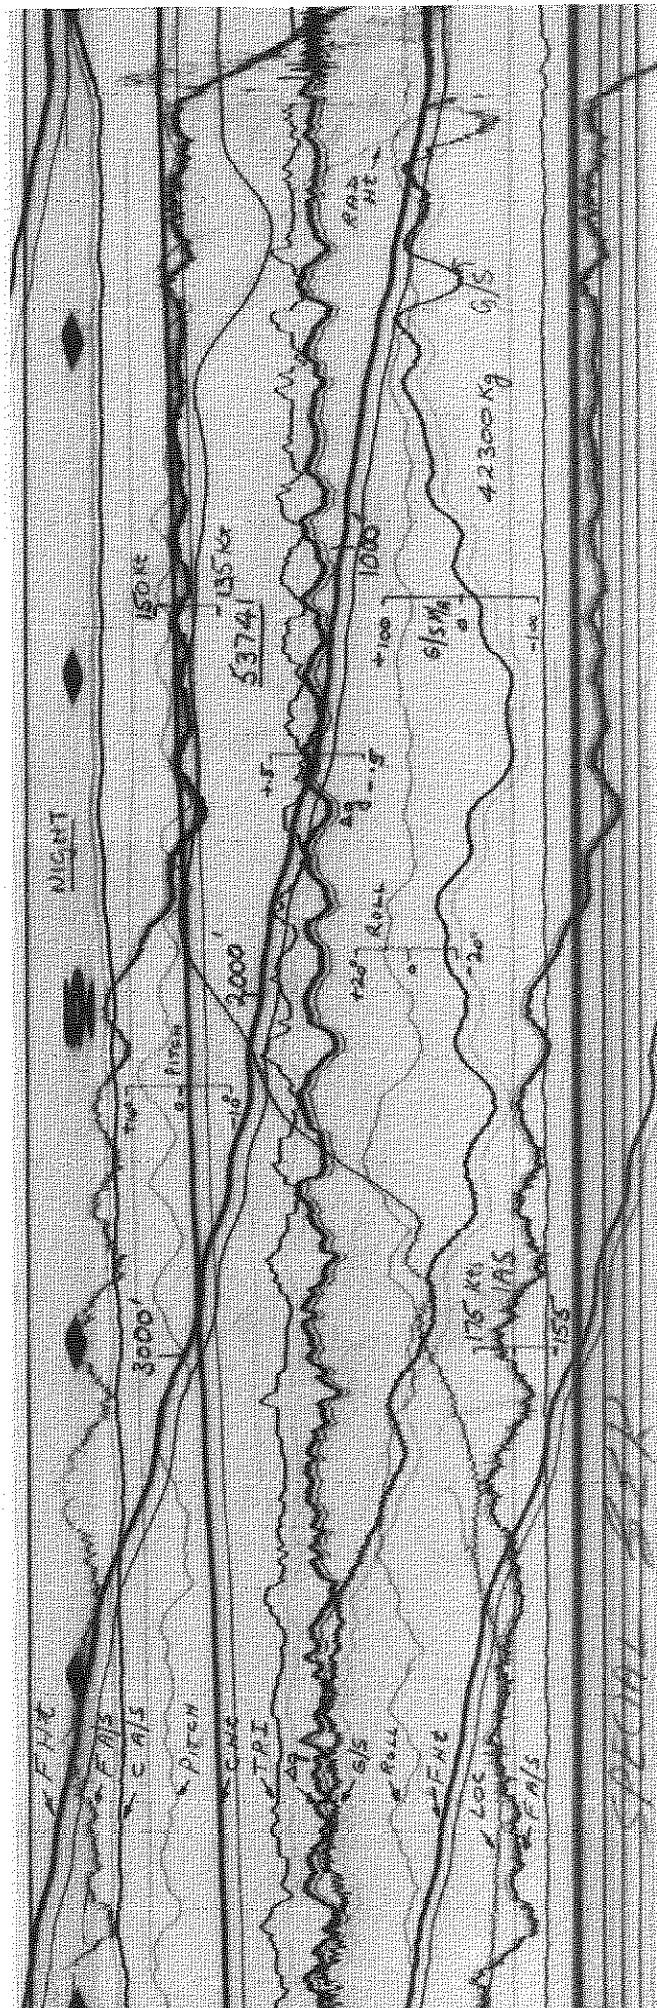
Fig.15. Event in flight 53741

A pitch oscillation at 15 seconds period was present during the whole of the approach which was flown manually. (See Fig.15.)

The oscillation may have been caused by a faulty autothrottle, but there is insufficient information to make a positive identification of the cause.
