AERONAUTICAL RESEARCH COUNCIL
REPORTS AND MEMORANDA

Investigations on Stalling Behaviour,
Rudder Oscillations, Take-off Swing
and Flow Round Nacelles on the
Tudor I Aircraft

*Reports and Memoranda No. 2789**

December, 1947

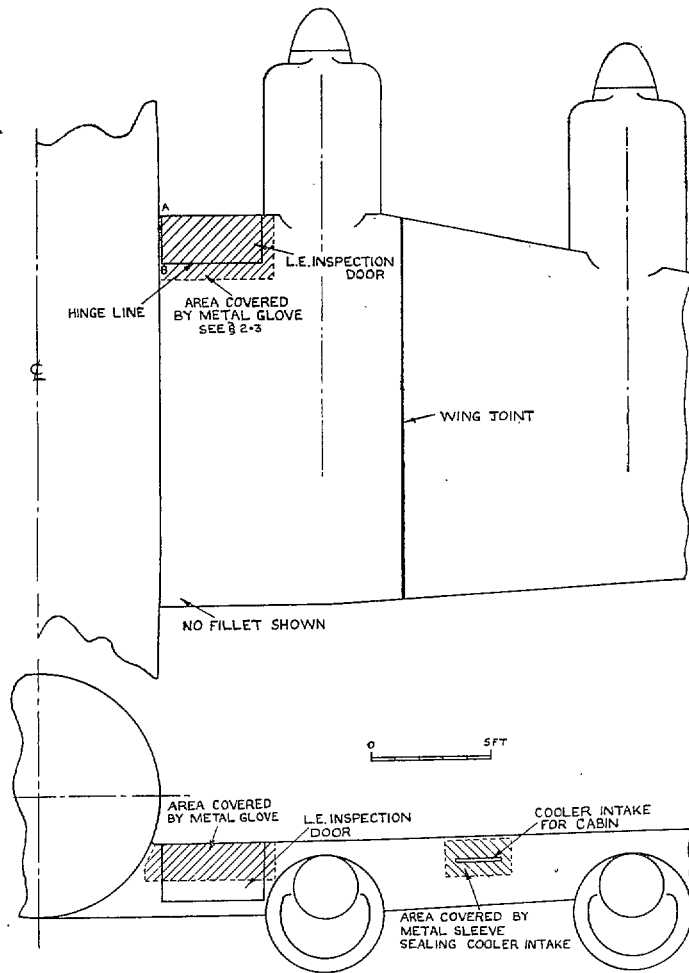
FIG. 5. Sketch of inner wing.

- (a) wing joint sealed with fabric strip doped to the aircraft skin (*see* Fig. 5),
- (b) cooler intake for cabin, open, closed and faired over with a metal sleeve (*see* Fig. 5),
- (c) wing root fillet edges sealed (*i.e.*, junctions between fillet and wing and body surface sealed with fabric strip doped to the aircraft skin),
- (d) extension of the inner nacelles.

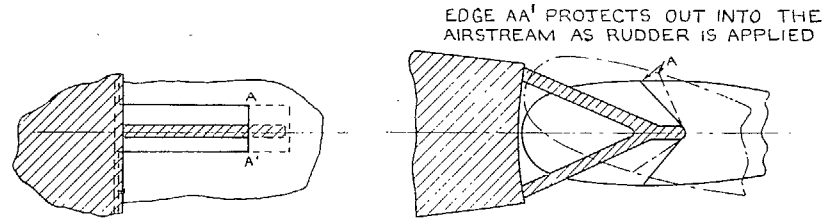
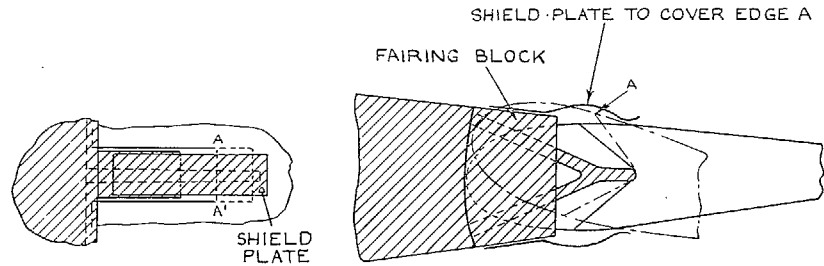
FIG. 7. Hinge cutout modifications on the rudder.

3.3. *Tests of Hinge Cutout Modifications.*—Close examination of the hinge cutouts on the full-scale aircraft (G.AGST), showed that, besides the existence of the large area through which air could flow, a sharp edge at the rear of the cutout projected out into the airstream as rudder was applied (see Fig. 7a). A preliminary modification was made at the R.A.E. by filling in the cutout by a fairing attached to the fin and by fitting suitably curved plates to this fairing to cover the projection on the rudder when rudder was applied (see Fig. 7b). Flight tests with all three cutouts modified in this way, showed that the kicking had been eliminated up to ± 16 deg rudder angle. The aircraft was then returned to Messrs. A. V. Roe for a production hinge cutout fairing to be incorporated; the production modification is the local formation of a concentric nose at the hinge cutout, so that the fairing block attached to the fin can be extended right up to the concentric nose, and only a very small leak is left (see Fig. 7c). In this condition there was only minute kicking up to $\pm 18\frac{1}{2}$ deg of rudder angle. The rudder pedal forces were then adjusted by means of the gearing of the geared tab, until full rudder could be obtained at low flight speeds with reasonable foot loads. It was clear, therefore, that bad flow initiated by the hinge cutouts was solely responsible for the rudder kicking at low rudder angles on the *Tudor*, and that the wind tunnel tests had rightly predicted this. Previous wind-tunnel tests⁵ had shown the bad effect of hinge cutouts on the hinge moment characteristics of controls.

As related in section 3.2 above the minimum speed obtained in the original condition with *climbing power* only, was 120 knots A.S.I. The first R.A.E. modification of the hinge cutouts with ± 16 deg of rudder angle available, dropped this figure immediately to 100 knots A.S.I. with climbing power, and 105 with take-off power. The Avro production hinge cutout modification produced a further drop to 92 knots A.S.I. with climbing power with a rudder angle of ± 16 deg, and when the rudder angle available was increased to $\pm 18\frac{1}{2}$ deg, the minimum speed was below the violent longitudinal pre-stall buffeting speed then present on the aircraft (< 92 knots A.S.I.) with climbing power, and was 95 knots with take-off power. It was found necessary, of course, during this sequence of tests to lighten off the rudder pedal loads by increase of the rudder tab gearing (see section 3.3), the figures quoted in all cases refer, however, to full rudder pedal movement, without retrimming from the symmetrical power case. Later more accurate tests at A.A.E.E. of actual conditions during a take-off with an engine cut, showed that the safety control speed is about 100 knots A.S.I. at 80,000 lb A.U.W. with the rudder in the fully modified condition.

It appears, therefore, that a reduction of approximately 30 knots has been made in the minimum forward speed necessary to be able to hold an engine cut, merely by these hinge cutout modifications. This reduction would appear greater than would be expected from the increase in available rudder travel only, and suggests that some increase in rudder effectiveness was also obtained by the modification.

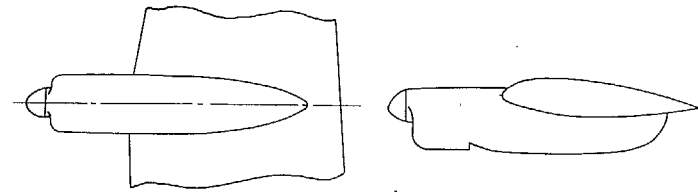
(a) ORIGINAL TYPE (17-7-46)

5. *Nacelle Design.*—5.1. *Flow Tests on Original Inner Nacelle.*—The original inner nacelle shape is shown in Fig. 8a. It was not the first type flown on the *Tudor*, but a compromise arrived at after the *Lancaster* type nacelles had given vibration troubles during early development tests at the firm. Shortening the nacelle to finish at the flap hinge had eliminated a periodic shake felt on the whole aircraft.

Because of the loss in performance from that estimated, attention was drawn by the R.A.E. to the probability that the flow round the rather bluff ends of the inner nacelles was bad. Flow observations in flight by means of 'deep-tufting' showed clearly that a complete breakaway of flow was occurring behind the nacelle over the whole speed range, slight improvement only being noticed as the stall was approached. It was also noted that the flow could be cleared up completely by lowering the flaps through a small angle (10 to 15 per cent of maximum travel), and that as the flow breakaway was stopped by this means a good deal of the continuous vibration felt on the aircraft ceased at the same time. The poor inner nacelle shape was, therefore, producing both drag and vibration. Clearly lengthening of the inner nacelle rear fairing was required, and both because of the previous trouble experienced by the firm, and of evidence produced by wind tunnel tests that the optimum nacelle design was not obtained by the nacelles finishing at the trailing edge (R. & M. 2406⁷), it was considered that the nacelle should extend some 18 in. to 2 ft behind the trailing edge. As an interim step, however, the *Lancaster* type nacelle was refitted.

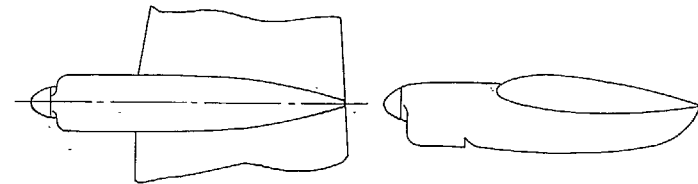
(b) 'LANCASTER' TYPE

Deep-tufting tests showed that while the breakaway in flow behind the nacelle had been reduced to about $\frac{1}{3}$ of that previously noted, there was still sufficient breakaway to cause concern about the drag resulting from it. Also the vibration experienced on the aircraft as a whole had changed character. Instead of the continuous vibration noted with the 'original' inner

nacelle, there was now a periodic and more violent shake on the aircraft, as had been reported previously by the firm. Smaller flap angles were now needed to clear up the breakaway and this periodic shake (5 to 10 per cent of full flap travel).

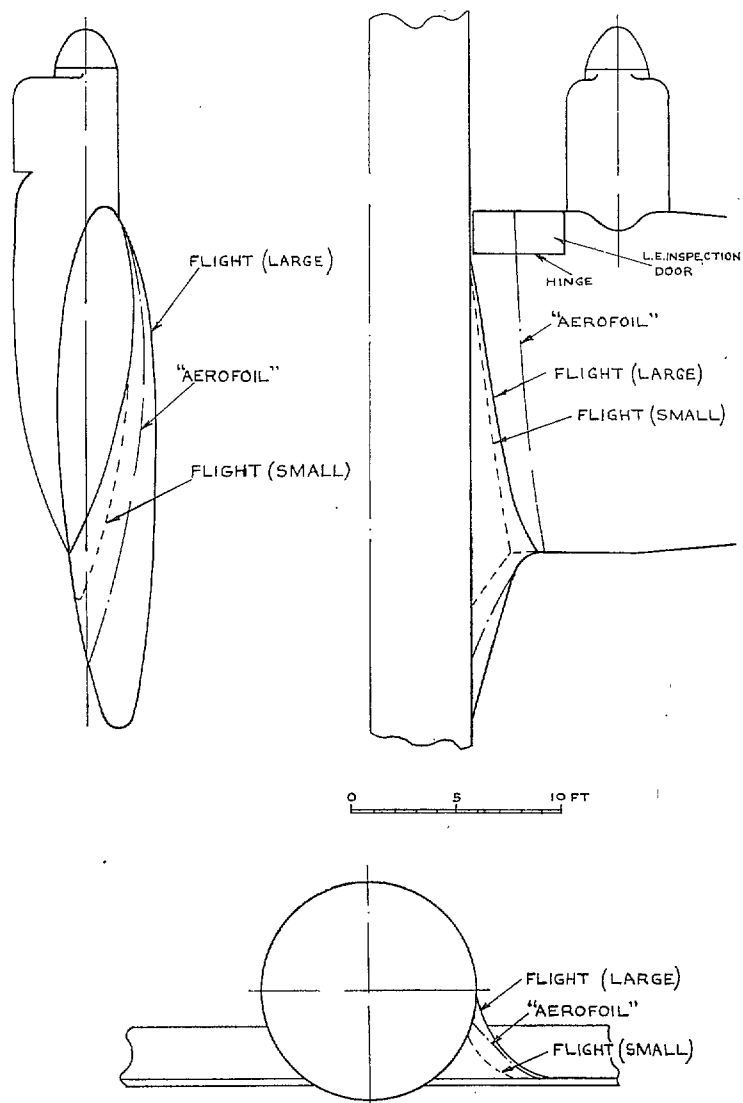
FIG. 4. Sketches of wing root fillets flown on the aircraft.

(iii) From the observations described in (ii) it was clear that the $C_{L\max}$ values on the *Tudor I* were normal (Ref. 2) though on the low side, and that the severe buffeting, which in practice limited the apparent stall to a very low $C_{L\max}$, was caused by a deep and violent wing root breakaway, occurring at a very low C_L , the resultant violent wake passing over the tail end of the aircraft. It was fairly evident, therefore, that prevention of the premature wing root breakaway would obviate the early buffeting. There was some possibility that the fairly sharp insweep of the body in both plan and side view just forward of the tailplane position, may have worsened the effect of the wake hitting the tailplane, by causing a further breakaway to occur at the change in body shape; but this would be, clearly, a secondary effect and it was considered that the best dividend would be paid by obviating the wing root breakaway at its source. The first and obvious method of doing this was to improve the wing root filleting. At this time Messrs. A. V. Roe Ltd. had designed a new and larger fillet and were fitting it to *Tudor G.AGST*. Accordingly this aircraft was sent to the R.A.E. for test with the new fillet and the next section describes the results of tests made on this aircraft with this fillet. The drawing of this large fillet is shown in Fig. 4.
