# The Fatigue Strength Characteristics of a Single Spar Wing

*W. J. Winkworth*

October, 1959

Full scale fatigue tests have been made on the wings of the Vickers Varsity aircraft, in which the conditions of atmospheric turbulence and the transition from ground to air were represented in the fatigue loading programme.

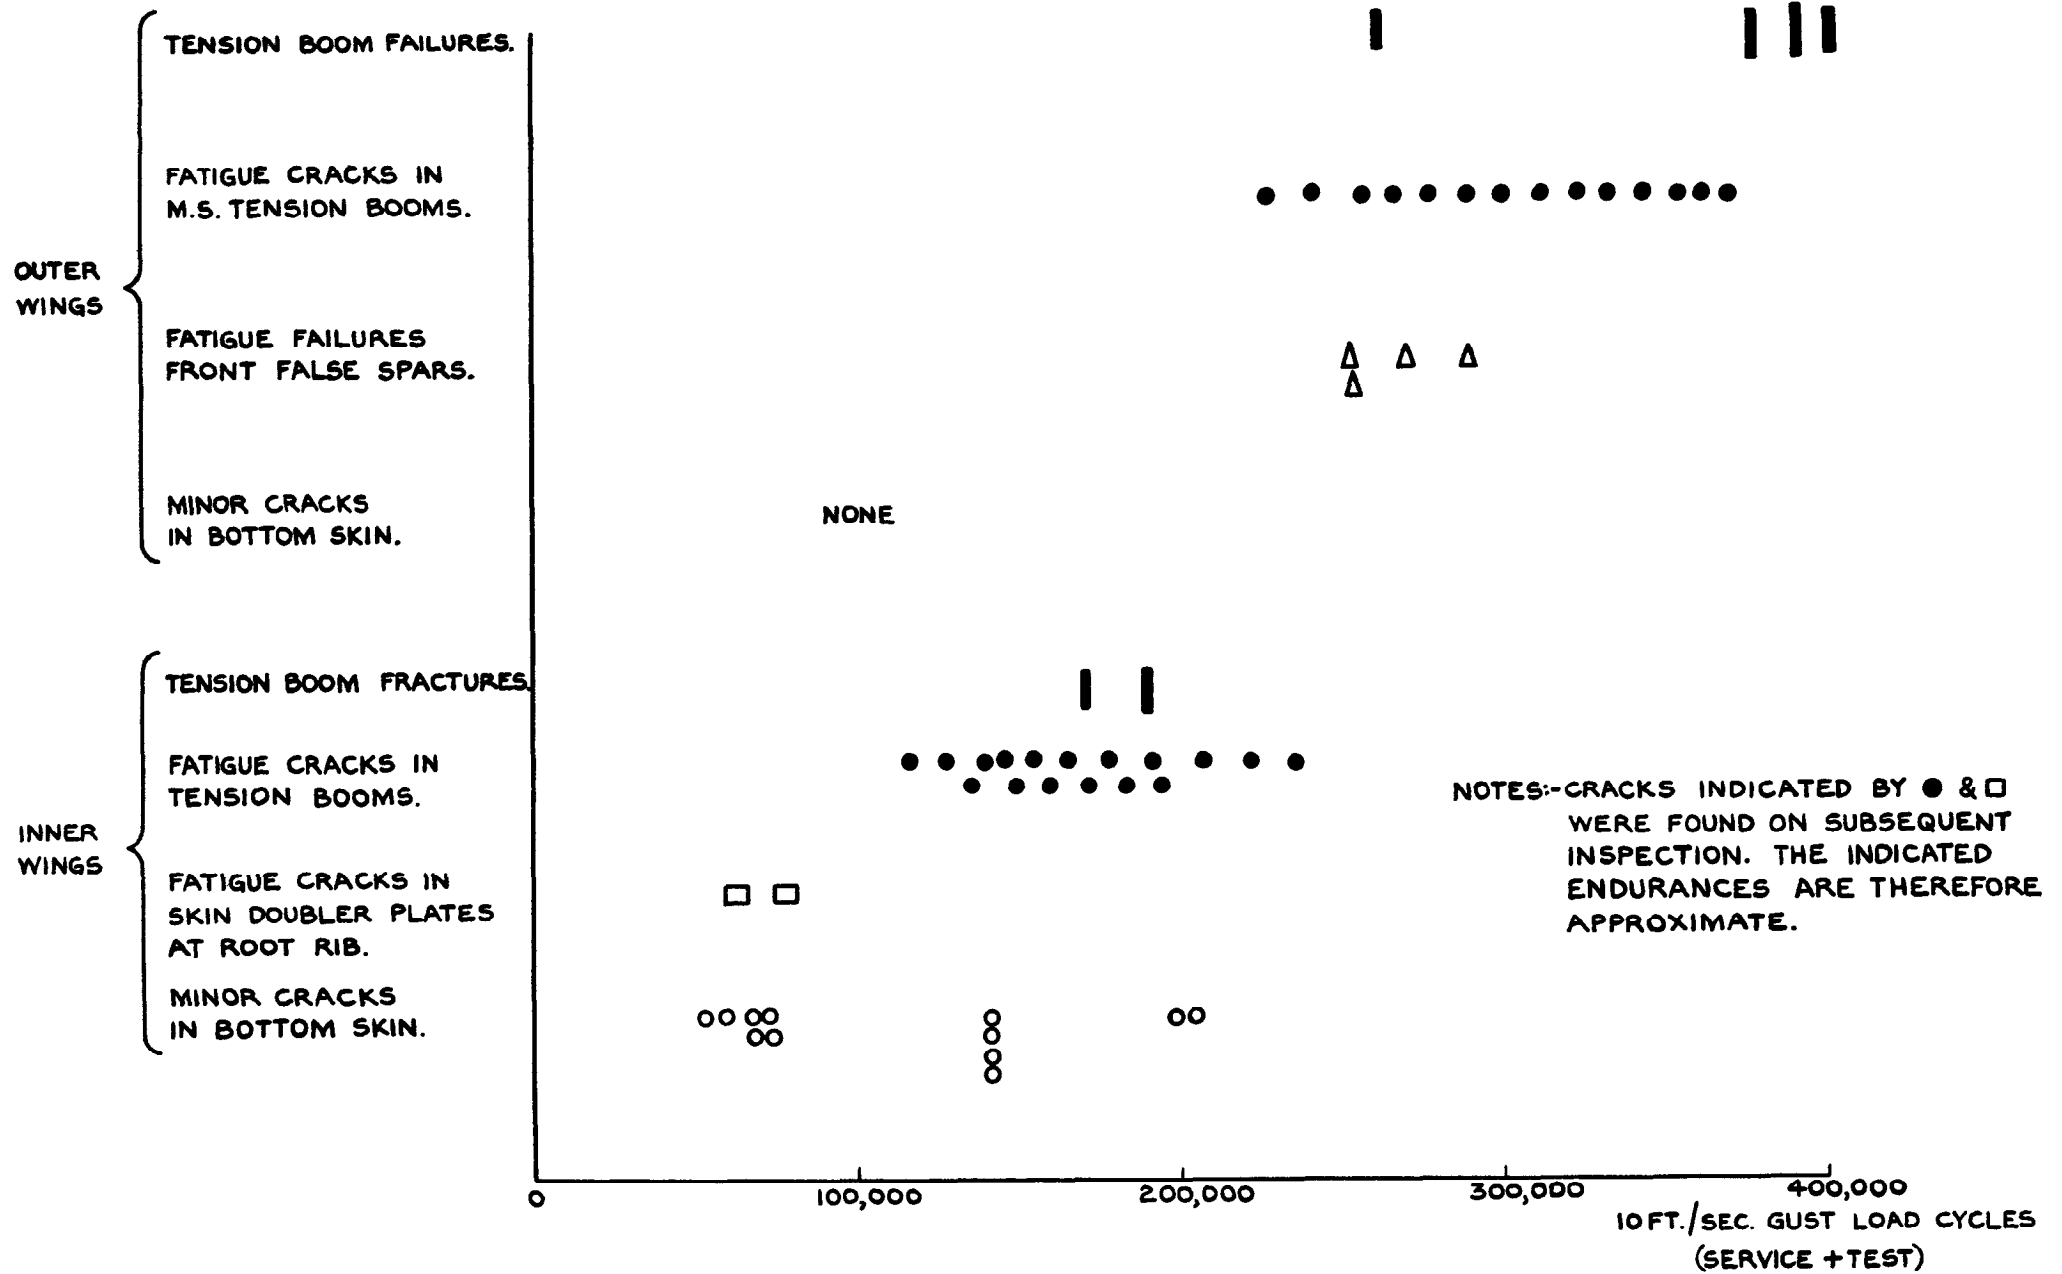
FIG.6. SEQUENCE OF FATIGUE DAMAGE.

In the Varsity tests, the earlier major failures were preceded by the formation of fatigue cracks in the wing skin (Figure 6) and possibly also by fatigue damage in the front false spars. The characteristics of the skin cracks with respect to position, size, and rates of growth, indicated that they had no influence on the major structures, but failures in the tension member of the front false spar would introduce some redistribution of load which would be slightly detrimental to the main spar at the outer wing joint.

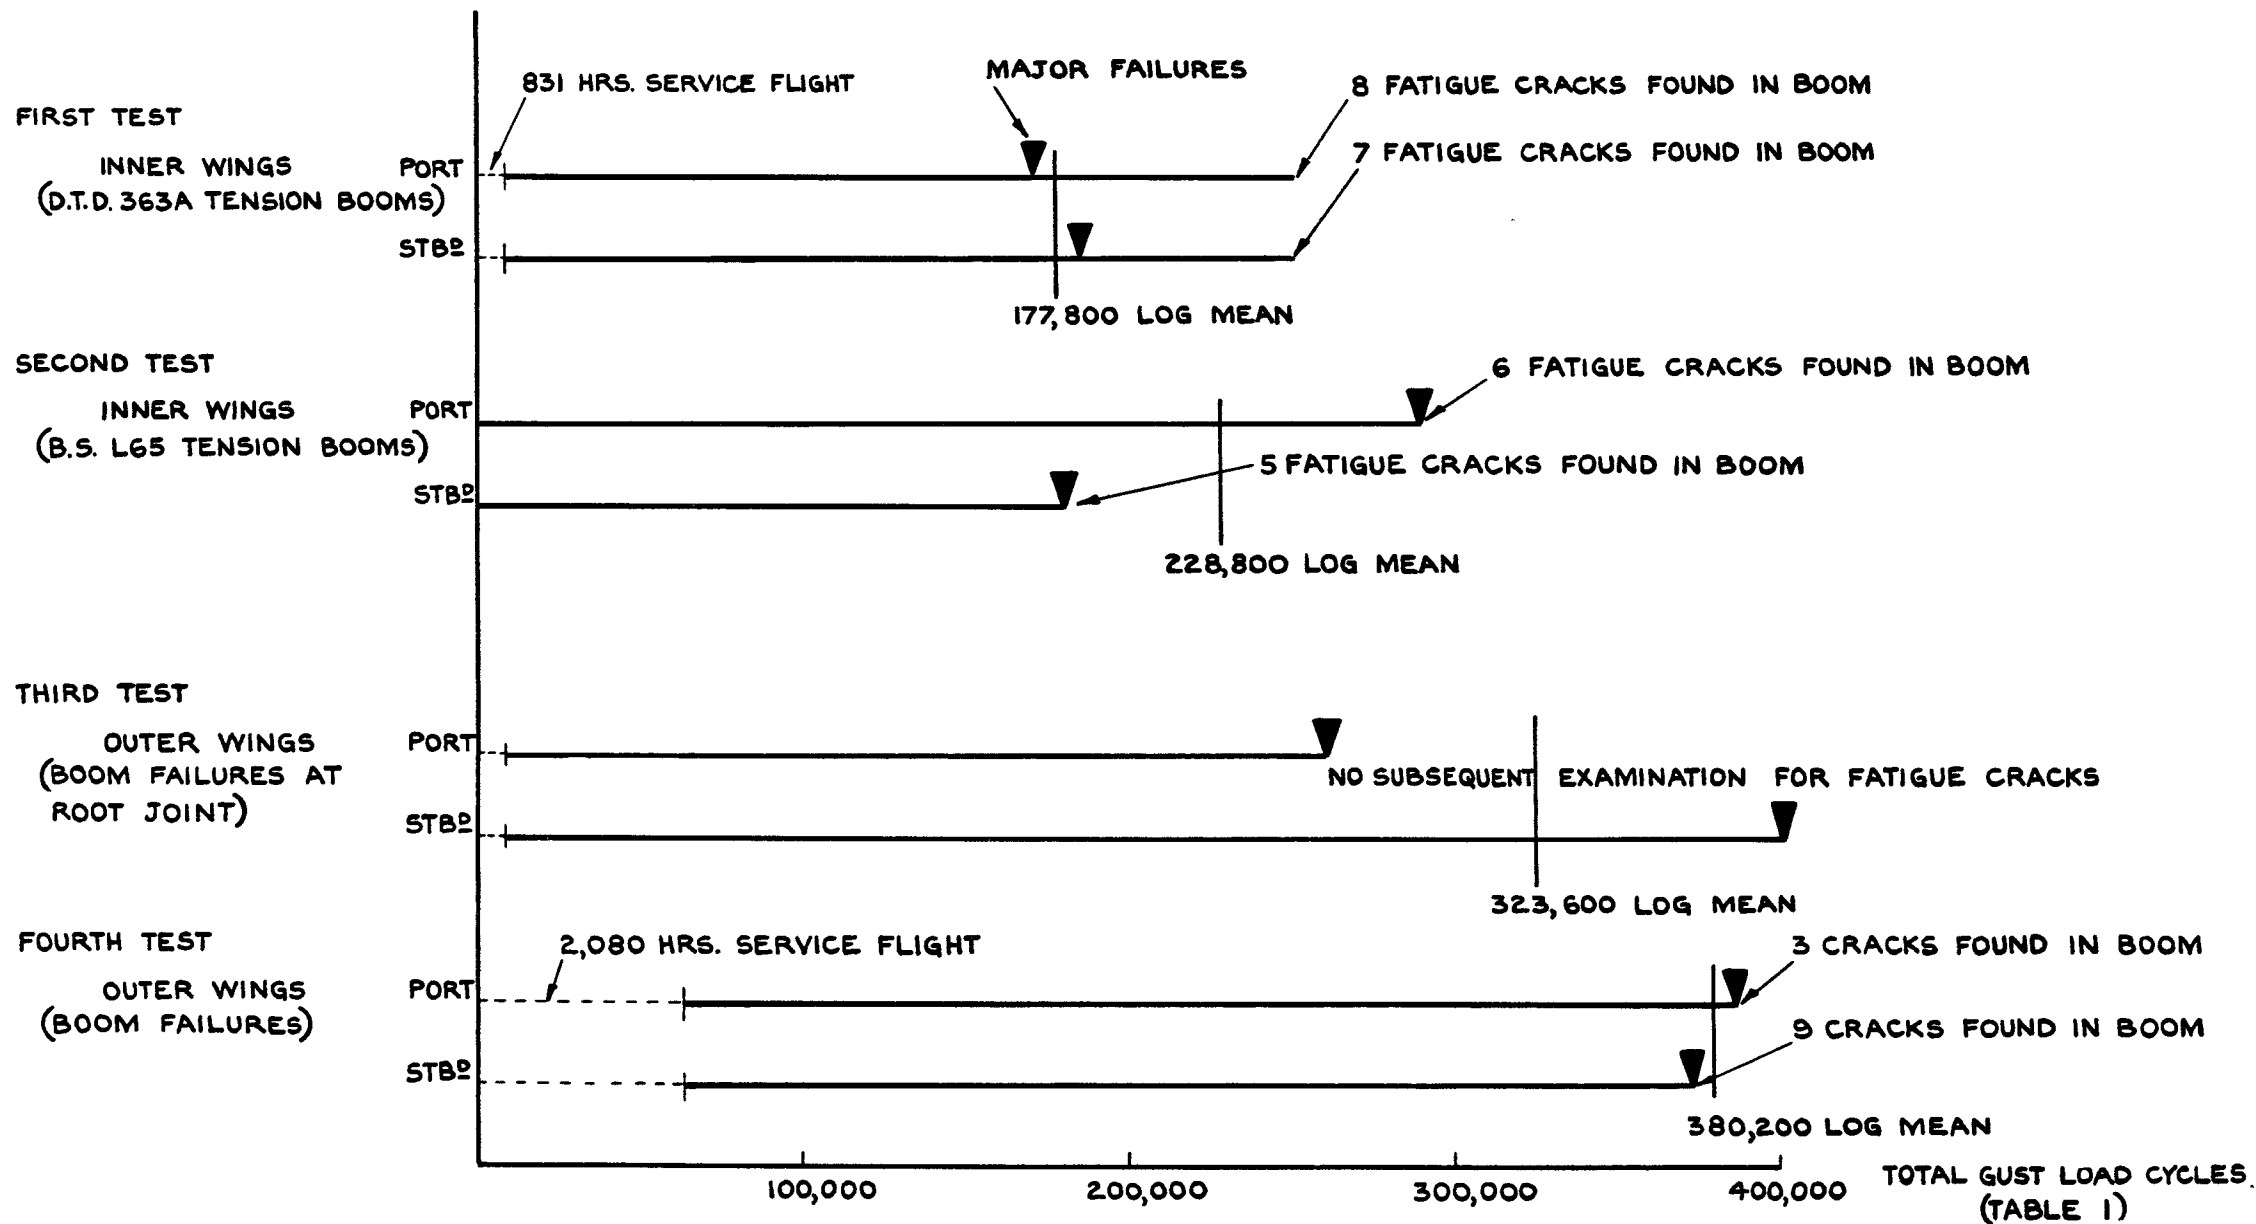
FIG.7. SCATTER OF ENDURANCE

The scatter of endurances for similar failures on the port and starboard wings was very small in two of the tests and moderate in the remaining two (Figure 7). Taking an overall view of the original wing structure, six major failures occurred between 170,500 gust load cycles and 387,200 gust load cycles. The numerous fatigue cracks - some in an advanced stage of growth - which were found throughout the tension boom indicate that further major failures were imminent. The fatigue strength at various points throughout the structure did not therefore vary to any great extent.

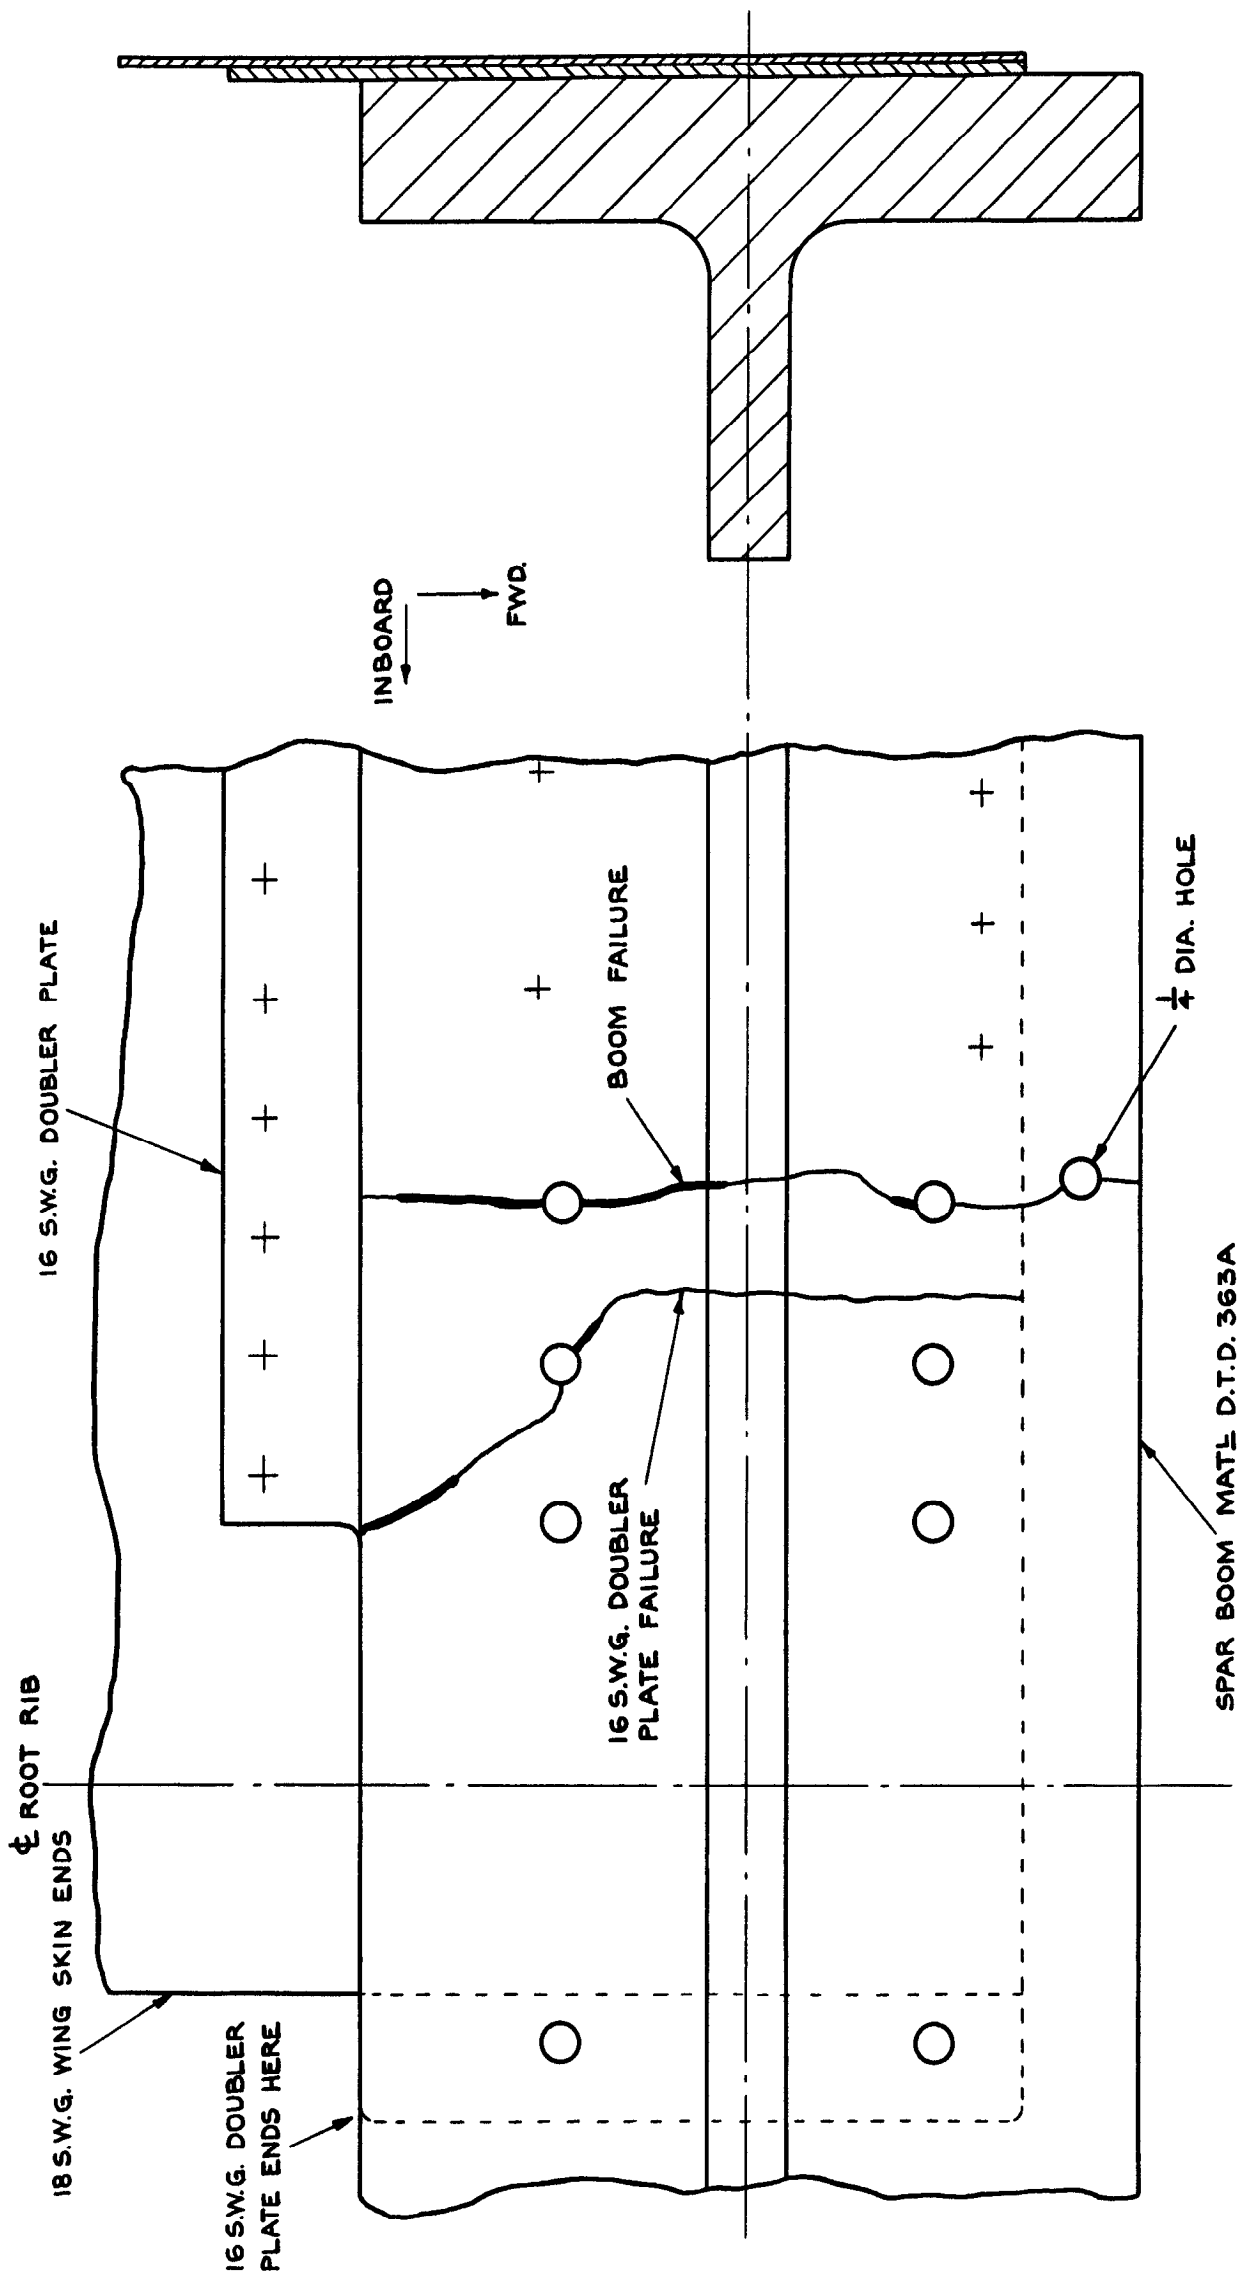
FIG.8. SPAR TENSION BOOM FRACTURE (PORT INNER WING) AND ASSOCIATED FATIGUE CRACK IN DOUBLER PLATE 170,500 GUST LOAD CYCLES FIRST TEST.

The 6 in. x 16 SWG doubler plate between the boom and the wing skin had been fractured by a fatigue crack, which had originated at a sharp reduction in its width (Figure 8). Being sandwiched between the skin and the boom, it had not been possible to visually inspect the doubler plate during the test, but the appearance of the fractured surface and the conditions at the origin gave the impression that this individual failure may have occurred relatively early in the test. The respective cross-sections of the boom and the doubler plate were 5.0 and 0.6 sq in. so that once the doubler had failed the nominal increase in stress in the boom might be some 10%. When regard is paid to load diffusion from the broken doubler plate, however, it is possible that an appreciable increase of load occurred at the next row of bolts, which would significantly affect the fatigue behaviour of the boom. In this connection it is thought significant that the boom actually failed in the next row of bolts, see Fig. 8.

In addition to the conditions of stress arising from the load in the boom plus the effect of the skin load diffusing into the boom at this point, a close examination of the boom fracture indicated that the origins of fatigue appeared to have been associated with local areas of fretting on the boom surface and/or just inside the holes. There was no evidence of corrosion.

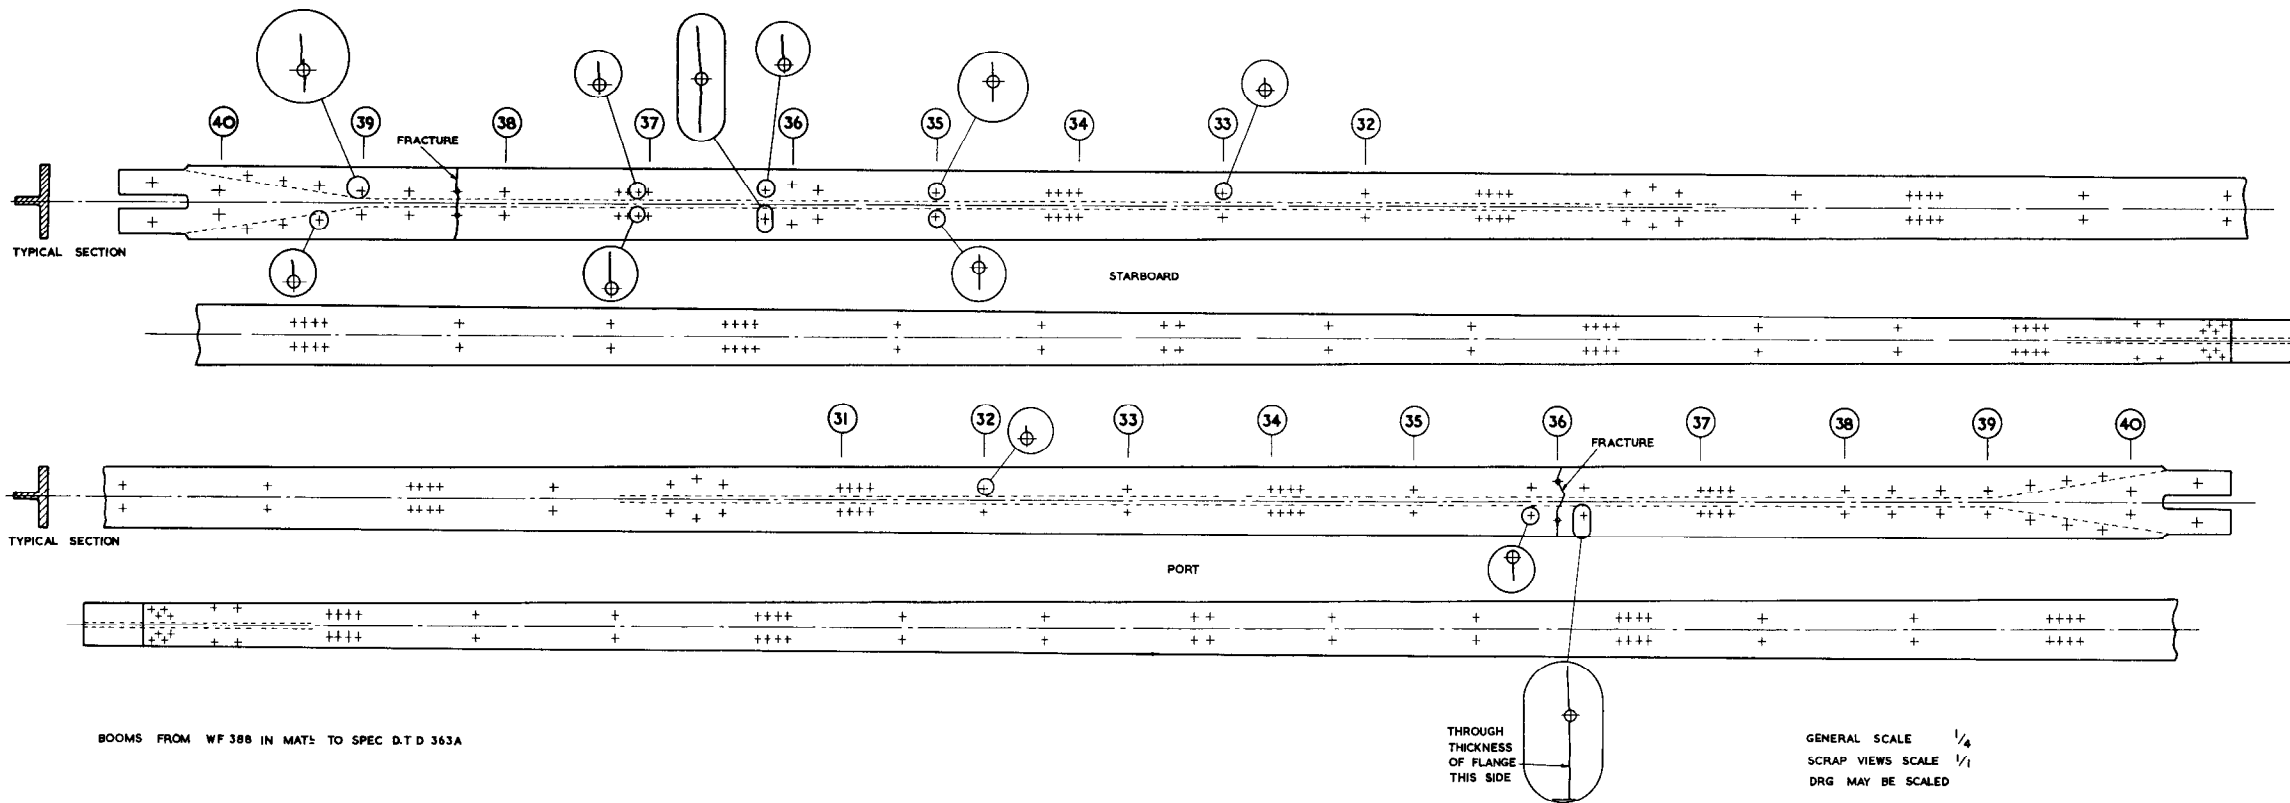
FIG.10. LOCATION OF FATIGUE CRACKS IN THE OUTER WING TENSION BOOMS. (FOURTH TEST)

Nine fatigue cracks were found in the spar tension boom from the starboard outer wing and three in the one from the port outer wing. All were located at skin attachment bolt holes. (Figure 10).
