Fatigue Behaviour Under Service and Ground Test Conditions (A Comparison Based on the Dakota Wing)

By
W.J. Winkworth

November, 1961

Several Dakota wings have been tested in fatigue under various conditions. The objective was to obtain an assessment of full scale testing procedures.

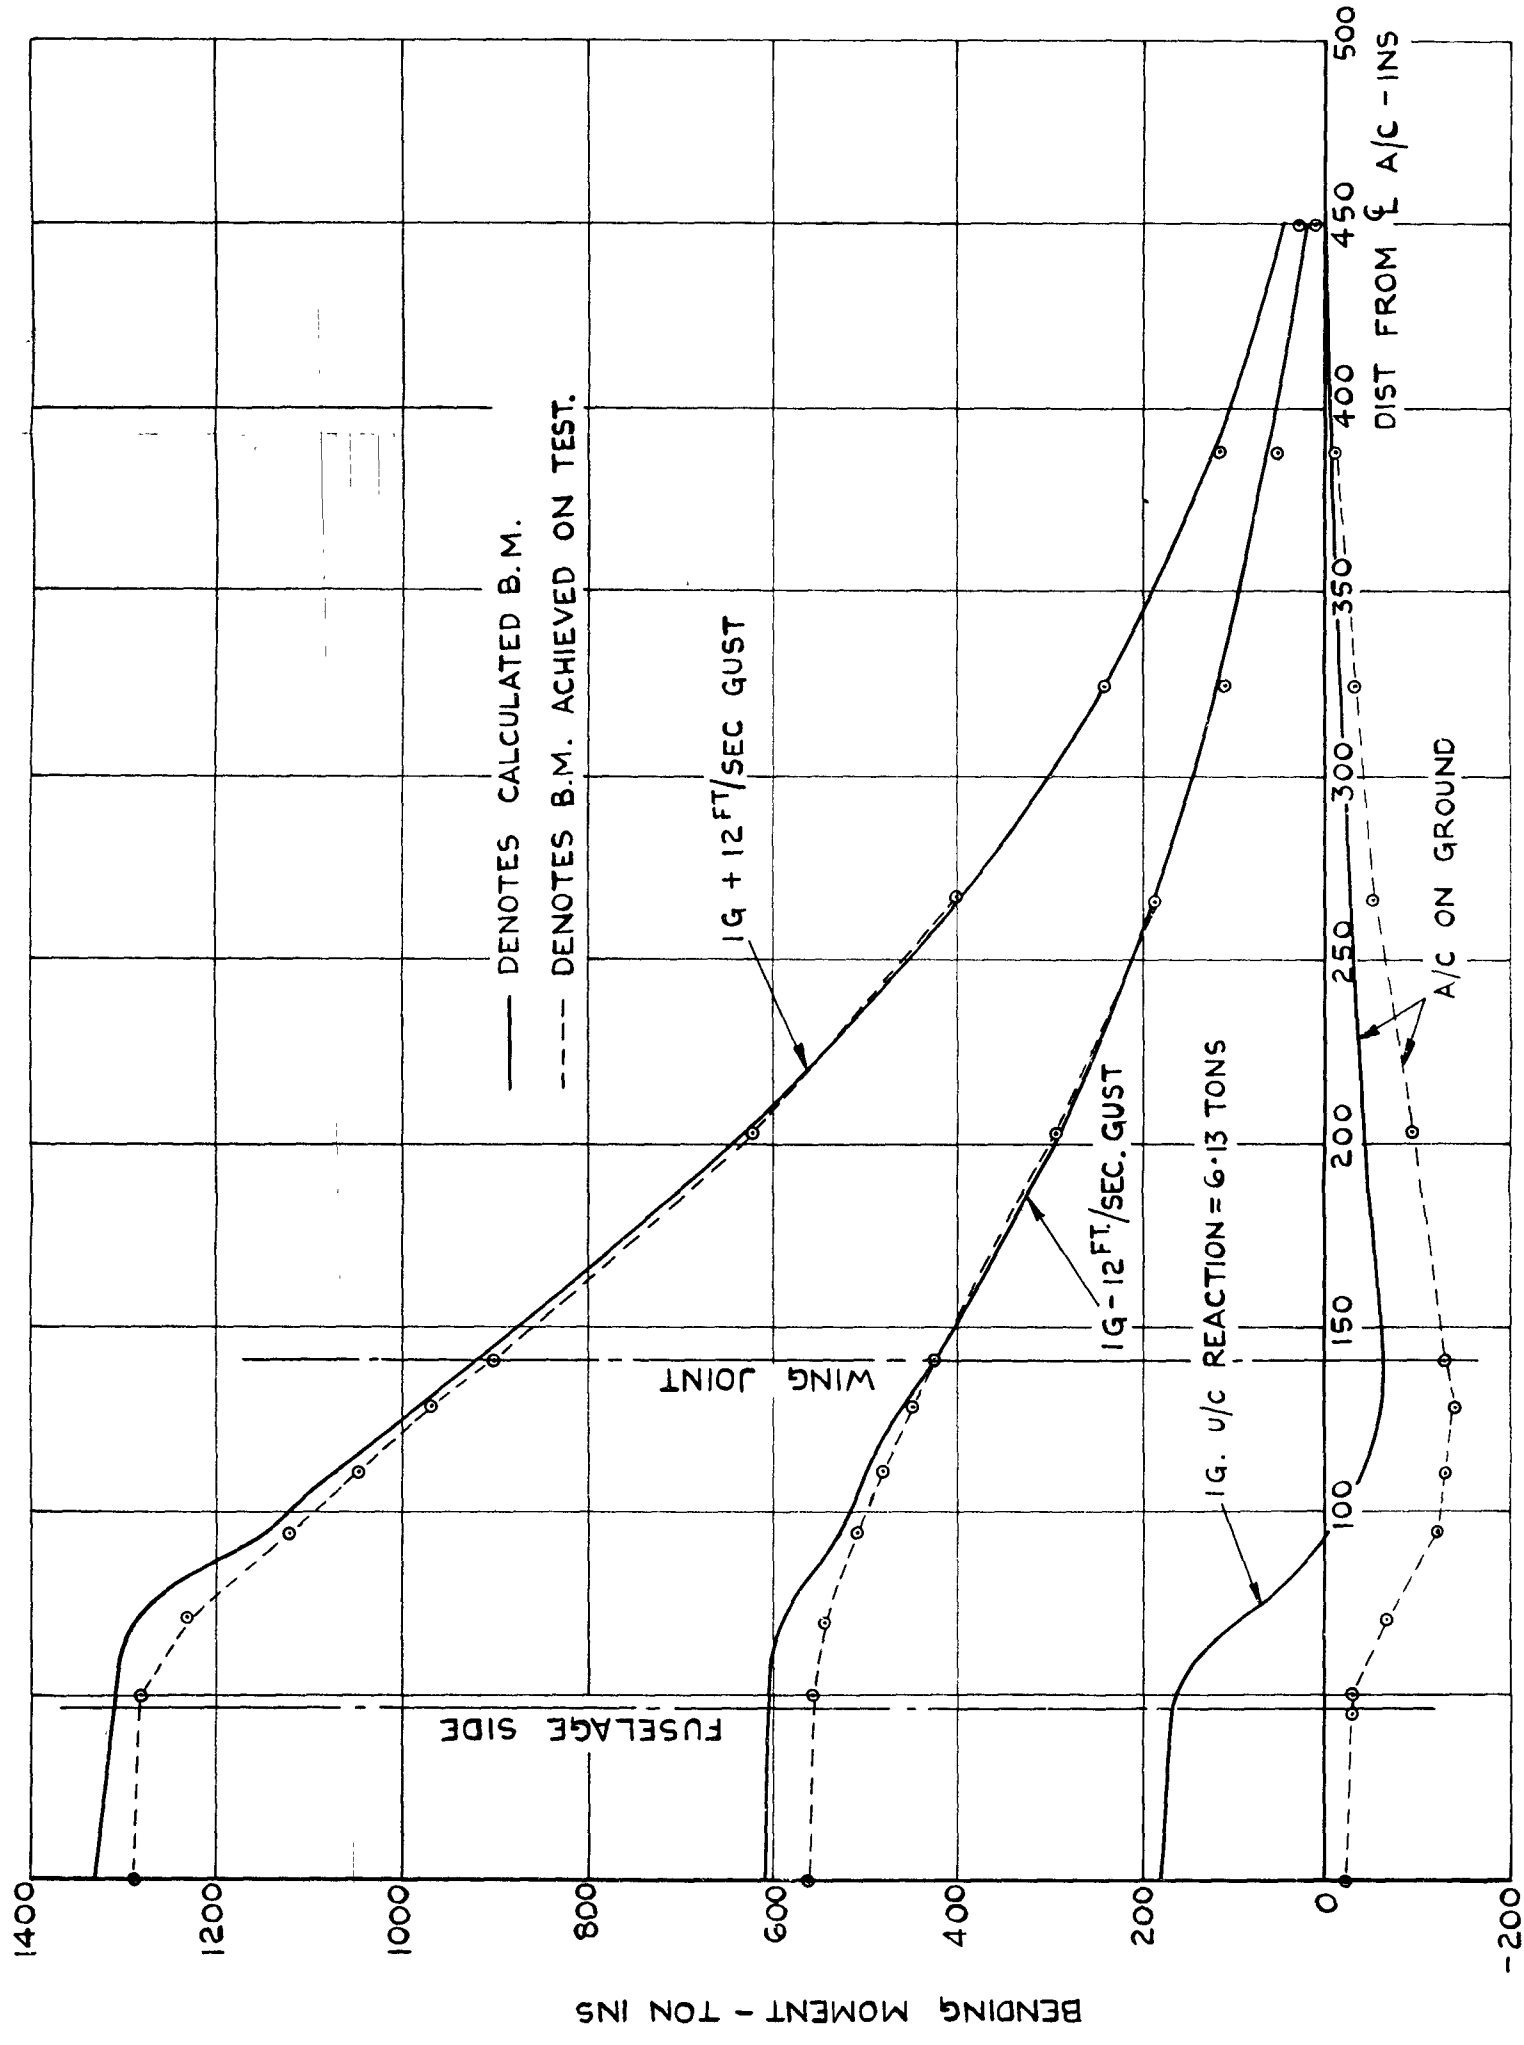
FIG. 3 WING BENDING MOMENT DIAGRAM

The 'on-ground' condition was represented by applying down load to the outer wings, the amount being such that they supported twice their own weight. This was done to obtain compressive stress in the bottom surface of the wing centre-section such as might arise during taxiing. The ground-to-air cycle was produced by varying the load between the $1g$ steady flight and the 'on ground' conditions.

NOTE:- TO OBTAIN SLIGHT COMPRESSIVE STRESS IN THE BOTTOM OF THE WING CENTRE-SECTION THE 'ON GROUND' TEST LOADING WAS ARRANGED SO THAT THE OUTER WINGS CARRIED TWICE THEIR OWN WEIGHT.

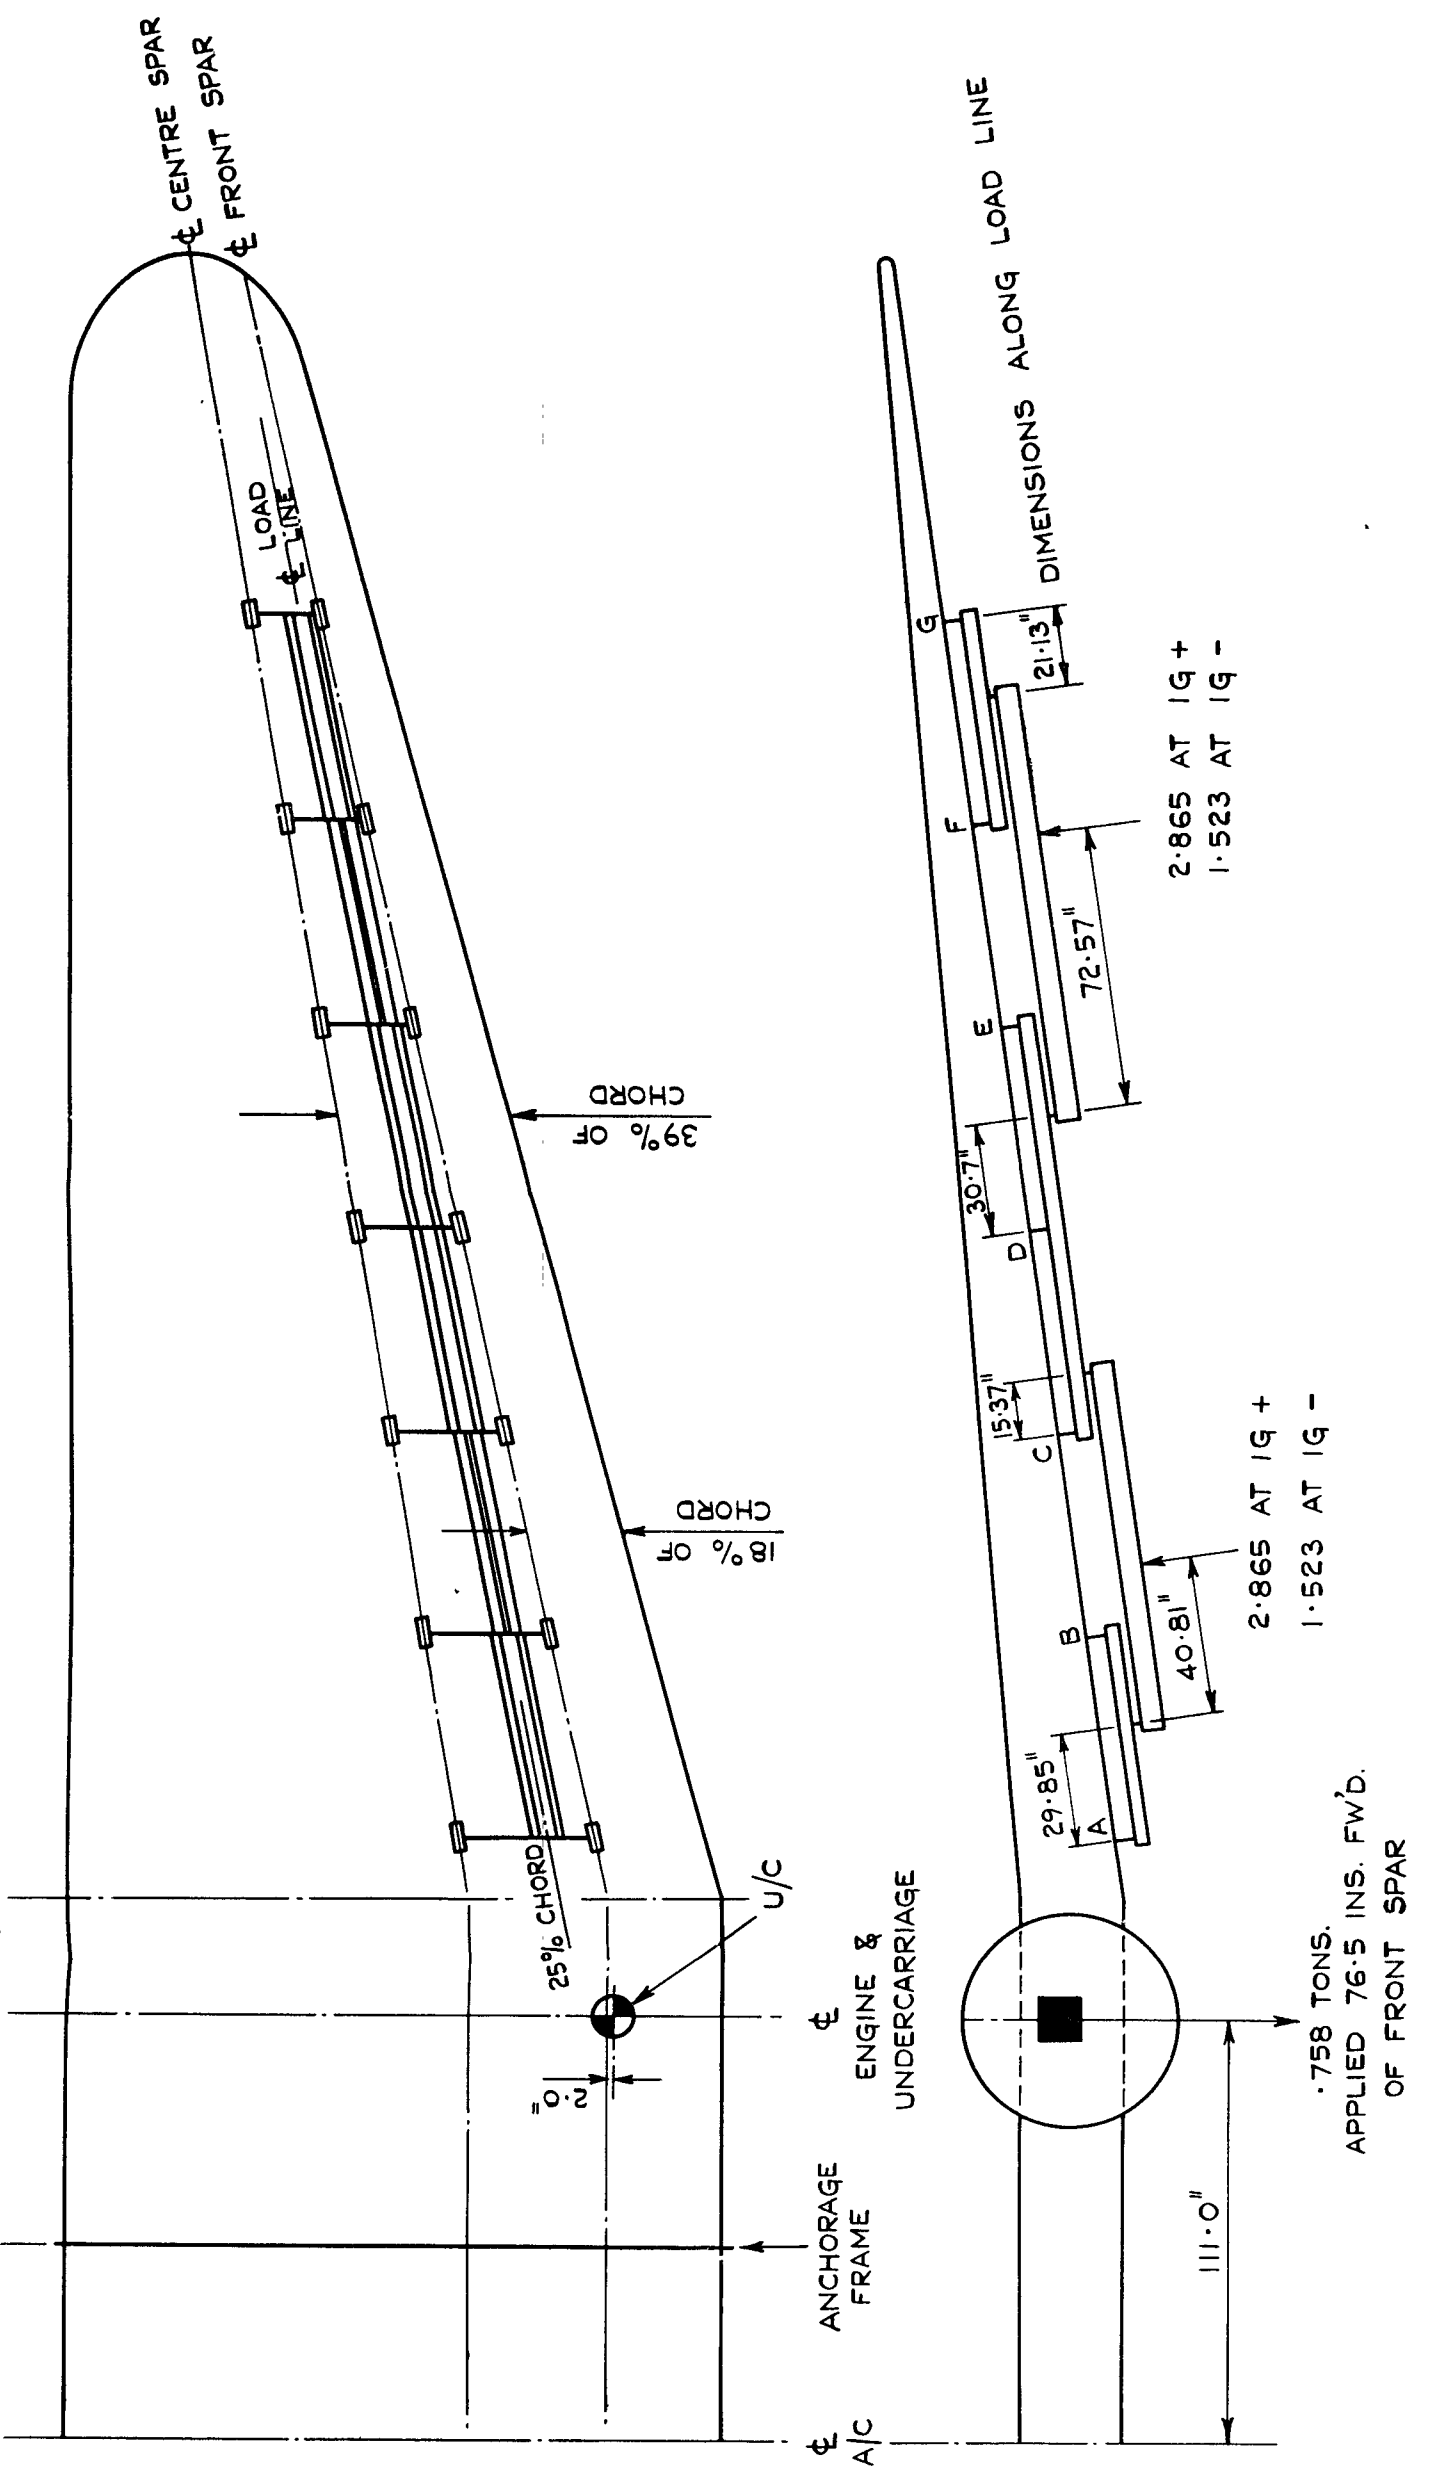
FIG. 4. LEVER SYSTEM & APPLIED LOADS.

The fatigue test loading was applied by a hydraulic system using jacks in compression which reacted between the ground and lever systems attached to the bottom surface of the wing, Figs.4 and 5.

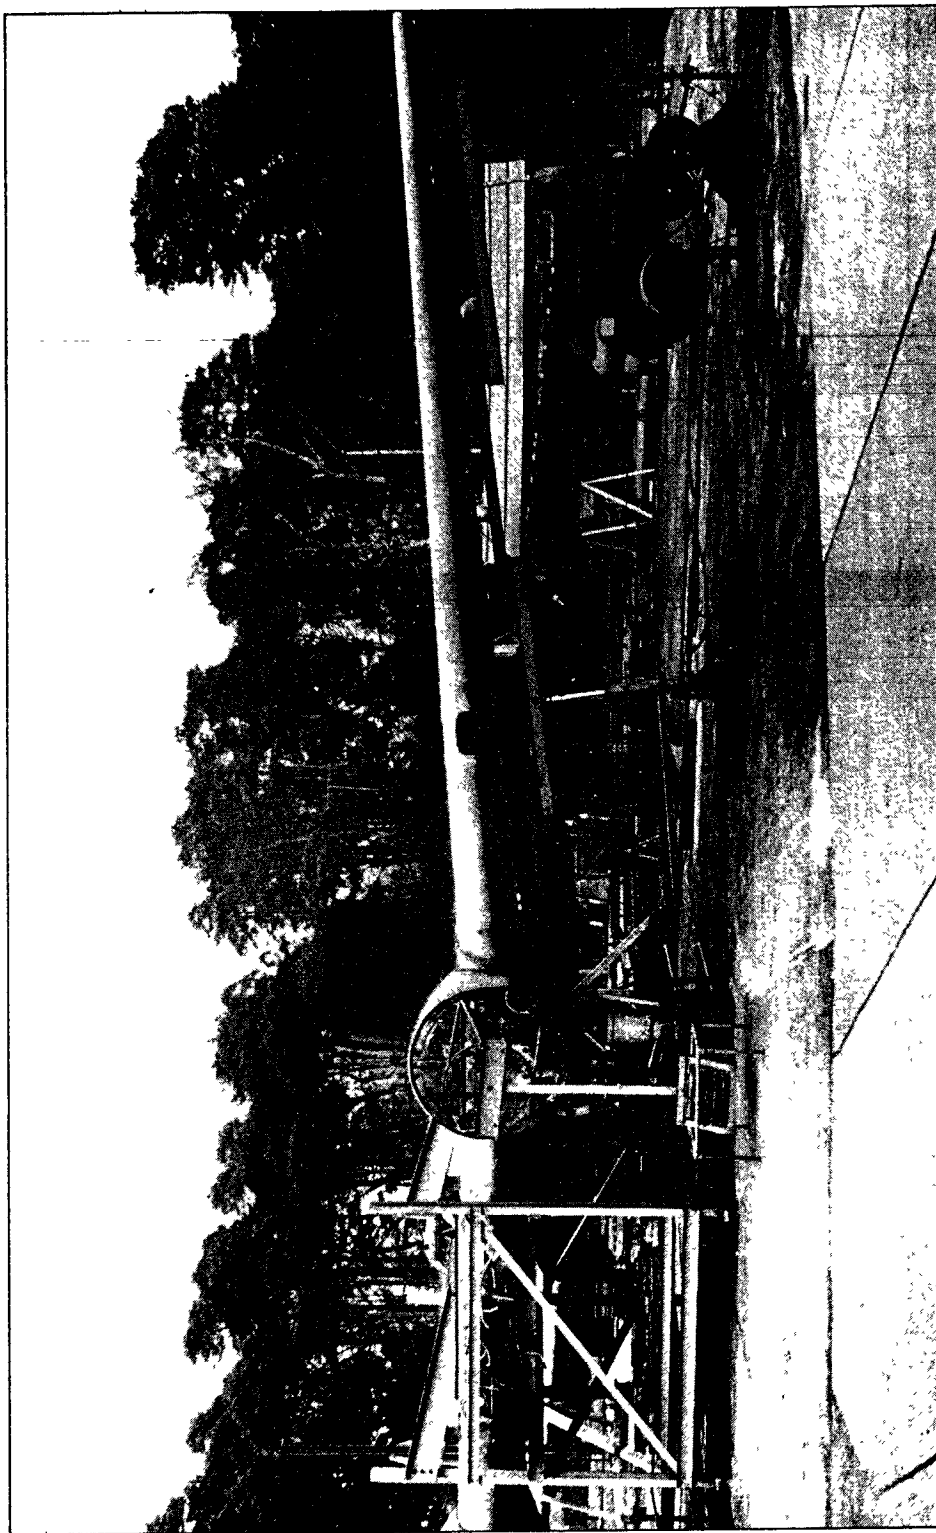
FIG.5. GENERAL VIEW OF DAKOTA WING FATIGUE TEST

By means of a hydraulic system, loads were applied through jacks acting in compression between the ground and lever systems attached to the bottom surface of the wing. Reactions were provided by a frame which supported the wing at the fuselage attachments, Fig.5.
