Civil Aircraft Airworthiness
Data Recording Programme
Special Events Relating to
Airspeed Control and Handling
(January 1968 to February 1969)

CAADRP Special Events Working Party

CIVIL AIRCRAFT AIRWORTHINESS DATA RECORDING PROGRAMME

SPECIAL EVENTS RELATING TO AIRSPEED CONTROL
AND HANDLING (January 1968 to February 1969)

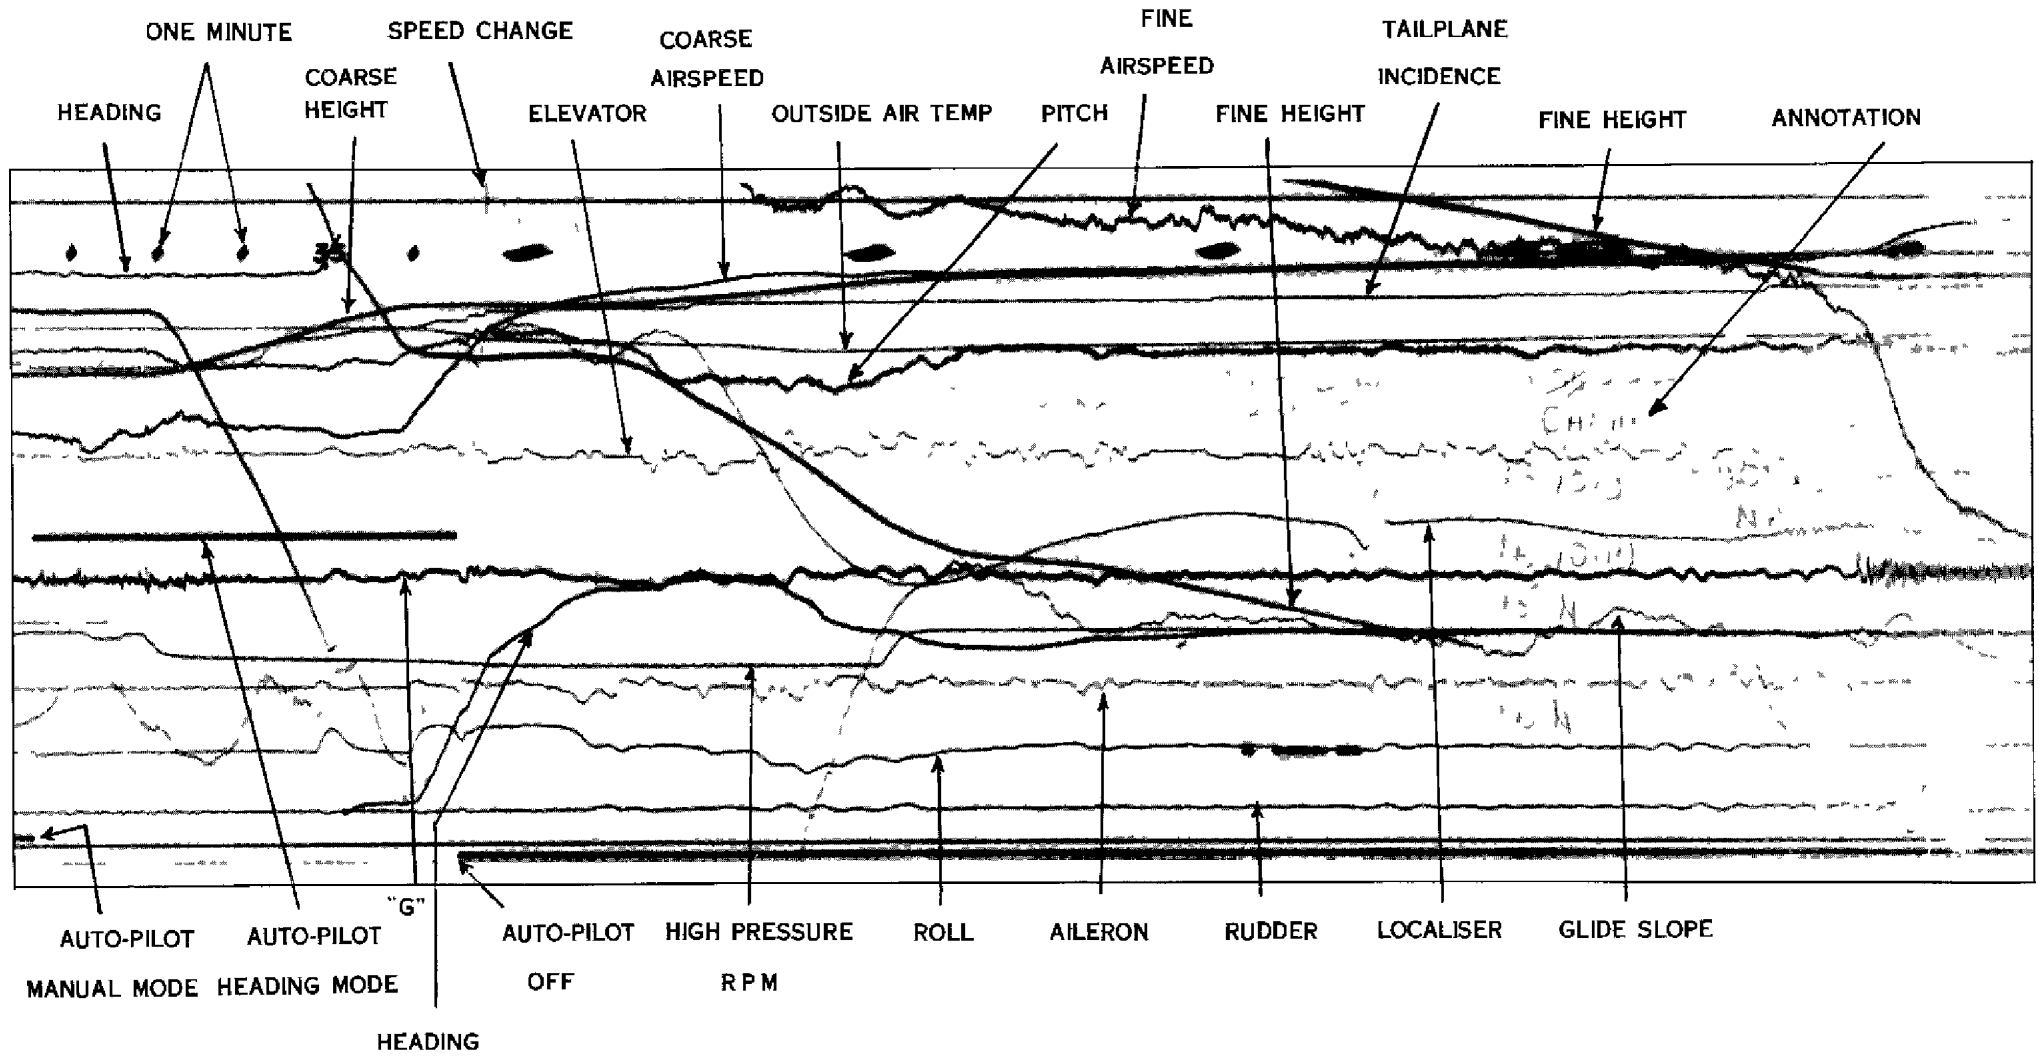
Fig.1. Sample record

Fig.1 shows a sample of normal flight to familiarise the reader with the recorded parameters. The events have been grouped according to flight phase.
