AERONAUTICAL RESEARCH COUNCIL
REPORTS AND MEMORANDA

Investigations on Stalling Behaviour,
Rudder Oscillations, Take-off Swing
and Flow Round Nacelles on the
Tudor I Aircraft

*Reports and Memoranda No. 2789**

December, 1947

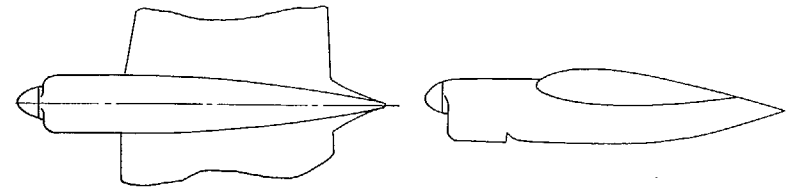
FIG. 8. Sketches of inner nacelle shapes.

5.3. *Flow Tests on Extended Type Inner Nacelle.*—A sketch of the extended inner nacelle is given in Fig. 8c. Deep-tufting tests showed no signs of any flow breakaway round the nacelle over the speed range from slow cruising to top speed; at low speeds the flow over the top of the nacelle rear fairing became confused with the wing root breakaway. The vibration level of the aircraft with the extended nacelles, flaps up, was lowered appreciably from either of the other two cases.

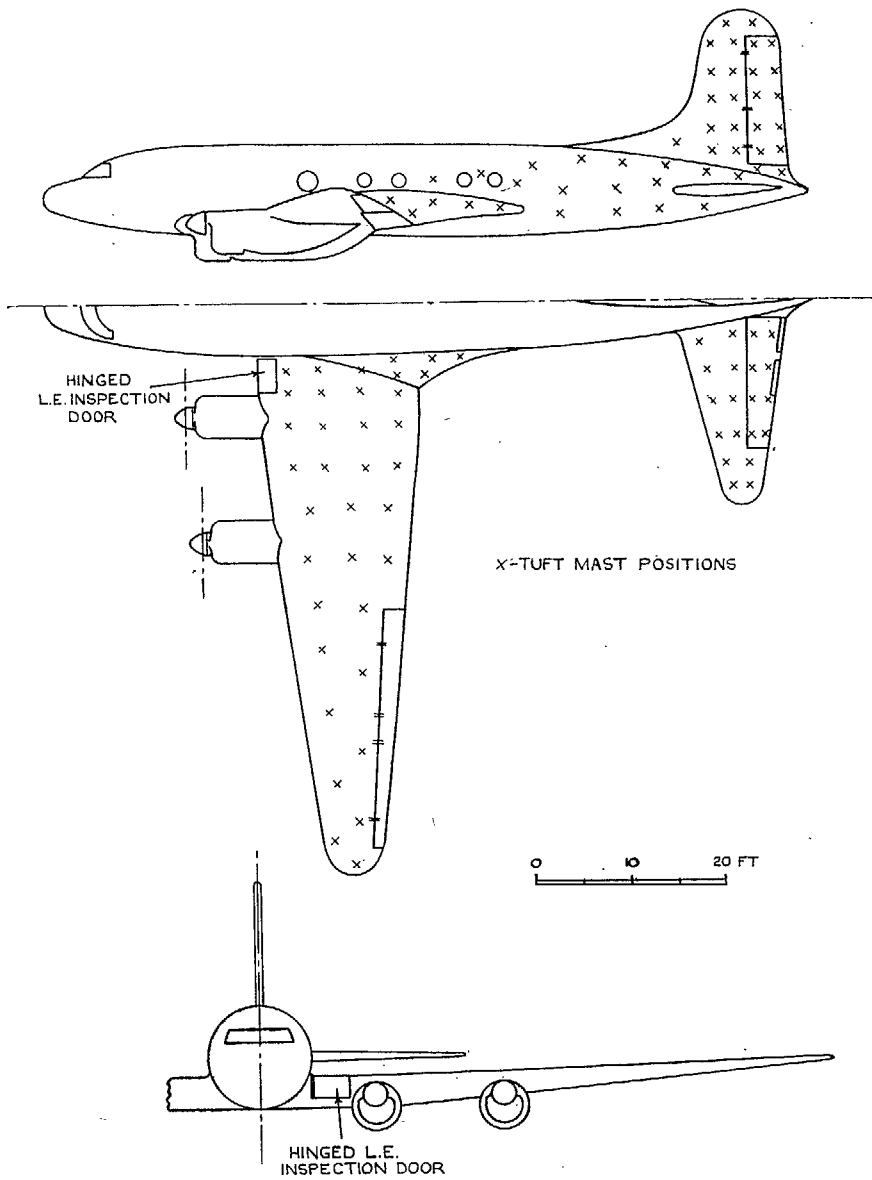
FIG. 1. Three-view general arrangement drawing of *Tudor I* with large fillets showing deep-tufting positions.

A map of the tuft mast positions indicating the density of tufting is given in Fig. 1. The behaviour of the tufts was observed visually mostly through the cabin windows, but a periscope was used for observation of the tailplane, fin and body tufting.
