Report of the Third Year's Flying on the Development
of Flight Testing Techniques for Finding and Measuring
Natural Icing Conditions

Report of the third year's flying on the development
of flight testing techniques for finding and measuring
natural icing conditions

Summary

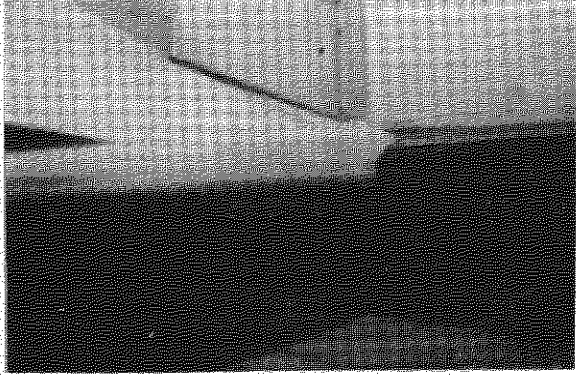
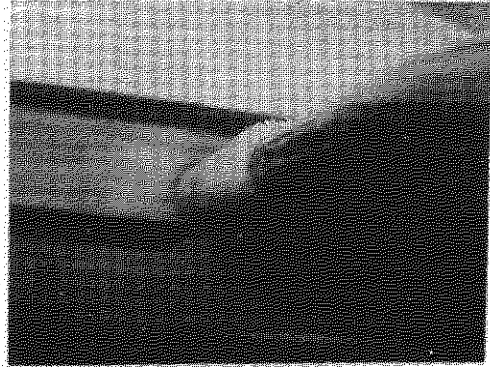
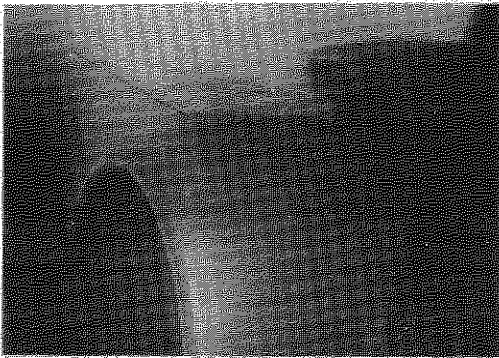
FIG.4.

FLIGHT 76

FLIGHT 65

FLIGHT 73

ICE FORMATION ON THE TAILPLANE AND OTHER PARTS OF THE AIRCRAFT.
PARTS OF THE AIRCRAFT.

4.3. Type of ice formation. With the addition of the tail camera more information on ice formation is becoming available. Figures 1 - 3 show interesting sequences taken by this camera. Figure 3 shows the ice formation on the tailplane after the aircraft had landed. A piece has been broken off to give a better view. It is interesting to estimate the thickness at the break. (see discussion in para. 5.3.). Figure 3 also illustrates some different ice formations on other parts of the aircraft.

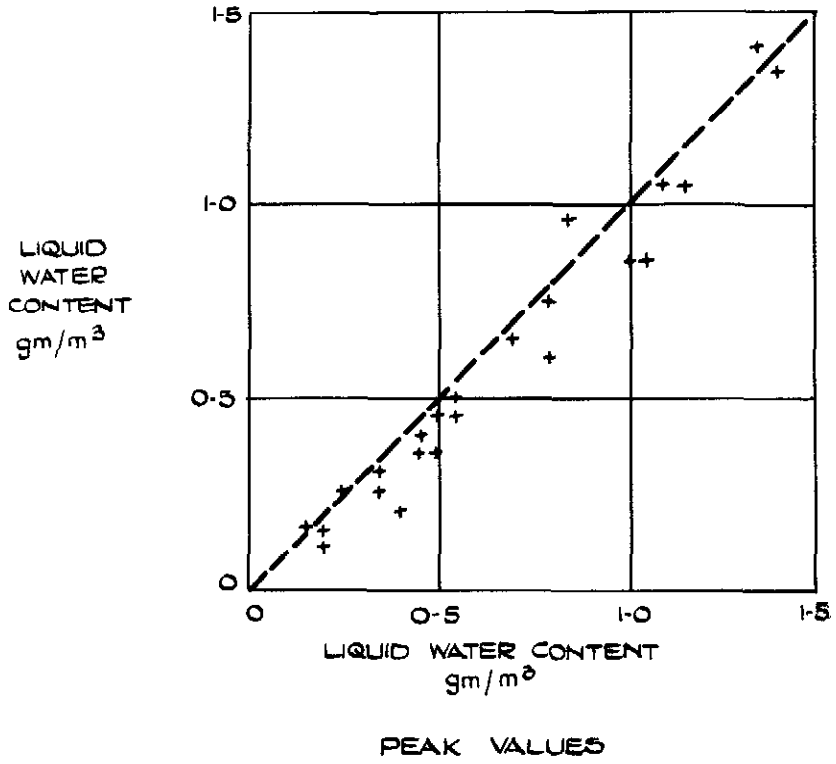
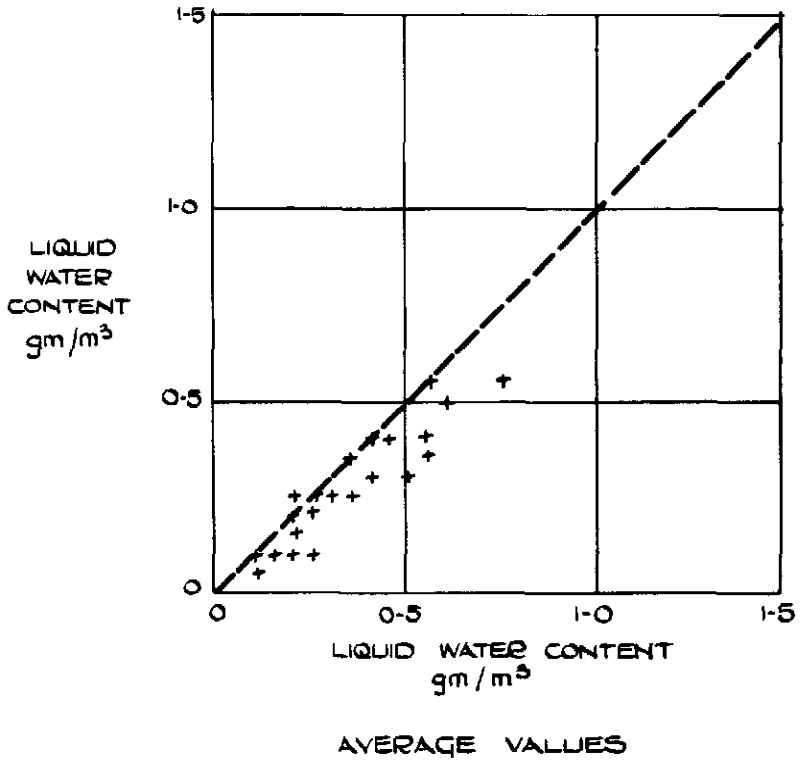
FIG. 7.

COMPARISON OF PORT & STARBOARD ROTATING DISC RECORDS.

COMPARISON OF PORT & STARBOARD ROTATING
DISC RESULTS.

5.4.2. Rotating discs. The rotating discs were both of a production pattern which had not been in use for long. During the year several small faults were found, most of which were finally eliminated. Apart from the inadequacy of the heater under severe icing conditions mentioned above, the two main faults arose from the adjustment of the feeler and the scraper. The feeler tensioning spring had to be reduced in size to give more adjustment at low tension and the friction of the feeler bearings had to be improved. The scraper was found to be ineffective on some types of ice and the tension of its spring had to be increased. Lastly the feeler and the disc being of the same metal, a groove was worn in the feeler which was not noticed at first but which made calibration difficult. The feelers are being replaced by new feelers of a harder steel. The other failures that were experienced were of a minor form such as broken electrical connections and were not attributable to the design of the disc. Now that the teething troubles have been overcome the discs are giving very useful measurements of liquid water content. Typical records of both discs are given in figure 6, for a small part of flight 71. This illustrates one of the early failings in that the feeler on the port disc pushed off the first piece of ice formation and so did not start to measure until some six seconds after the starboard disc. The starboard disc gives a lower liquid water content than the port of the order of 0.1 grams per cubic metre. This happened fairly generally as can be seen from figure 7 where the values of liquid water content obtained from each disc are plotted against one another. The port disc was sited much further forward than the starboard disc and it is to be expected that it would give a higher reading due to the effect of the fuselage on the droplet trajectories. This point is clearly illustrated in reference 4 where the liquid water concentrations round an ellipsoid are compared with the conditions in undisturbed air.
